Browns Ferry Nuclear Plant, Units 1, 2, and 3  
Renewed Facility Operating License Nos. DPR-33, DPR-52, and DPR-68  
NRC Docket Nos. 50-259, 50-260, and 50-296

Subject: **Proposed Technical Specifications (TS) Change TS-505 - Request for License Amendments - Extended Power Uprate (EPU) - Supplement 4, Responses to Requests for Additional Information**

**Responses to NRC Requests for Additional Information  
EEEEB-RAI 2, EEEB-RAI 3, EEEB-RAI 4, and ESGB-RAI 1**

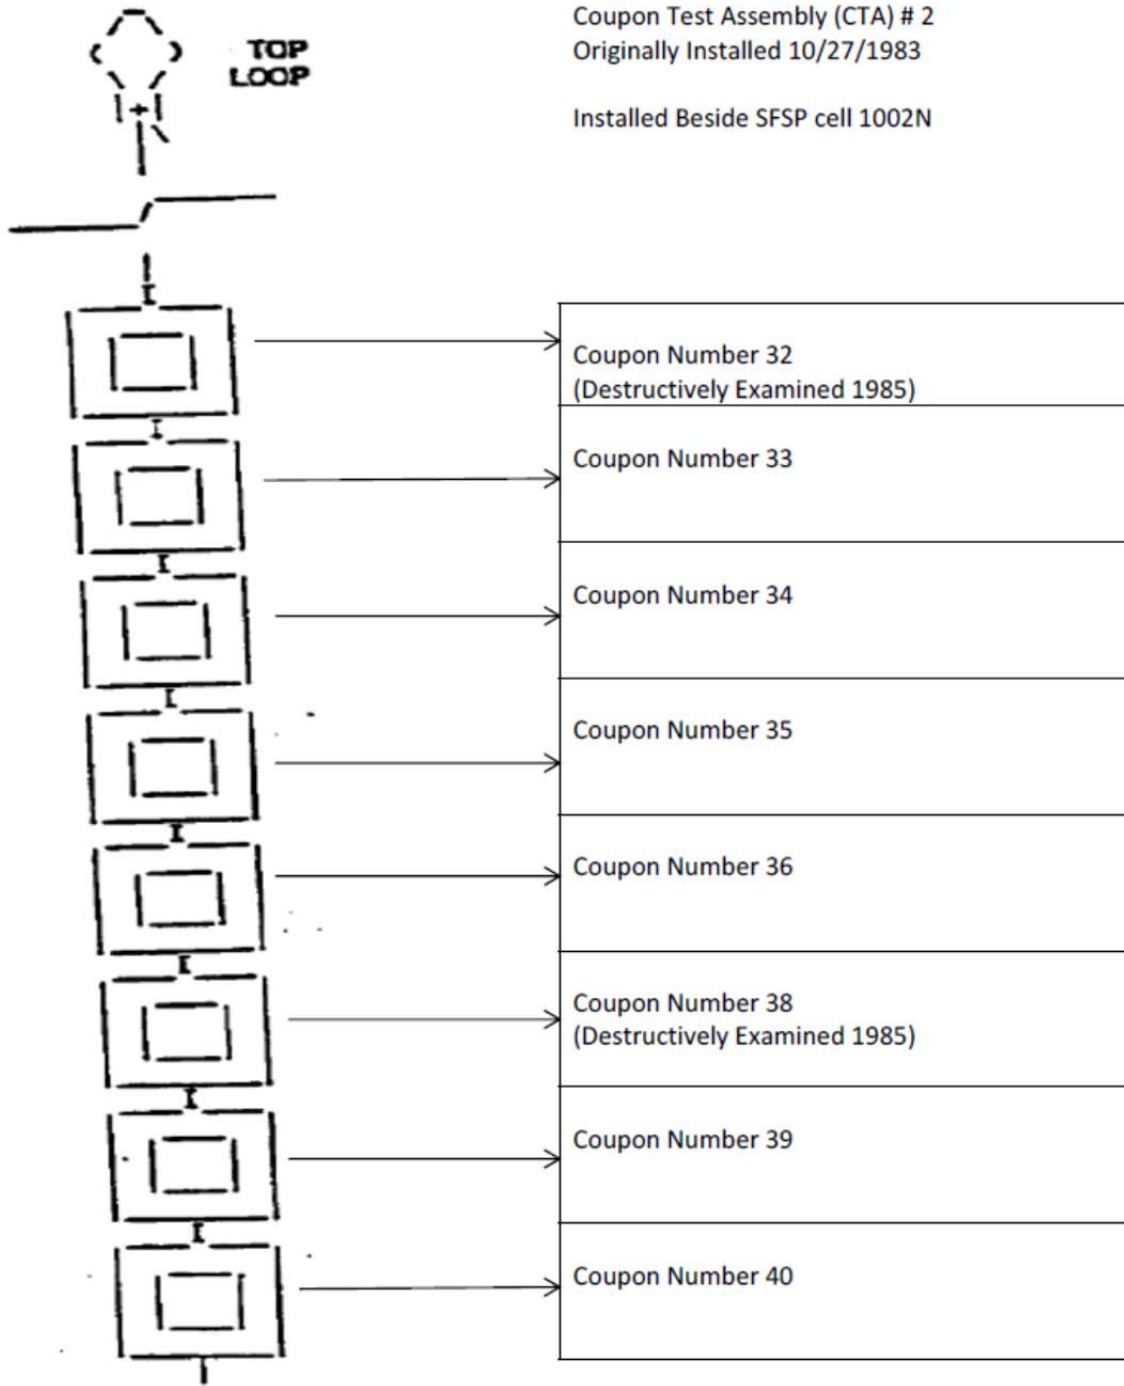
**Figure 1**  
**Coupon Test Assembly (continued)**

Coupon Test Assembly (CTA) # 2  
Originally Installed 10/27/1983

Installed Beside SFSP cell 1002N

In October 1983, a total of 16 Boral Cermet test coupons were installed in the Unit 3 SFSP. The 16 coupons were contained in two CTAs (CTA #1 and CTA #2) as shown in Figure 1. The test coupons were supplied by the HDFSR manufacturer and are of the same metallurgical condition as the HDFSR in thickness, chemistry, finish and temper. Each test coupon had a hole drilled through the stainless steel sheath covering the Boral Cermet, which allows exposure of the Boral

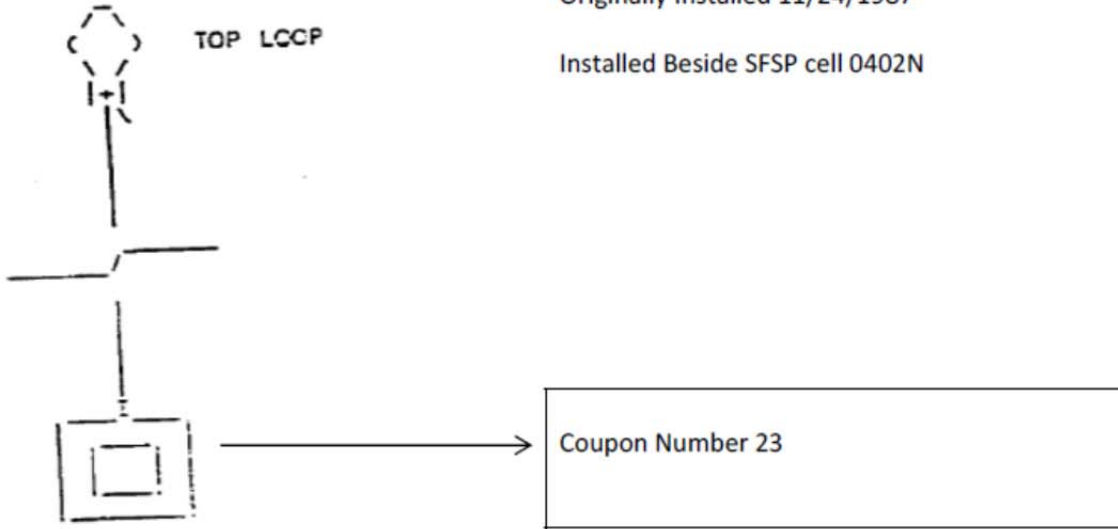
Coupon Test Assembly (CTA) # 3  
Originally Installed 11/24/1987

Installed Beside SFSP cell 0402N

<b>Inspection</b>	<b>Summary</b>
January 1987	Limited data available from search of TVA records. Thickness measurements for 4 coupons. No anomalies reported.
October 1987	<ul style="list-style-type: none"> <li>• Four new test coupons were installed. Coupon #23 (sheathed coupon) designated as CTA #3. Coupon #24 (sheathed coupon) designated as CTA #4. (See Figure 1). Coupon 22 (unsheathed coupon) designated as BPTA #1. Coupon #41 (unsheathed coupon) designated at BPTA #2. (See Figure 2). Pre-exposure thickness and linear dimension measurements were performed prior to installation.</li> <li>• Coupon #30 was unsheathed and redesignated as BPTA #3. Upon unsheathing coupon #30, small blisters (5 total) were observed and recorded. The blisters were evaluated to not have an effect on function of the Boral Cermet.</li> <li>• Thickness measurements were performed and recorded on all other coupons. No anomalies reported.</li> <li>• All coupons reinserted into the Unit 3 SFSP.</li> <li>• Recommendation was to continue with six month periodicity of inspection.</li> </ul>

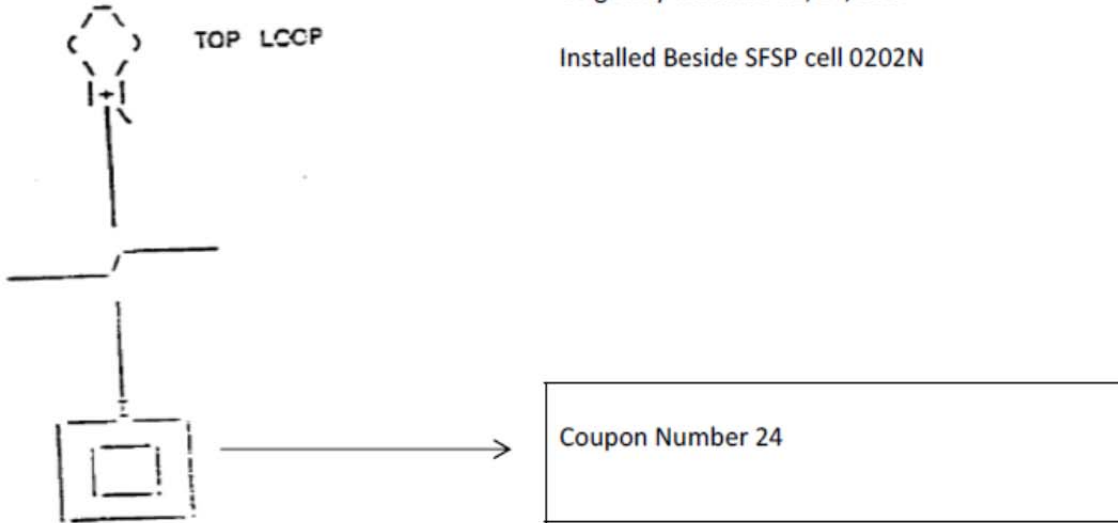
**Figure 1**  
**Coupon Test Assembly (continued)**

Coupon Test Assembly (CTA) # 4  
Originally Installed 11/24/1987

Installed Beside SFSP cell 0202N
