AEOD/S97-01

OCONEE ELECTRICAL SYSTEM DESIGN AND OPERATION

SPECIAL STUDY

**Reactor Analysis Branch
Safety Programs Division
Office for Analysis and Evaluation
of Operational Data
U.S. Nuclear Regulatory Commission**

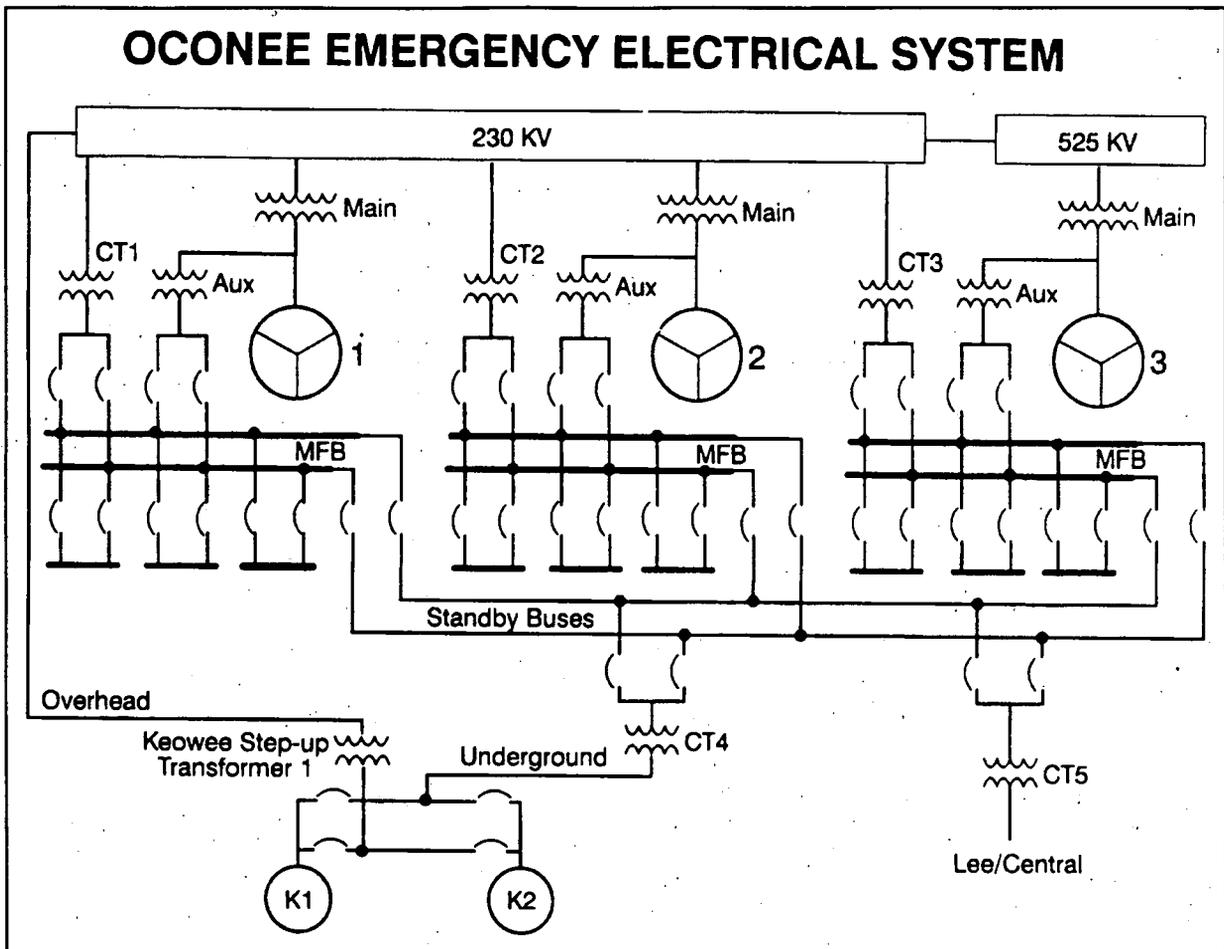
Emergency ac power is provided to the three Oconee nuclear units by two Keowee hydroelectric units rather than by the typical diesel generator systems. Figure 1 represents a simplified diagram of the power sources and connections. Upon a LOOP at any Oconee unit, both Keowee hydroelectric units start automatically, with one Keowee hydroelectric unit connected to the underground path, capable of feeding the Oconee main feeder buses through transformer CT4 and the standby buses, and the other Keowee hydroelectric unit connected to the overhead path, capable of feeding the Oconee main feeder buses through the startup transformer CT3 (for Oconee Unit 3, CT2 for Oconee Unit 2, and CT1 for Oconee Unit 1). The overhead path connections are through the 230 kV switchyard and connected with circuits which are also used for normal power generation. Initial information provided to the Nuclear Regulatory Commission's Office of Analysis and Evaluation of Operational Data (AEOD) staff indicated that both Keowee units were used several hours a day for generating power to the grid. However, in their peer review comments (Ref. 1), Duke Engineering indicated that review of Keowee operating data showed that the Keowee units were actually used for commercial power generation (to the grid) approximately six percent of the year — with dual unit grid generation approximately three percent of the year.

Following a LOOP, emergency power to all Oconee nuclear units may be supplied either through the underground path or the overhead path; and in some cases, a single Keowee hydroelectric unit could supply power to all emergency loads. Most nuclear plant emergency power systems provide power to one safety division from one diesel and to the second safety division from a second diesel.

Figure 1 Oconee Emergency Electrical System

Since the overhead path for emergency power is through the switchyard, a LOOP event which originates in the switchyard can disable the overhead path as a source of emergency power. Operating experience at Oconee, as well as other U.S. nuclear plants, shows that this is the most likely LOOP scenario. Thus, the overhead path is more likely to be lost than the underground path.

The source of power for the main feeder buses is chosen by automatic auctioneering of the available power sources; if the startup transformer loses power and the standby buses are energized, the main feeder buses are automatically connected to the standby buses, and if the standby buses lose power and the startup transformer is energized, the main feeder buses are automatically connected to the startup transformer. The Lee Station gas turbine units and the Central substation provide additional offsite power sources via manual connection through the CT5 transformer. In this case, the Lee gas turbines must be separated from the grid. In addition, Central can be used as a maintenance source of power during Oconee unit outages for brief periods of time. For SBO scenarios caused by LOOP and failure of Keowee hydroelectric units to start or run, the CT5 source could be available in approximately 1 hour. The main feeder buses are powered from the auxiliary transformer during normal power operation and from the startup transformer (CT1, CT2, or CT3 depending on the unit) during shutdown operation.

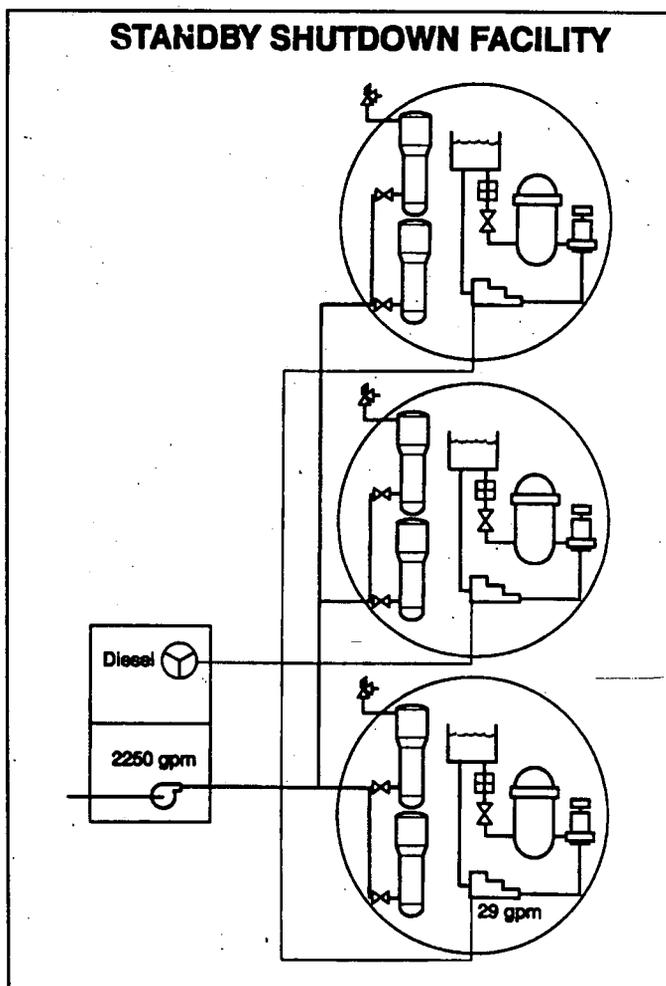
Figure 2 shows a simple schematic diagram of the SSF. Two basic functions are performed by the SSF:

Figure 2 Standby Shutdown Facility

(1) makeup water to the reactor coolant system through the reactor coolant pump (RCP) seals, and (2) feedwater to the steam generators. Primary system makeup water cools the RCP seals to prevent a seal loss-of-coolant accident (LOCA) and maintains primary system inventory to ensure natural circulation; feedwater to the steam generators removes decay heat. Feedwater to the steam generators of all three Oconee nuclear units is provided by a single 2250-gpm pump. The SSF water source for steam generator feedwater is raw water from the emergency condenser cooling water system. Primary system makeup water is provided by one positive displacement pump for each Oconee unit, each with a 29-gpm capacity. The water source for primary makeup water is the spent fuel pool (SFP). Electric power for the SSF is from a single diesel generator.

The SSF was not part of the original Oconee design but was installed in the early 1980s to respond to fire, flood, and sabotage events. Later, the SSF was utilized to meet the requirement of the SBO rule to cope with SBO for 4 hours. In addition, the NRC safety evaluation report (Ref. 2) which accepted the nonseismic emergency feedwater system design at the Oconee plant did so on the basis of the capabilities of the seismically robust SSF.
