SEABROOK STATION UPDATED FINAL SAFETY ANALYSIS REPORT	Time History Accelogram (0.25g), Horizontal Component 1 - SSE	
		Figure 3.7(B)-1

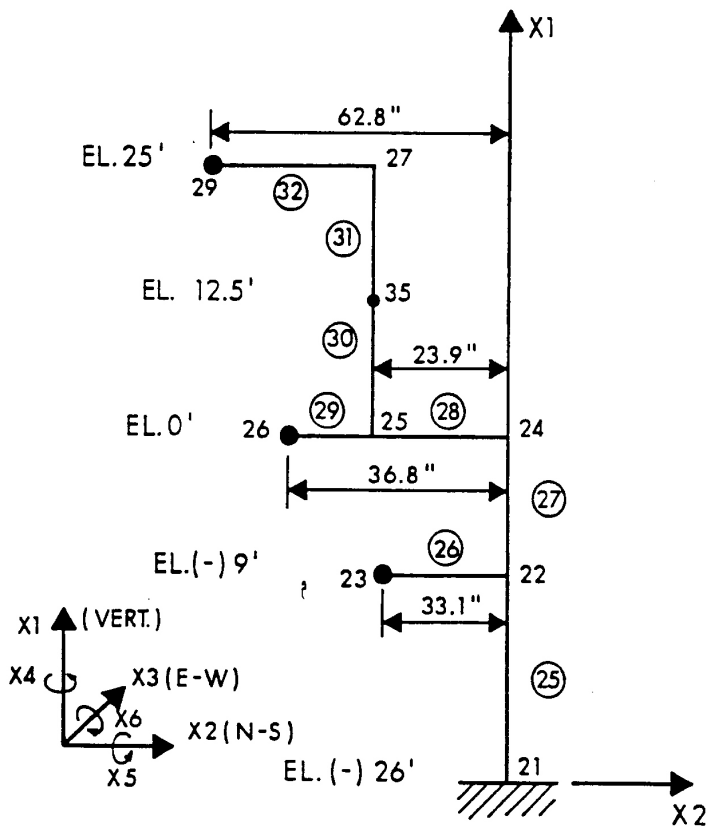
SEABROOK STATION UPDATED FINAL SAFETY ANALYSIS REPORT	Containment Internals - Mathematical Model	
		Figure 3.7(B)-22
