**BEFORE THE UNITED STATES
NUCLEAR REGULATORY COMMISSION**

_____)	
In the Matter of)	
)	Docket Nos. 50-247
ENTERGY NUCLEAR OPERATIONS, INC.)	50-286
)	
(Indian Point Nuclear Generating Station, Units 2 and 3))	
_____)

**FRIENDS OF THE EARTH’S EMERGENCY PETITION TO PROHIBIT RESTART
OF INDIAN POINT UNIT 2 AND INSPECT INDIAN POINT UNIT 3**

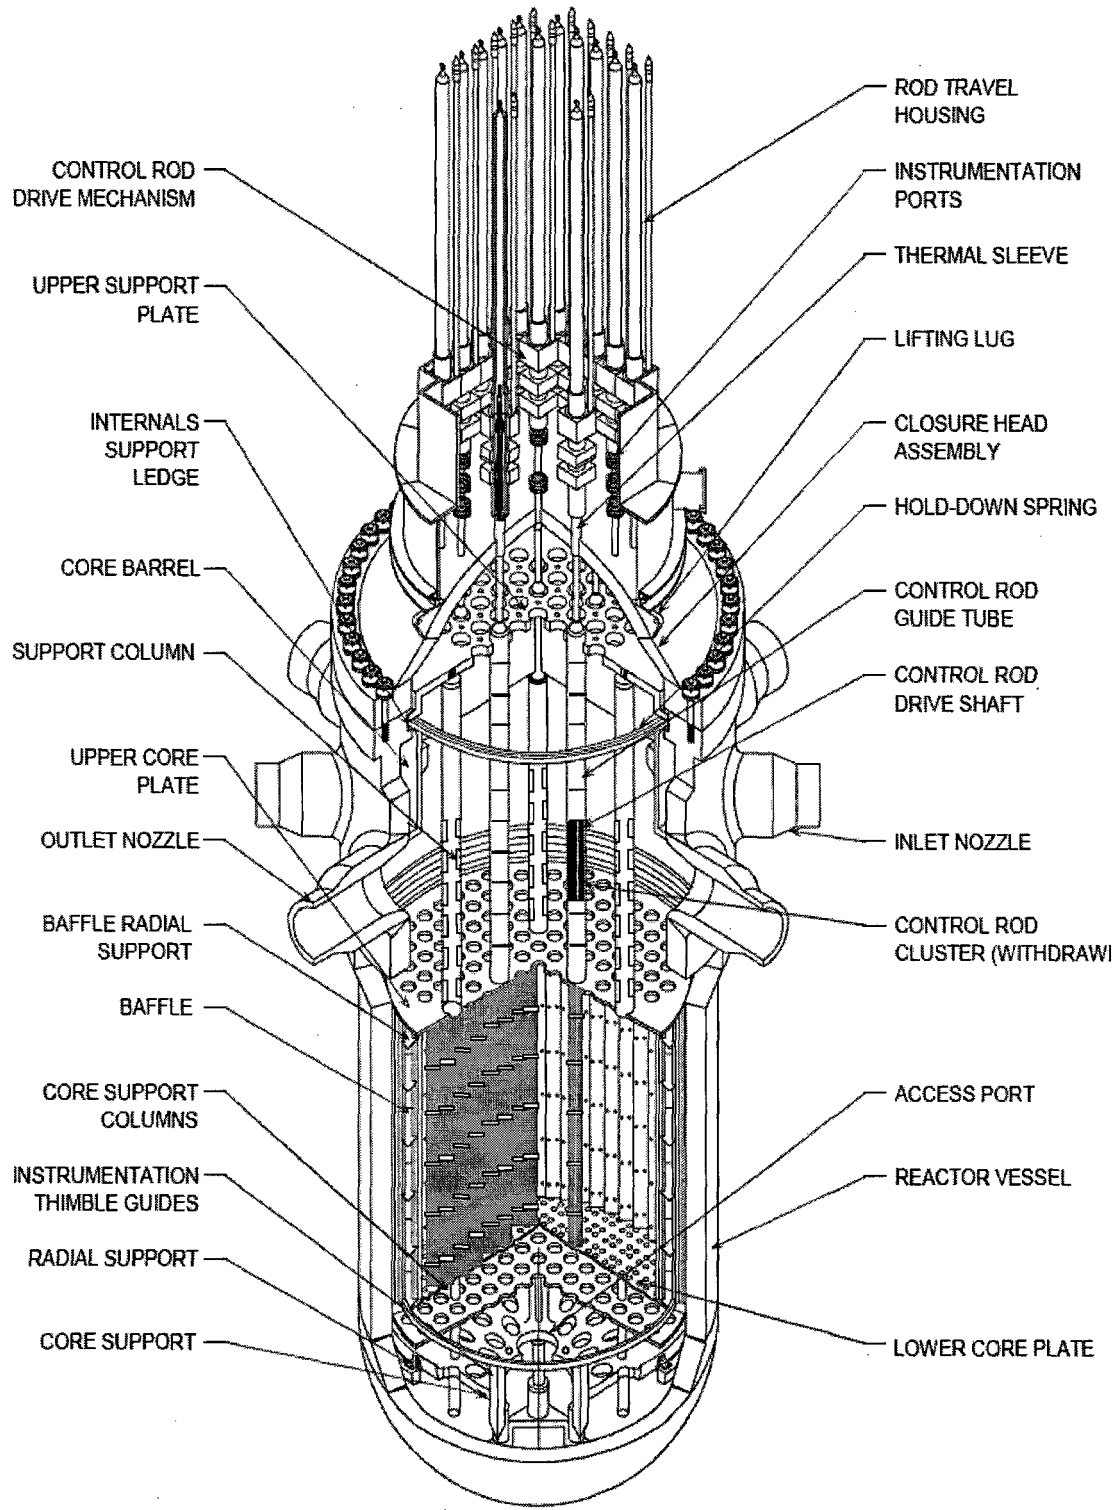
Indian Point Units 2 and 3 are Westinghouse pressurized water reactors. Each reactor contains hundreds of baffle-former bolts, which are stainless steel bolts approximately 5/8" in diameter and 2" long that hold the baffle plates to the former plates to form the baffle/former assembly. The baffle/former assembly forms the interface between the reactor core and the reactor core barrel, as shown in Figure 1, below.

Figure 1 – typical Westinghouse reactor vessel internals (source: ML15331A179)
