On behalf of Friends of the Earth, please find attached an emergency petition regarding Indian Point Nuclear Generating Station. We ask that you give it expedited consideration.

**BEFORE THE UNITED STATES  
NUCLEAR REGULATORY COMMISSION**

On March 29, 2016, Entergy discovered that over one-quarter of stainless steel bolts holding together metal plates inside Indian Point Unit 2’s reactor core—bolts that play a vital safety role by ensuring that coolant continues to flow through the reactor—were damaged, degraded, or otherwise failed. Some of these bolts were discovered to be missing entirely and, presumably, were floating around the inside of the reactor vessel. The regulator’s response so far to this increased risk to public health and safety is to allow *Entergy*, the licensee and regulated party, free rein to decide whether and to what extent it should analyze the cause of the failure, and to determine when, in *Entergy’s* opinion, the plant is safe to restart. To remedy this lapse in regulatory oversight in the face of a major failure affecting the safety of operating Indian Point, Friends of the Earth (“Friends”) asks the Commission to (1) prohibit the restart of Unit 2 unti

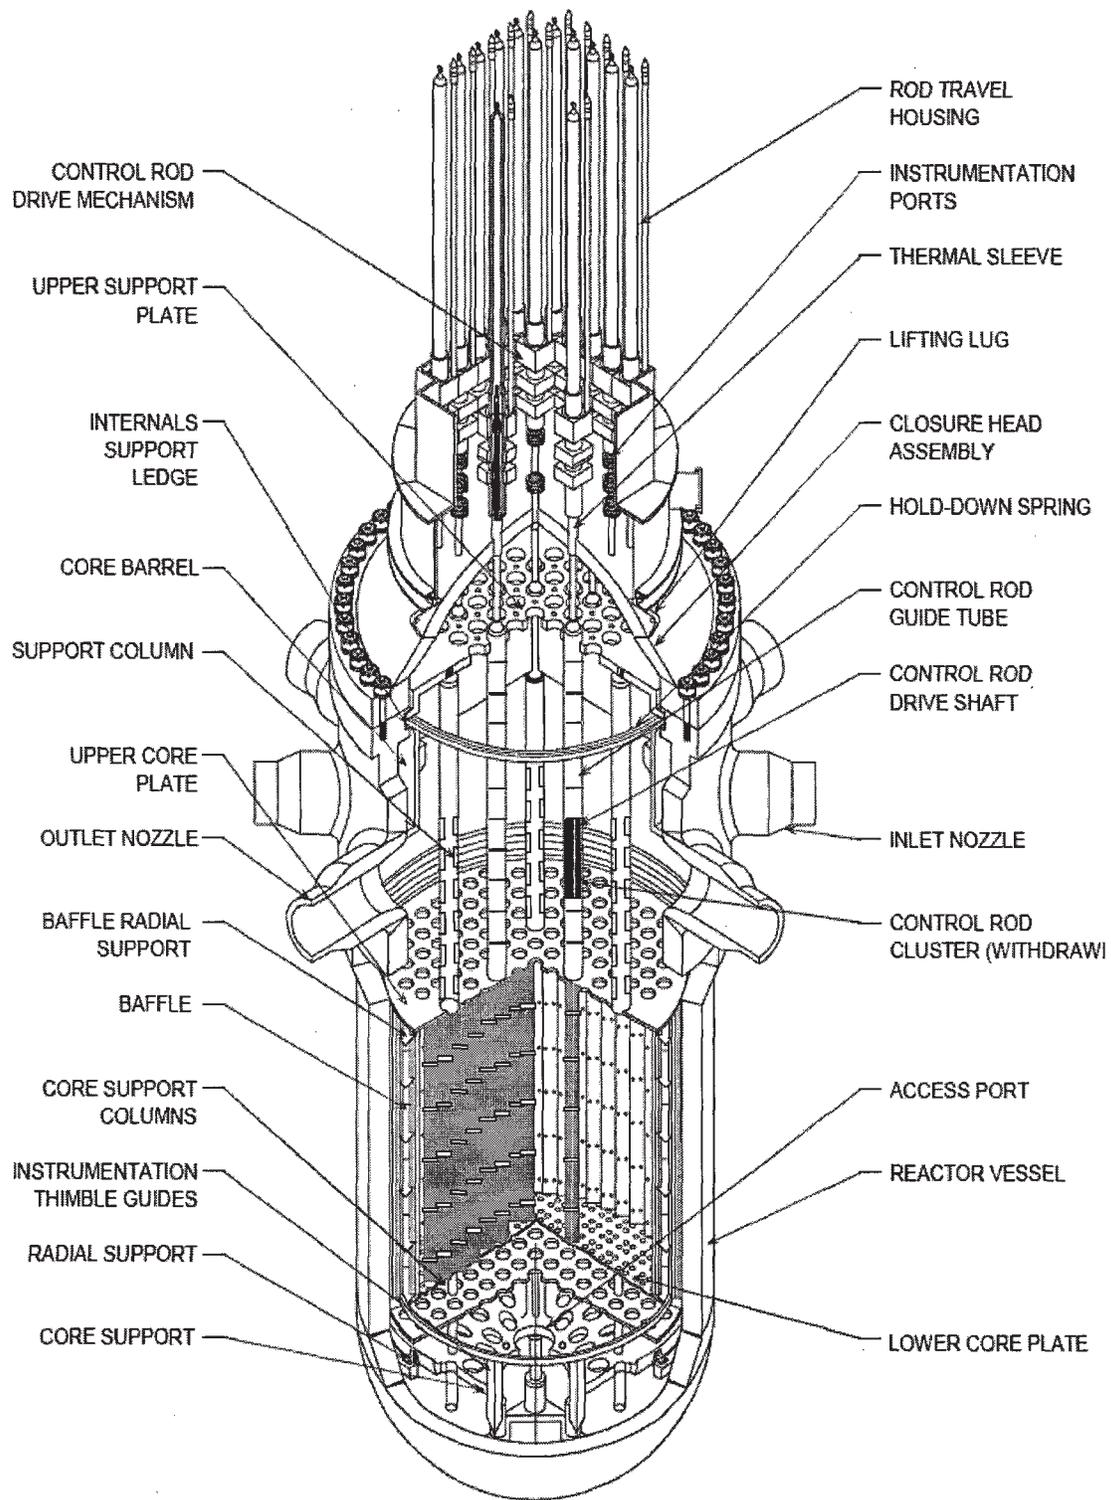
Indian Point Units 2 and 3 are Westinghouse pressurized water reactors. Each reactor contains hundreds of baffle-former bolts, which are stainless steel bolts approximately 5/8" in diameter and 2" long that hold the baffle plates to the former plates to form the baffle/former assembly. The baffle/former assembly forms the interface between the reactor core and the reactor core barrel, as shown in Figure 1, below.

Figure 1 – typical Westinghouse reactor vessel internals (source: ML15331A179)

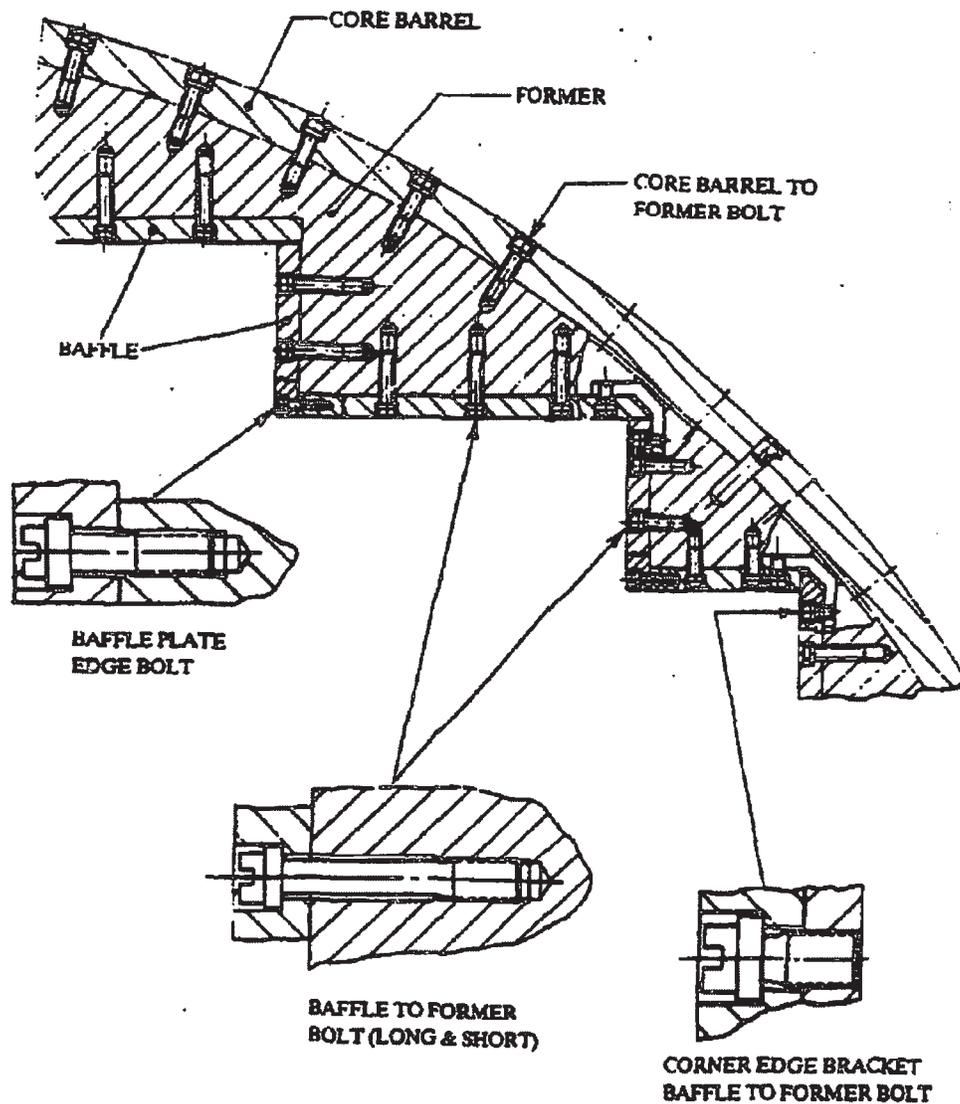
The bolts have a number of important safety-related functions. The baffles provide a barrier between the reactor core and the former to direct coolant flow through the reactor core. The bolts also provide lateral support to the reactor core during an earthquake or a loss-of-coolant accident and reduce neutron flux on the vessel, as shown in Figure 2, below.

Figure 2 – bolt locations in typical Westinghouse baffle-former-barrel structure (source: ML15331A179)

Failure of baffle-former bolts could cause coolant to leak through gaps between adjacent baffle plates, providing pathways for coolant to bypass the reactor core, potentially leading to a core meltdown. NRC Briefing of Commissioners on Indian Point Baffle Bolt Inspections (Apr. 19, 2016) at 4 (“NRC Slides”).<sup>1</sup> Degraded or missing bolts can also impede the assurance of core safety during an earthquake.
