**DAM BREACH MODELING FOR HAZARD CLASSIFICATION**  
**HOMESTAKE MINING COMPANY OF CALIFORNIA**  
**GRANTS RECLAMATION PROJECT**  
**GRANTS, NEW MEXICO**

Prepared by Alan Kuhn Associates LLC

March 23, 2016

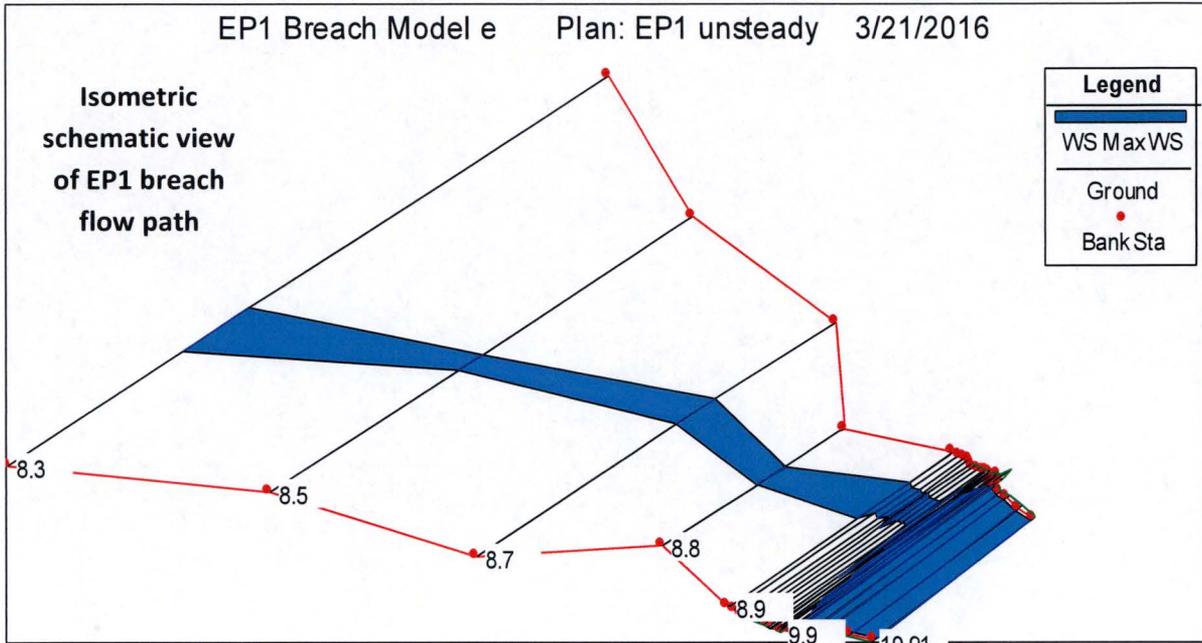
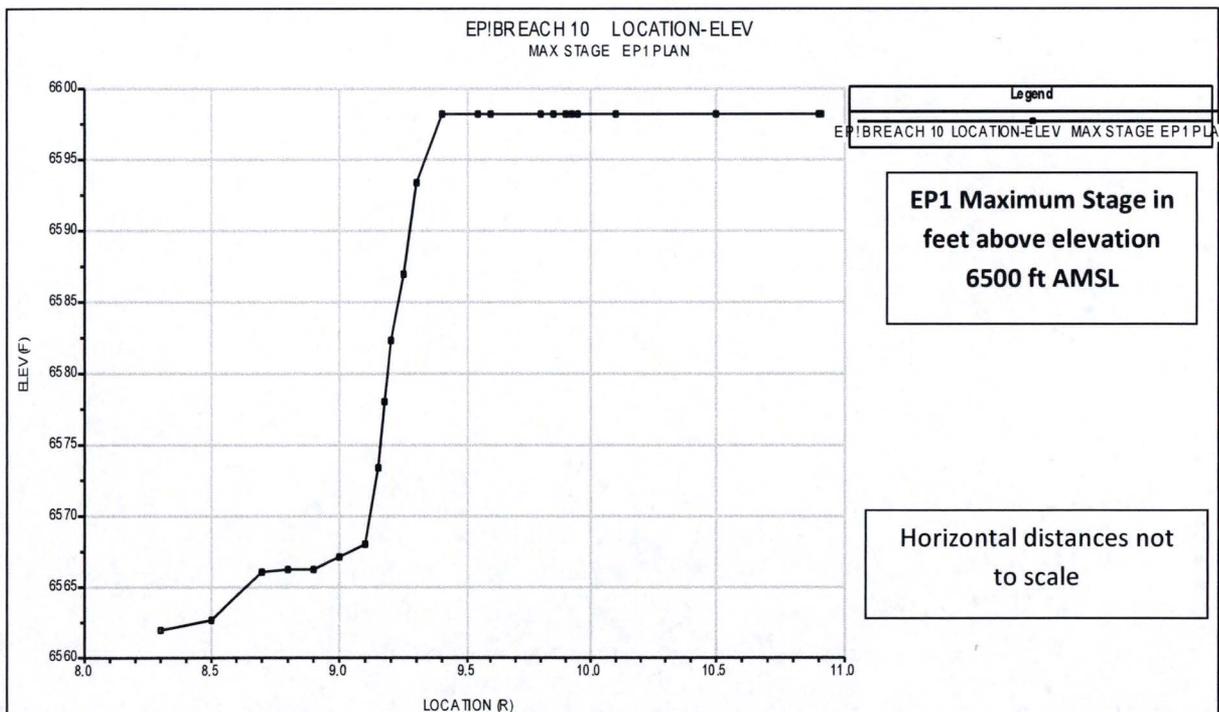
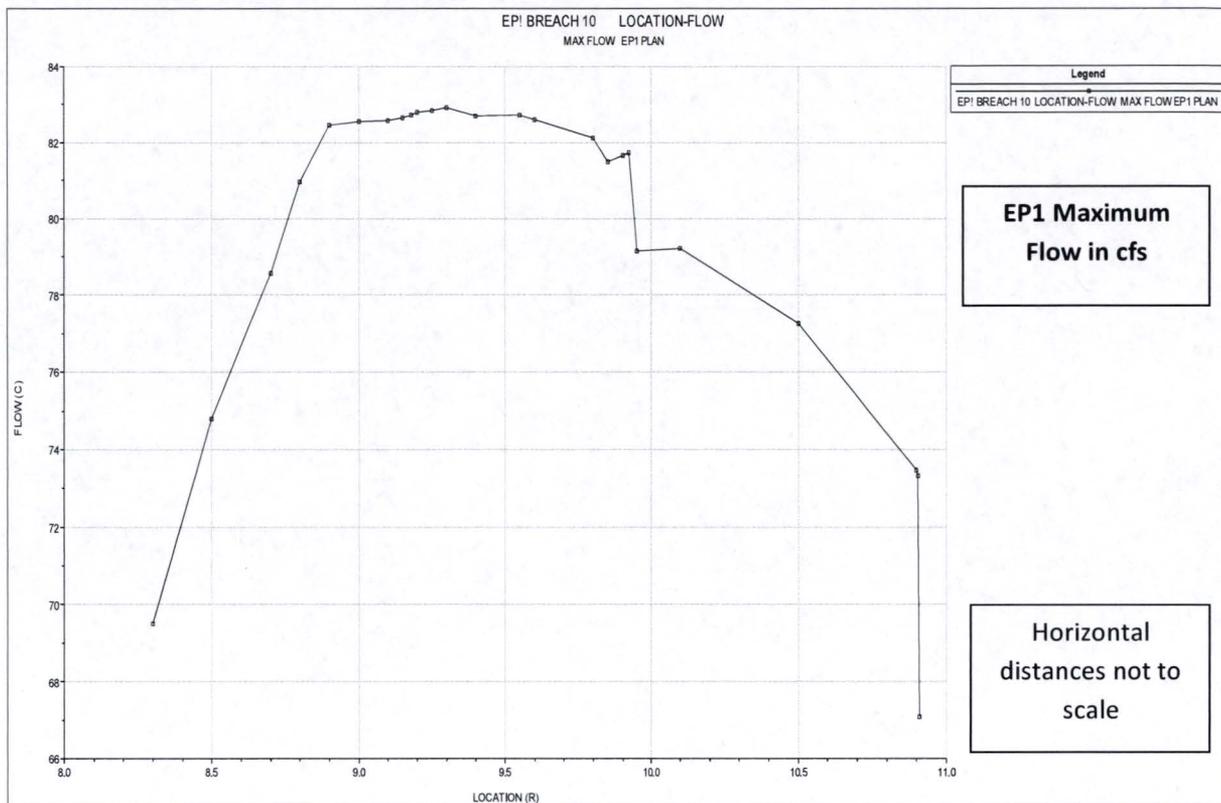
**EVAPORATION POND 1 (EP1) HEC RAS Output**

The results of the model (file name: EP1 Breach Model e) are illustrated by the following graphs, table and isometric image extracted from the output file of HEC RAS. As expected, the highest stages and flow rates occur as flow converges in the pond toward the breach and passes over the berm down the steep outslope. Once flow passes across the downstream toe and spreads out over the flat ground south of EP1, the flow rates and depths decrease. At the downstream end of the model flow path, near the south property boundary, the maximum flow would be 0.20 ft deep and approximately 300 ft wide.

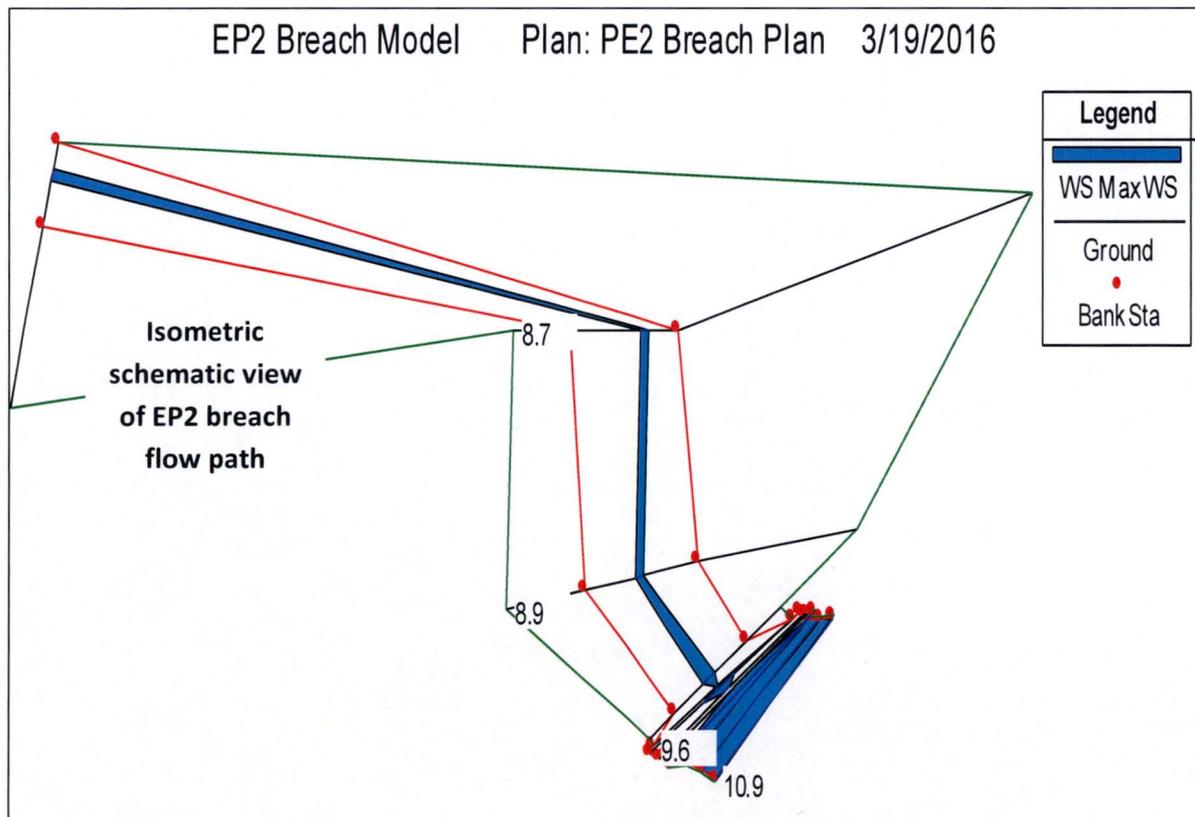
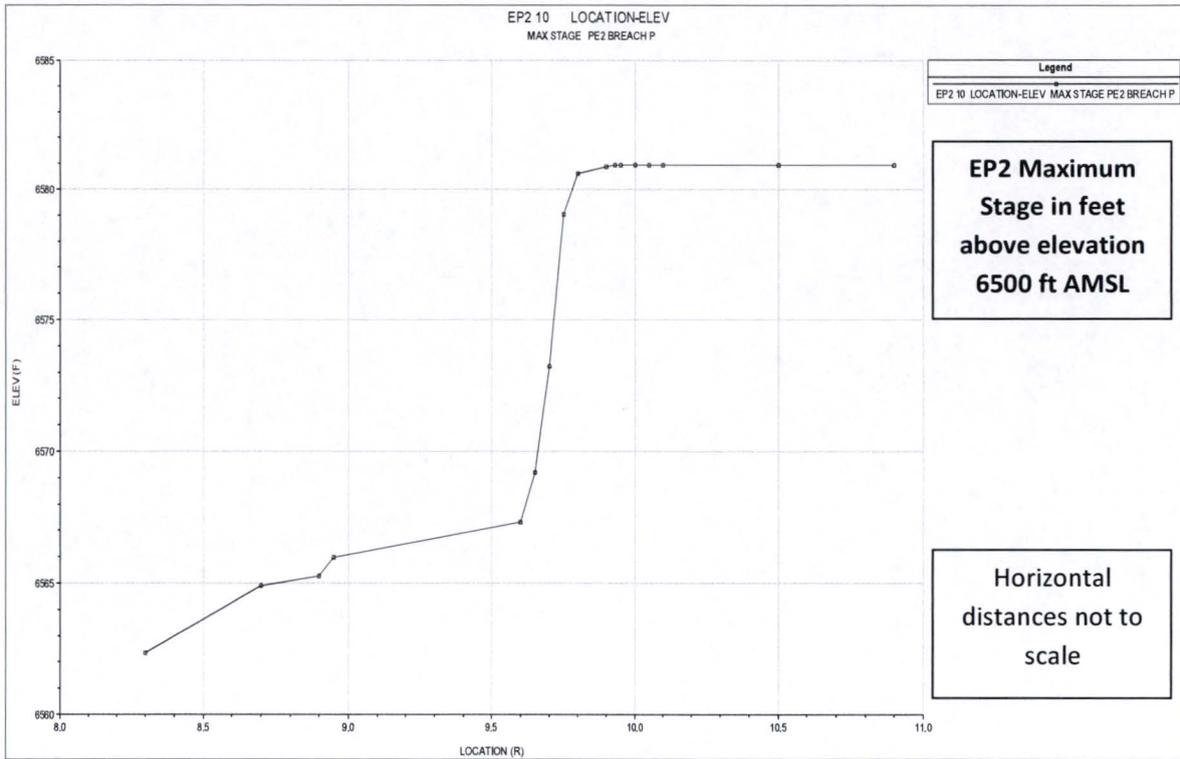
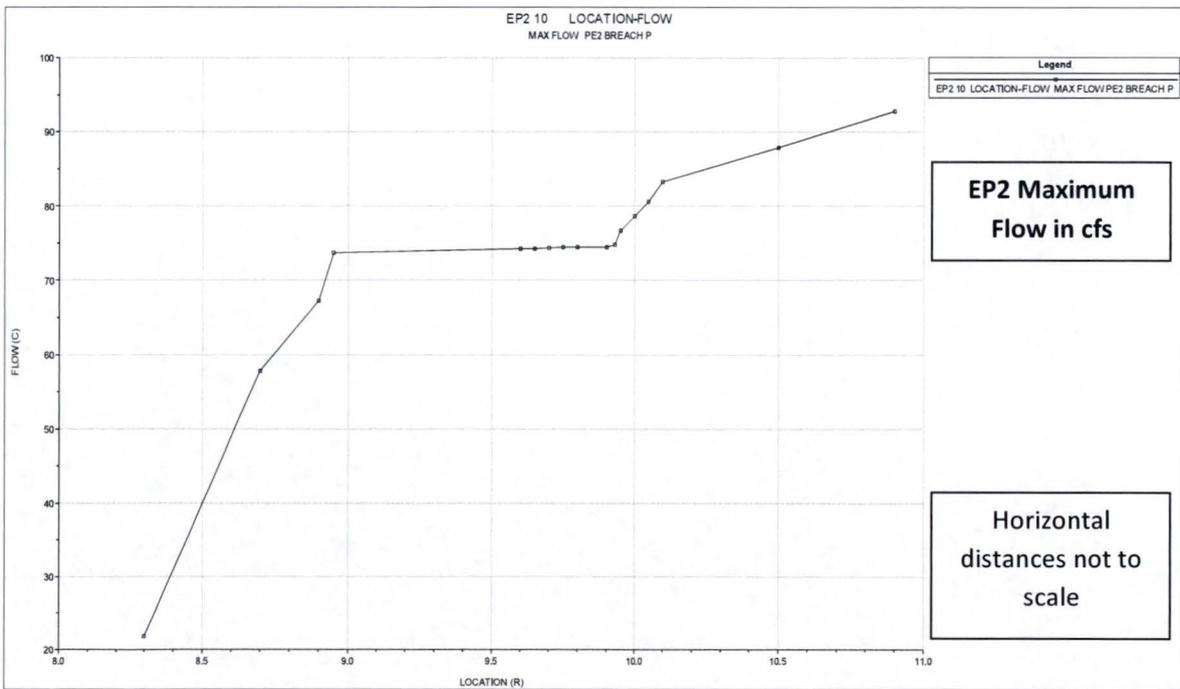
### EVAPORATION POND 2 (EP2) HEC RAS Output

The results of the model (file name: EP2 Breach Model a) are illustrated by the following graphs, table and isometric image extracted from the output file of HEC RAS. Highest stages and flow rates occur as flow converges in the pond toward the breach and passes over the berm down the steep outslope. Once flow passes across the downstream toe and spreads out over the flat ground south of EP2, the flow rates and depths decrease. The flow is deflected from southwesterly to southerly flow when it encounters the old Thunderbird Road embankment. At the downstream end of the model flow path, near the south property boundary, the maximum breach flow would be 0.84 ft deep and approximately 260 ft wide.

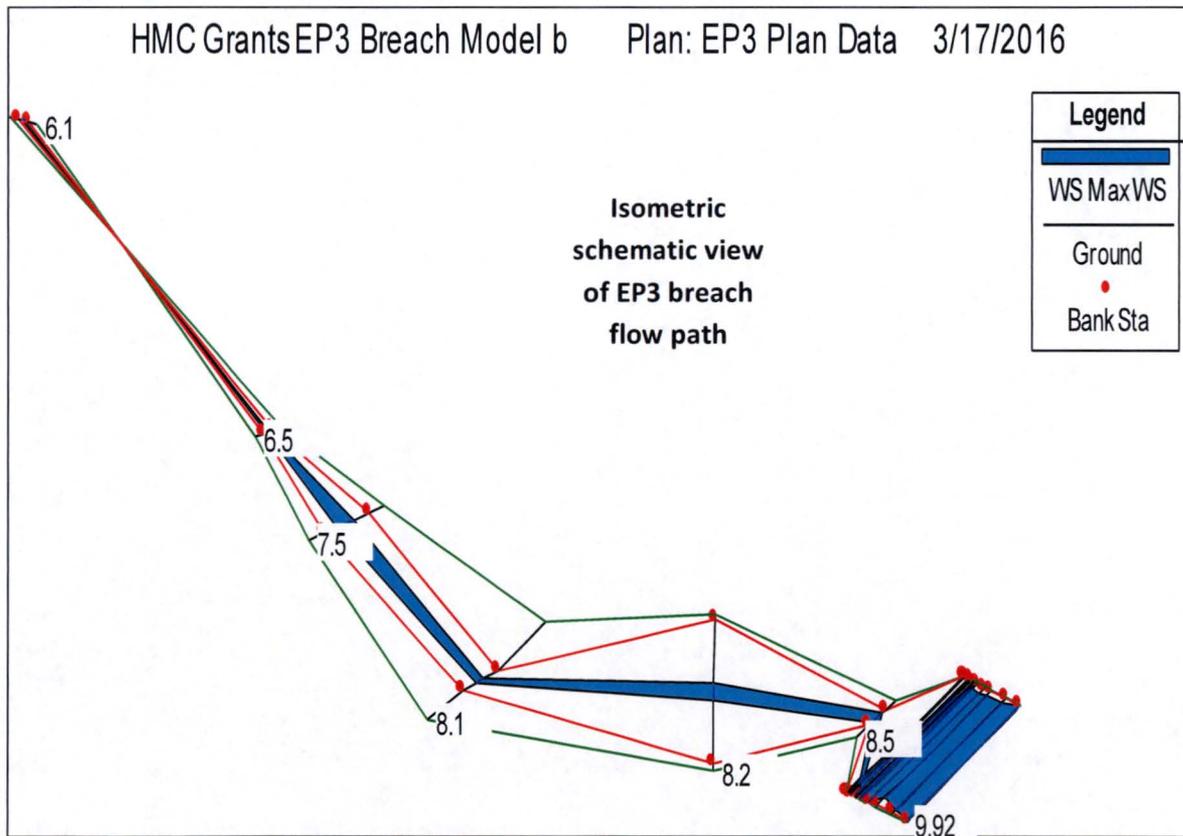
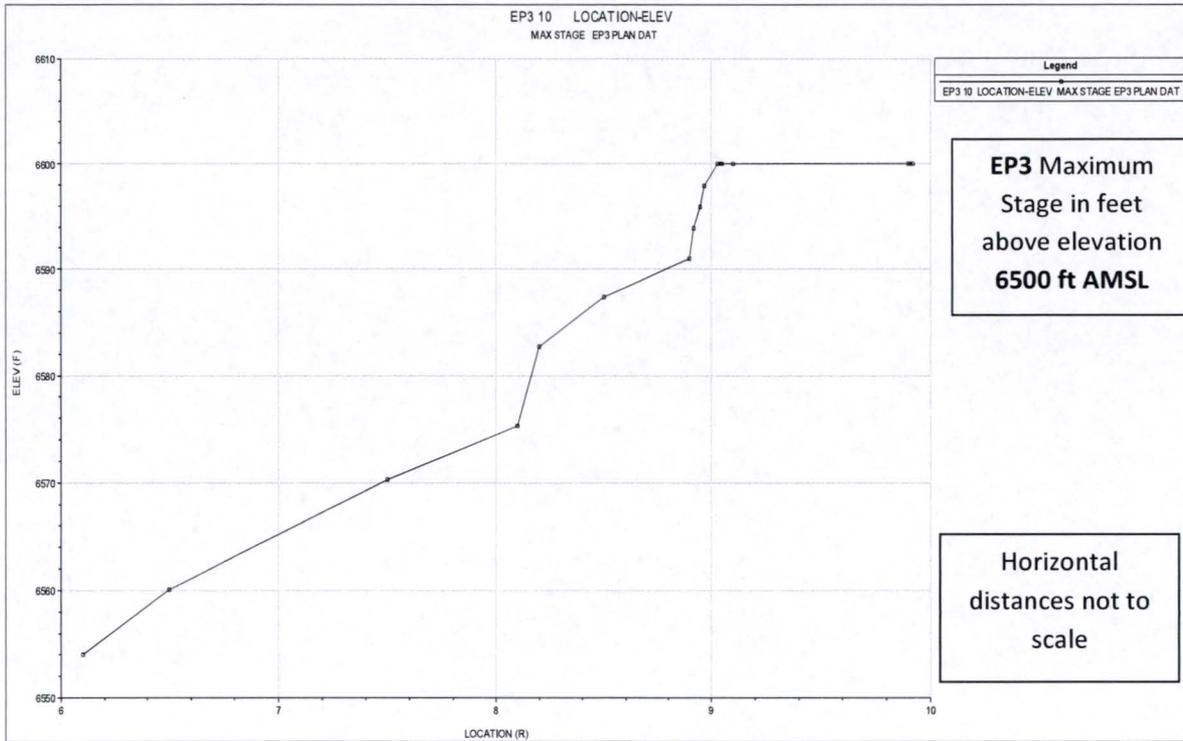
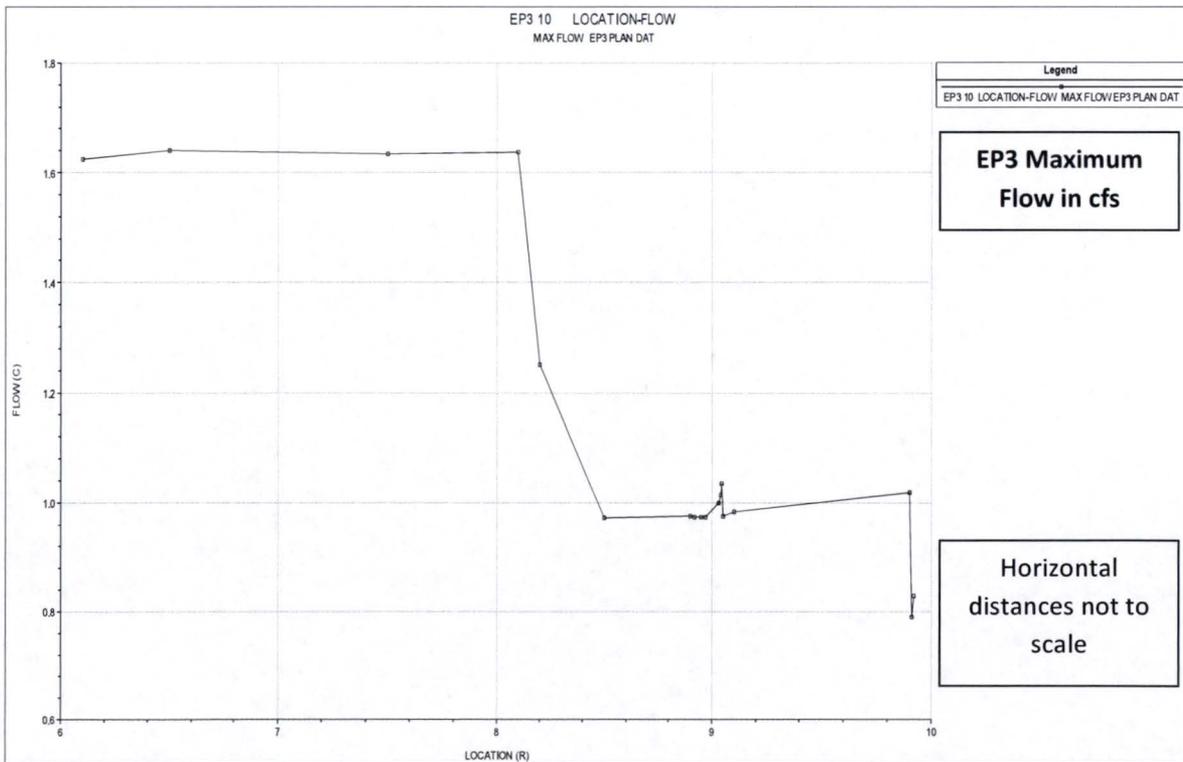
### EVAPORATION POND 3 (EP3) HEC RAS Output

The results of the model (file name: EP3 Breach Model) are illustrated by the following graphs, table and isometric image extracted from the output file of HEC RAS. Highest stages occur as flow converges in the pond toward the breach and passes over the berm down the steep outslope. Once flow passes across the downstream toe, it spreads out over the flat ground south of EP3 until it intersects the PMF diversion channel off the northwest corner of the large tailing pile, then becomes more confined, causing the flow rates to increase. At the downstream end of the model flow path, near the west property boundary, the maximum breach flow would be 0.07 ft deep and approximately 20 ft wide.
