# Turkey Point

## Units 6 & 7

### Mitigation Plan Rev. 2 (USACE Supplement)

093-87652

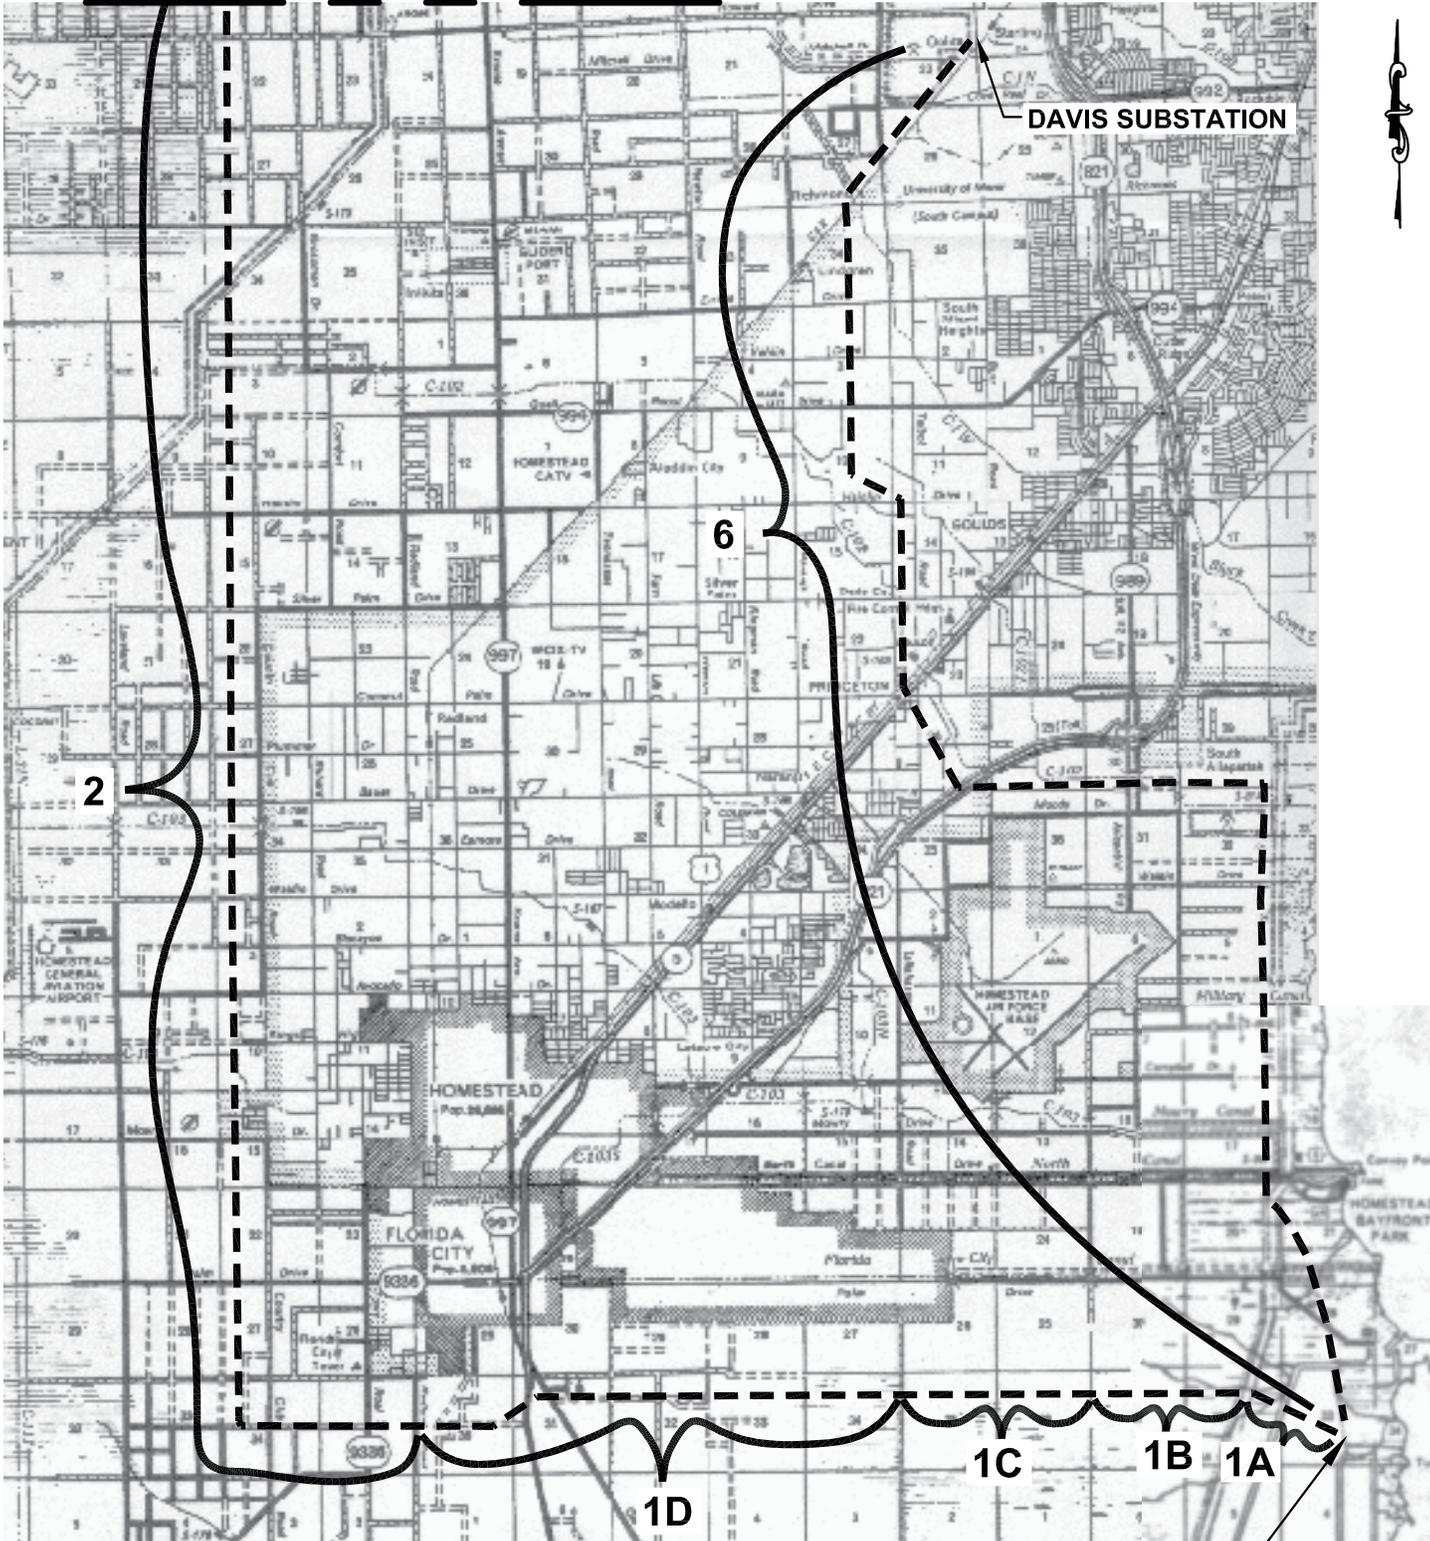
--- PROPOSED CORRIDORS FOR TRANSMISSION LINES  
1B SEGMENT NUMBER

**Figure 5**  
**Location of Transmission Line Corridors**  
**Showing Segments**

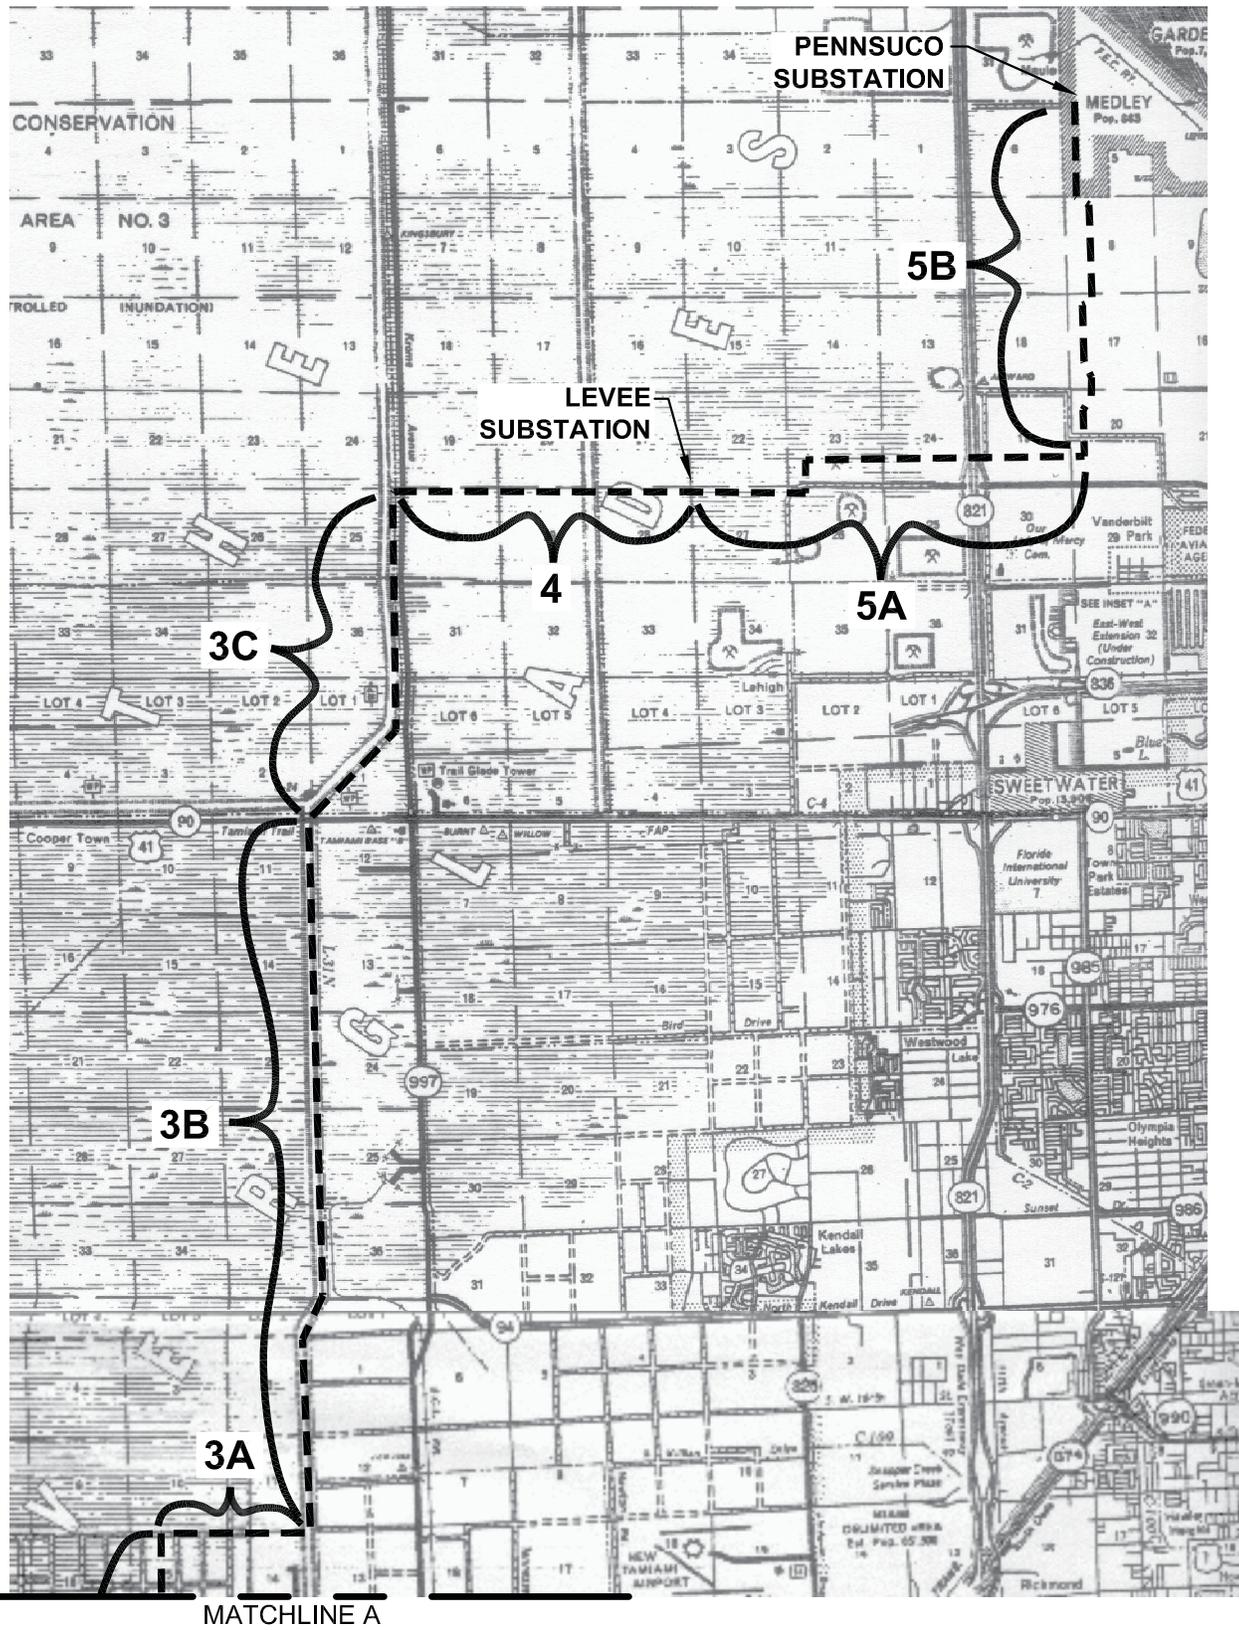
**Figure 5**  
**Location of Transmission Line Corridors**  
**Showing Segments**

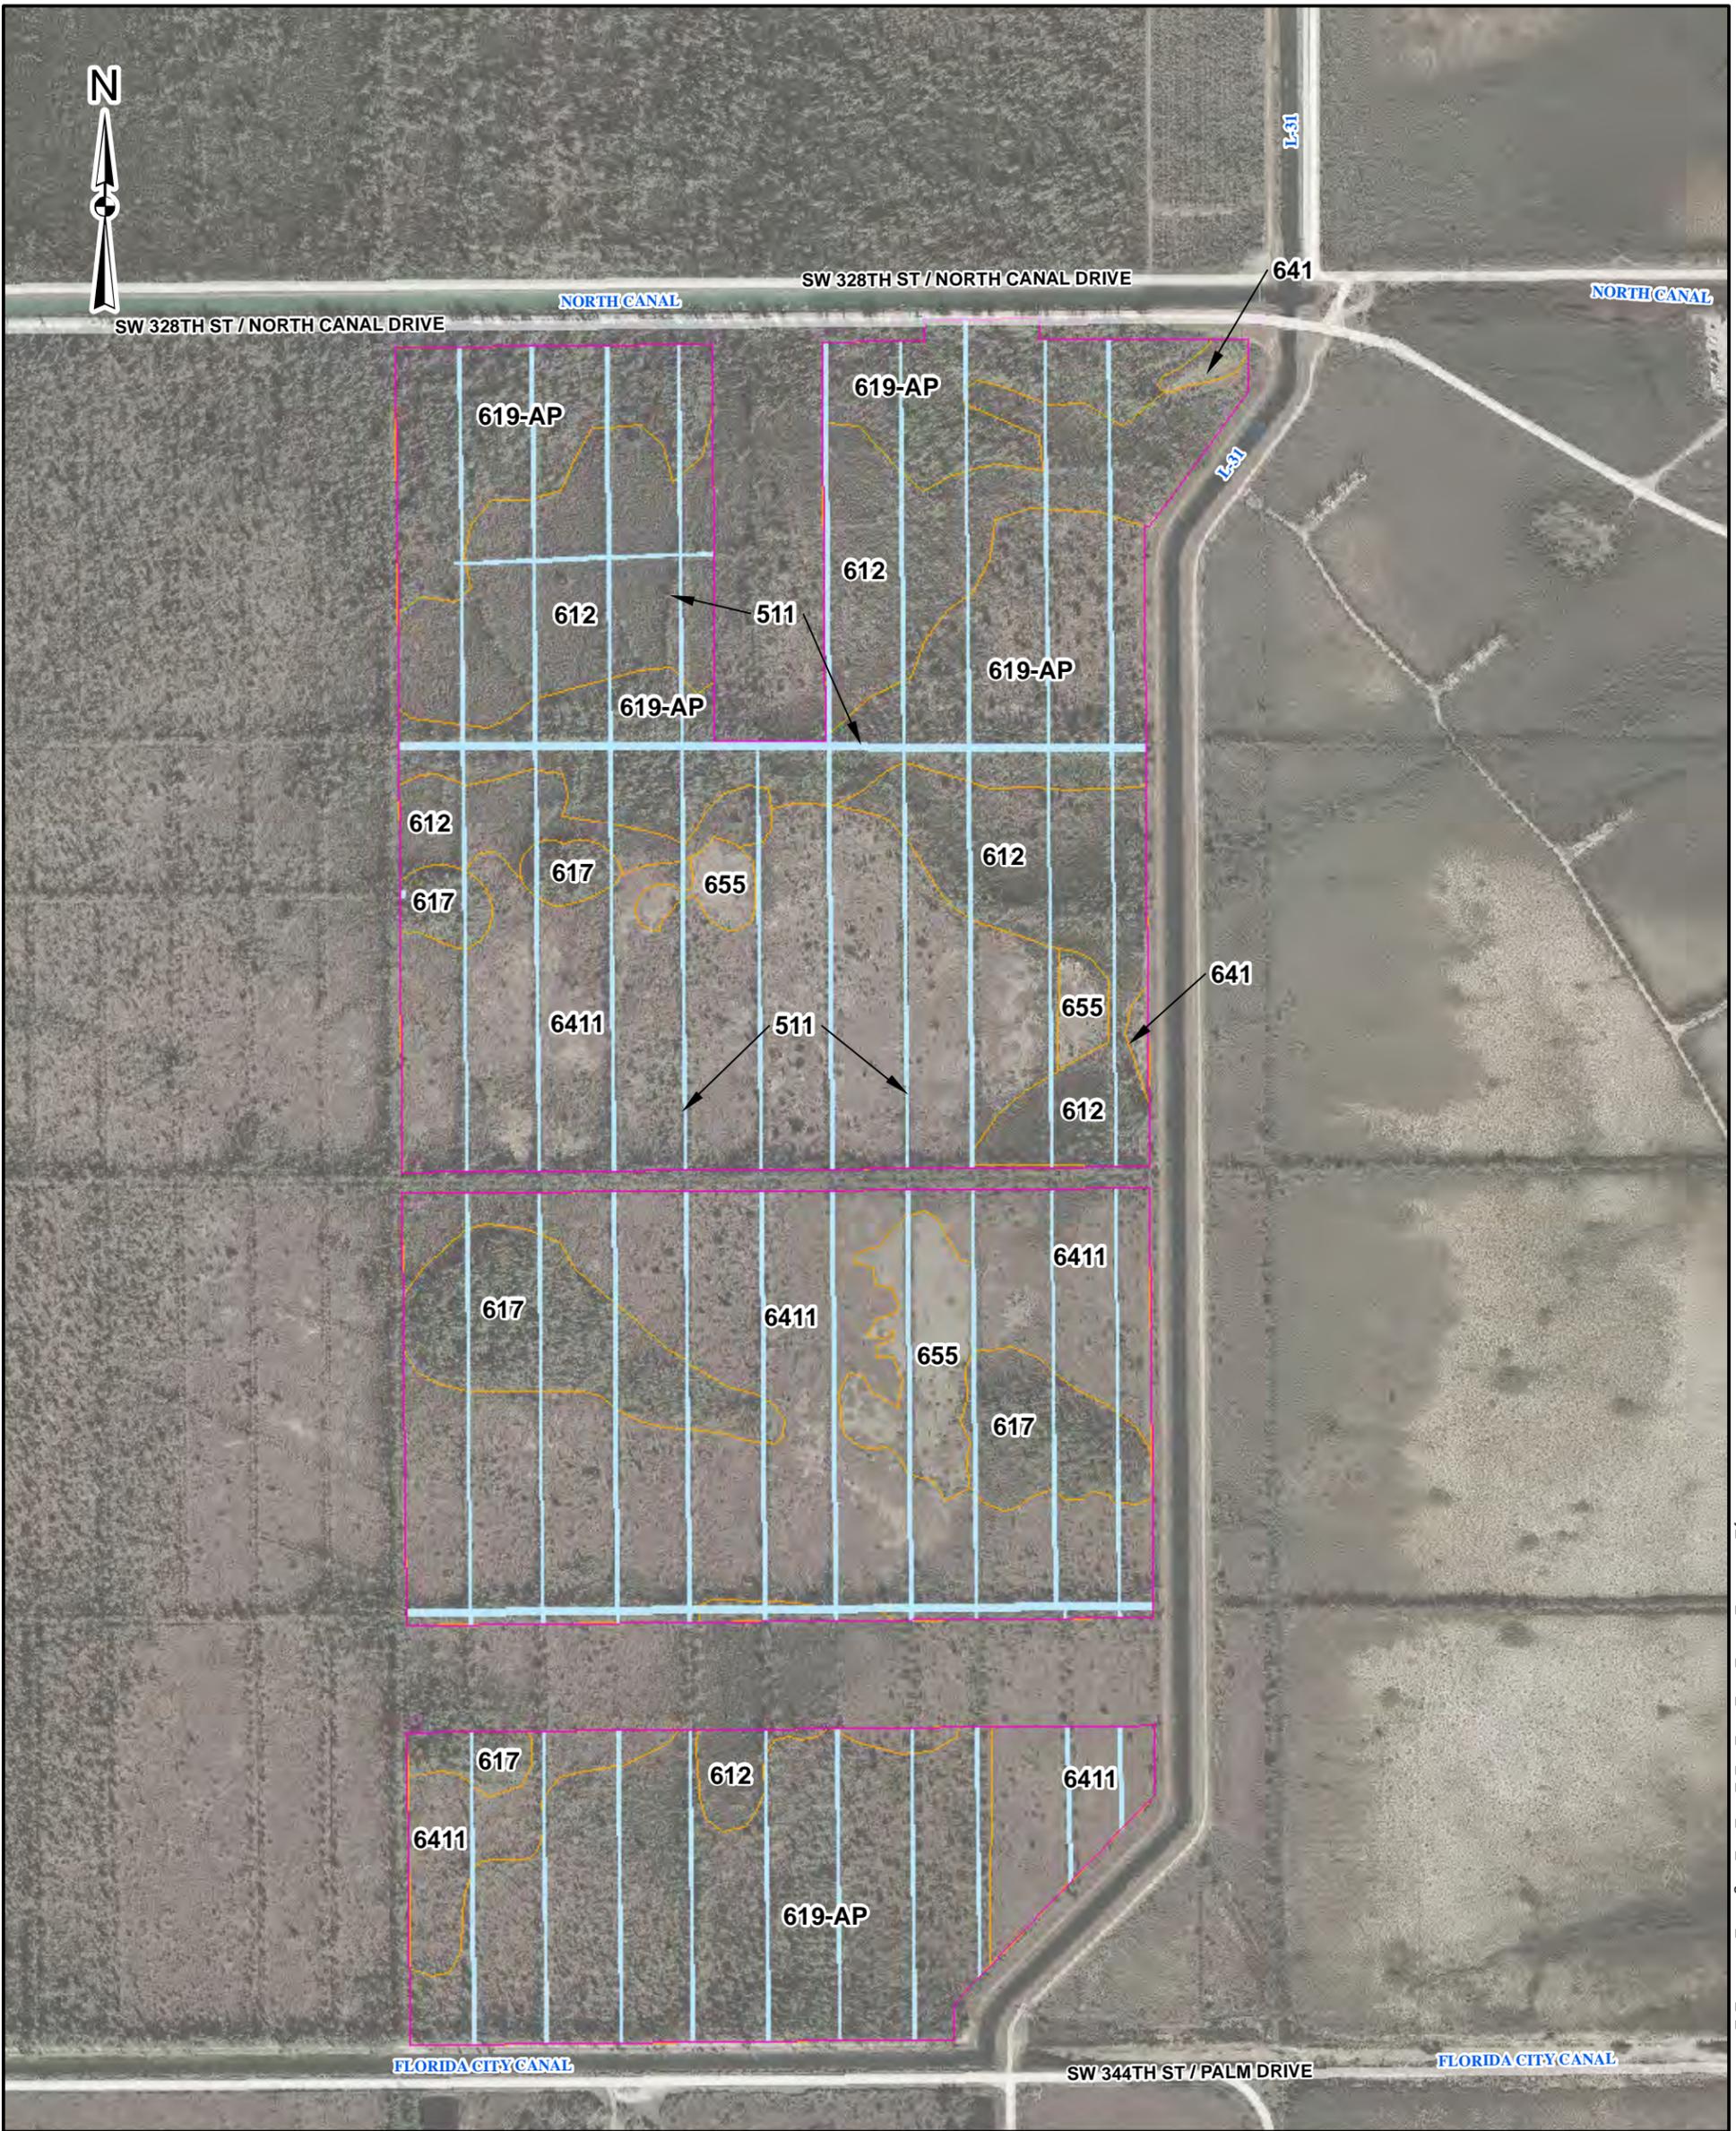
- █ Northwest Restoration Site
- █ Habitat Classification
- █ 511 - Ditches
- 612 - Mangrove Swamps
- 617 - Mixed Wetland Hardwoods
- 619-AP - Exotic Wetland Hardwoods-Australian Pine
- 641 - Freshwater Marshes
- 6411 - Sawgrass Marsh
- 655 - Periphyton Mat

The area is impacted due to historic hydrologic alteration through a network of mosquito ditches and prevalence of exotic species, resulting in reduced quality of wildlife habitat and vegetative species diversity (Appendix C, Photographs 1 and 2). A network of mosquito control ditches (FLUCFCS 511) crosses the parcel, with adjacent spoil materials supporting the exotic species Australian pine and Brazilian pepper. The east-west mosquito control ditches are typically approximately 4 feet wide by 4 feet deep, while north-south ditches are approximately 3 feet wide by 2 feet deep. Construction of the L-31E, Florida City, and North Canals has isolated the area from tidal influence, altering the salinity to that more characteristic of an oligohaline marsh community. Habitats within the Northwest Restoration Site (Appendix C, Photographs 3 and 4) are dominated by sawgrass marsh (FLUCFCS 6411), mangroves (FLUCFCS 612), exotic wetland hardwoods dominated by Australian pine (FLUCFCS 619-AP), and mixed wetland hardwoods (FLUCFCS 617), as illustrated in Figure 7 and described below.

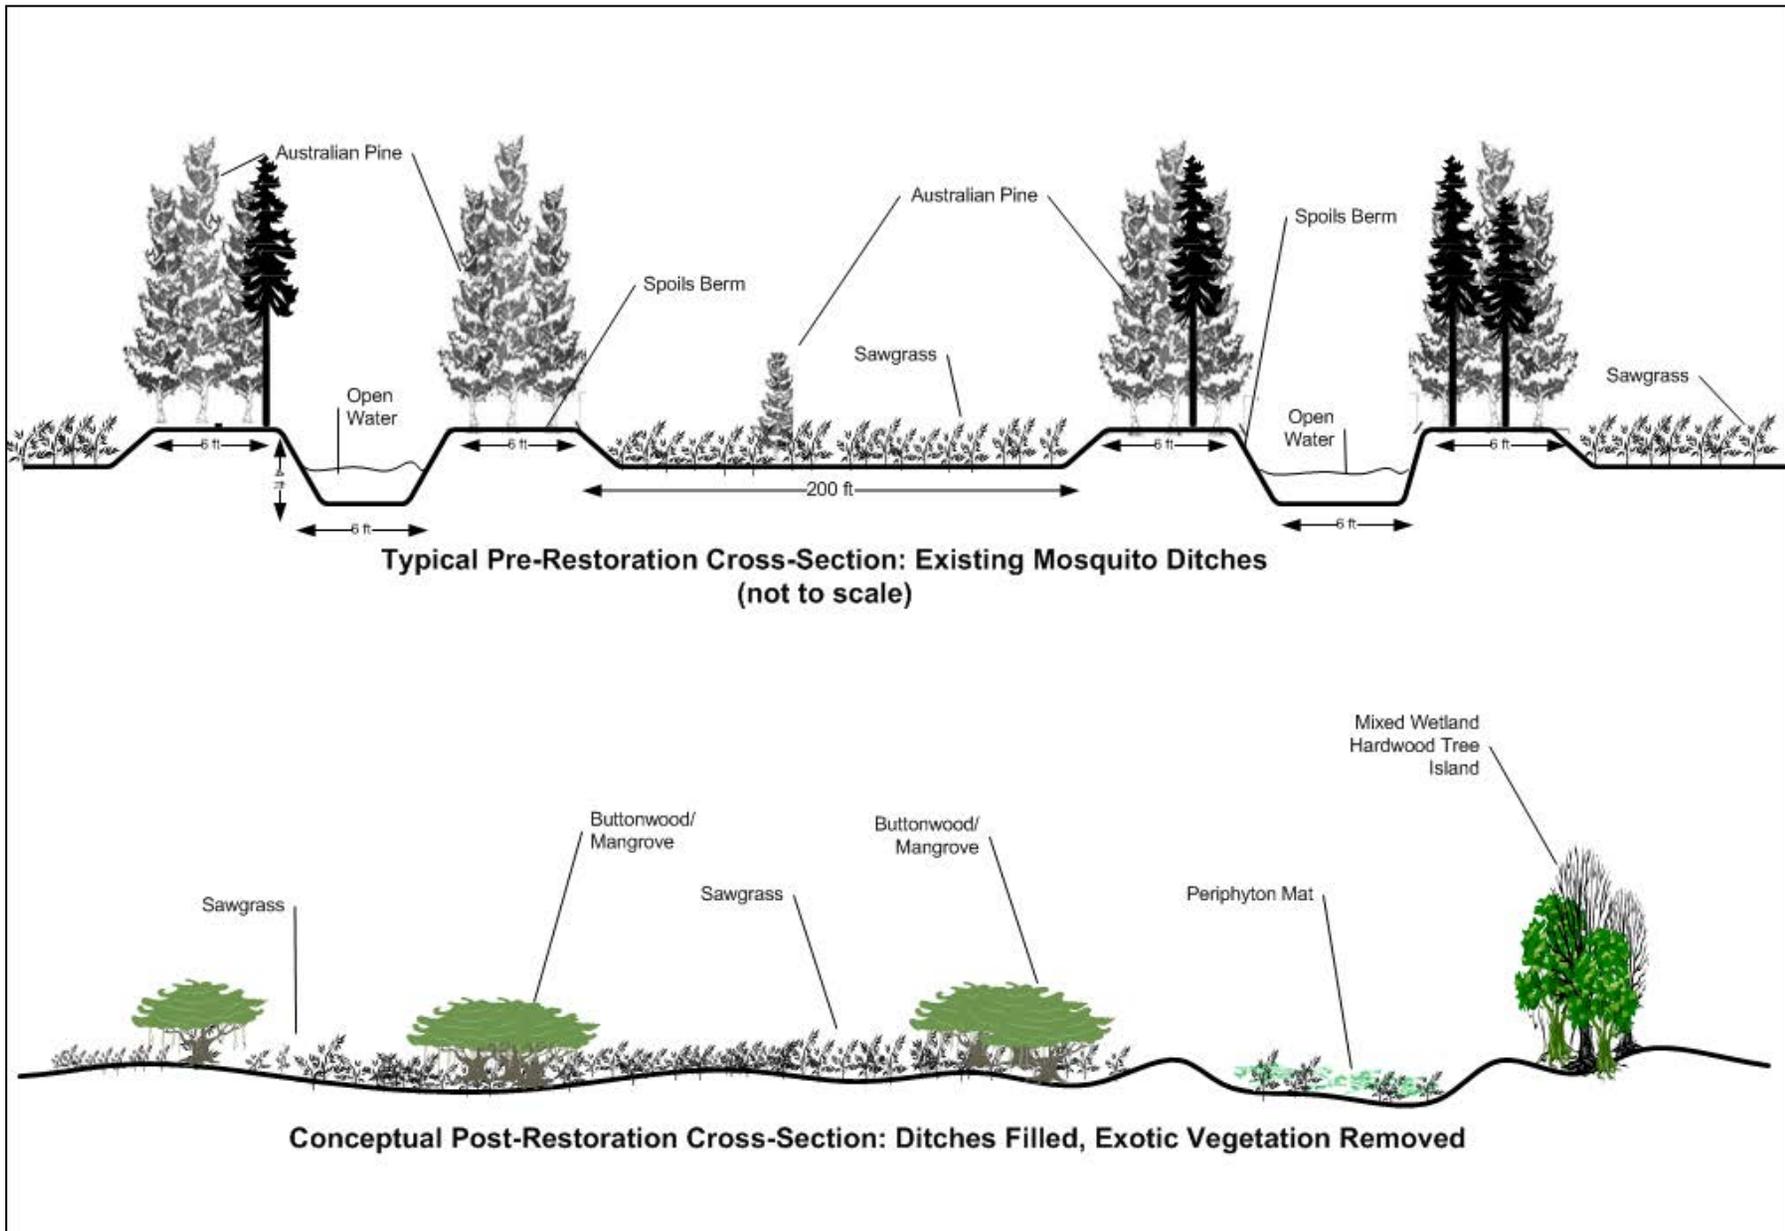
**Figure 9.**

Northwest Restoration Site Conceptual Cross Sections

Restoration of wetlands at the Northwest Restoration Site involves hydrologic enhancement and exotic vegetation eradication to achieve the target community. The existing network of mosquito ditches will be backfilled with adjacent spoil materials and topographically graded to encourage sheetflow distribution of water throughout the restored area and to facilitate the success of target native vegetative communities (Figure 9). The spoil areas adjacent to mosquito ditches are dominated by Australian pine; removal of these exotic species will occur prior to backfilling. Due to potential soil subsidence within the spoil areas,

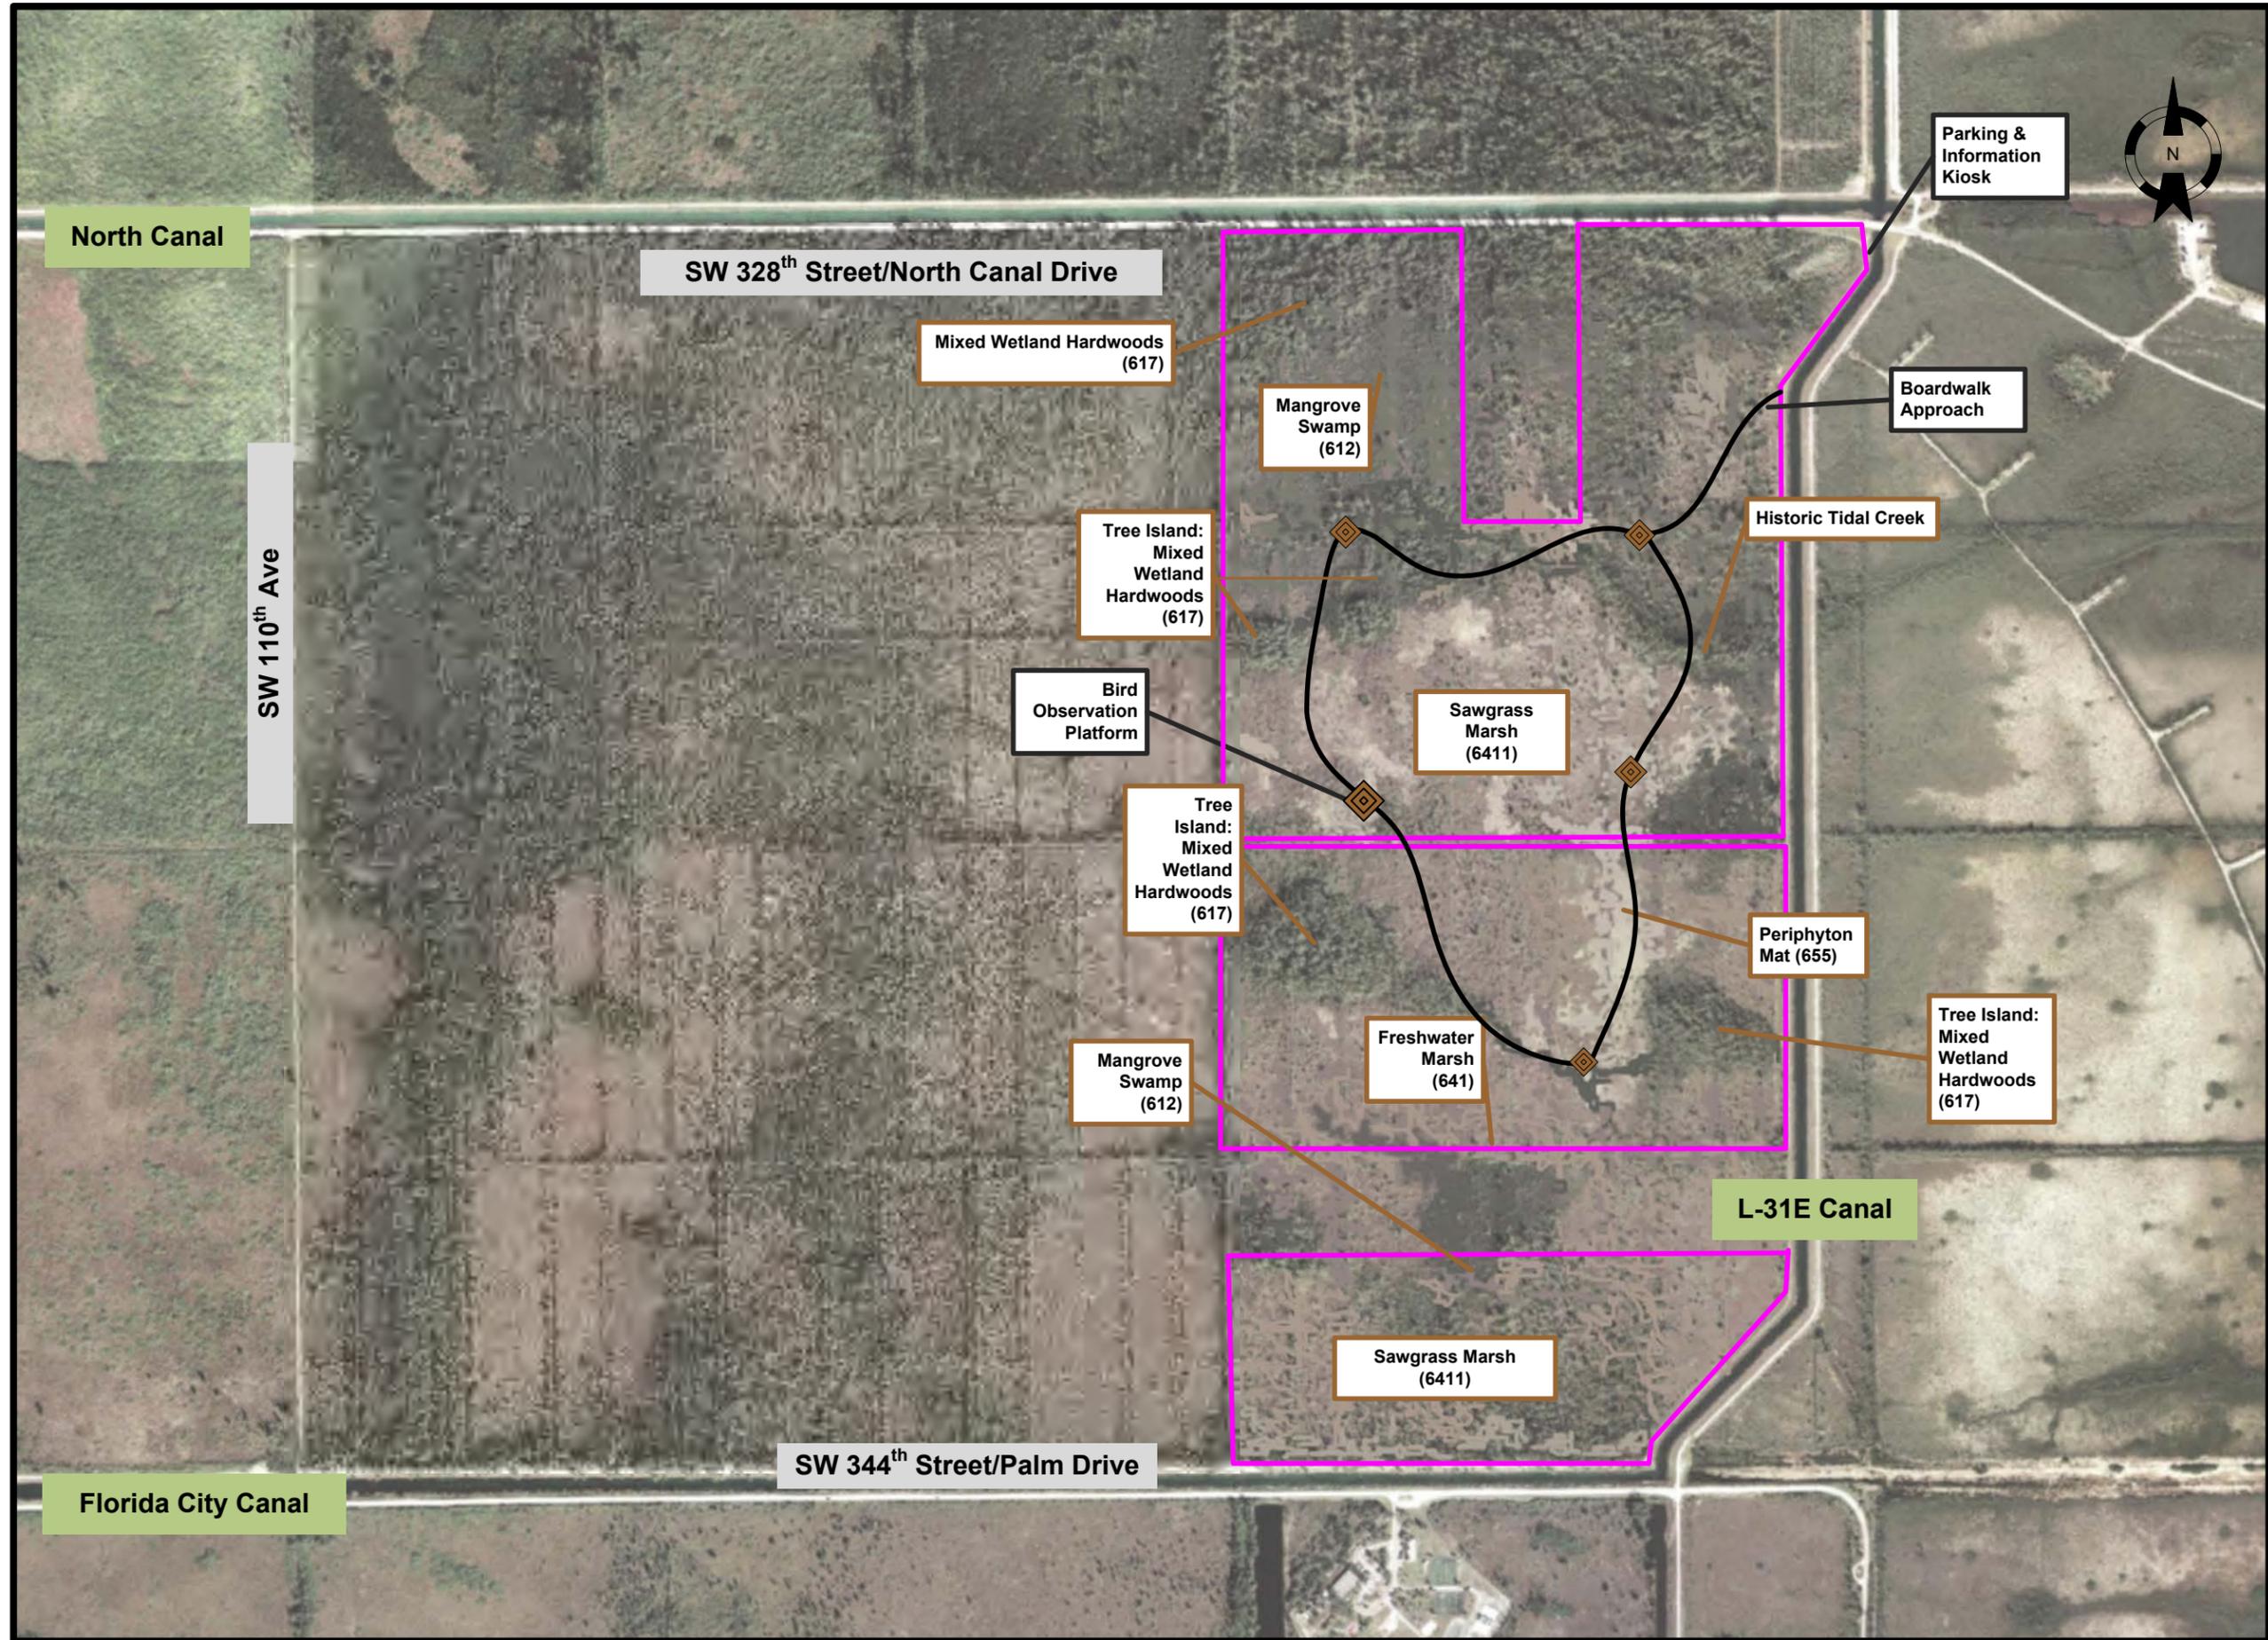
**Figure 10. Northwest Restoration Site Conceptual Illustration (not to scale)**

FPL proposes to provide public access to the mitigation parcel for passive recreation and environmental education opportunities. An elevated boardwalk may be constructed with interpretive kiosks and observation platforms for birdwatching, wildlife observation, and plant identification (Figure 10). The location of the Northwest Mitigation Site in close proximity to the BNP will provide Park visitors with the opportunity to explore a restored sawgrass marsh, marl prairie, and mangrove ecosystem. In addition, the Site’s location within the proposed Biscayne - Everglades Greenway would allow for potential incorporation into the Greenway’s overall plan to provide a network of bicycle trails and walkways between the two parks.

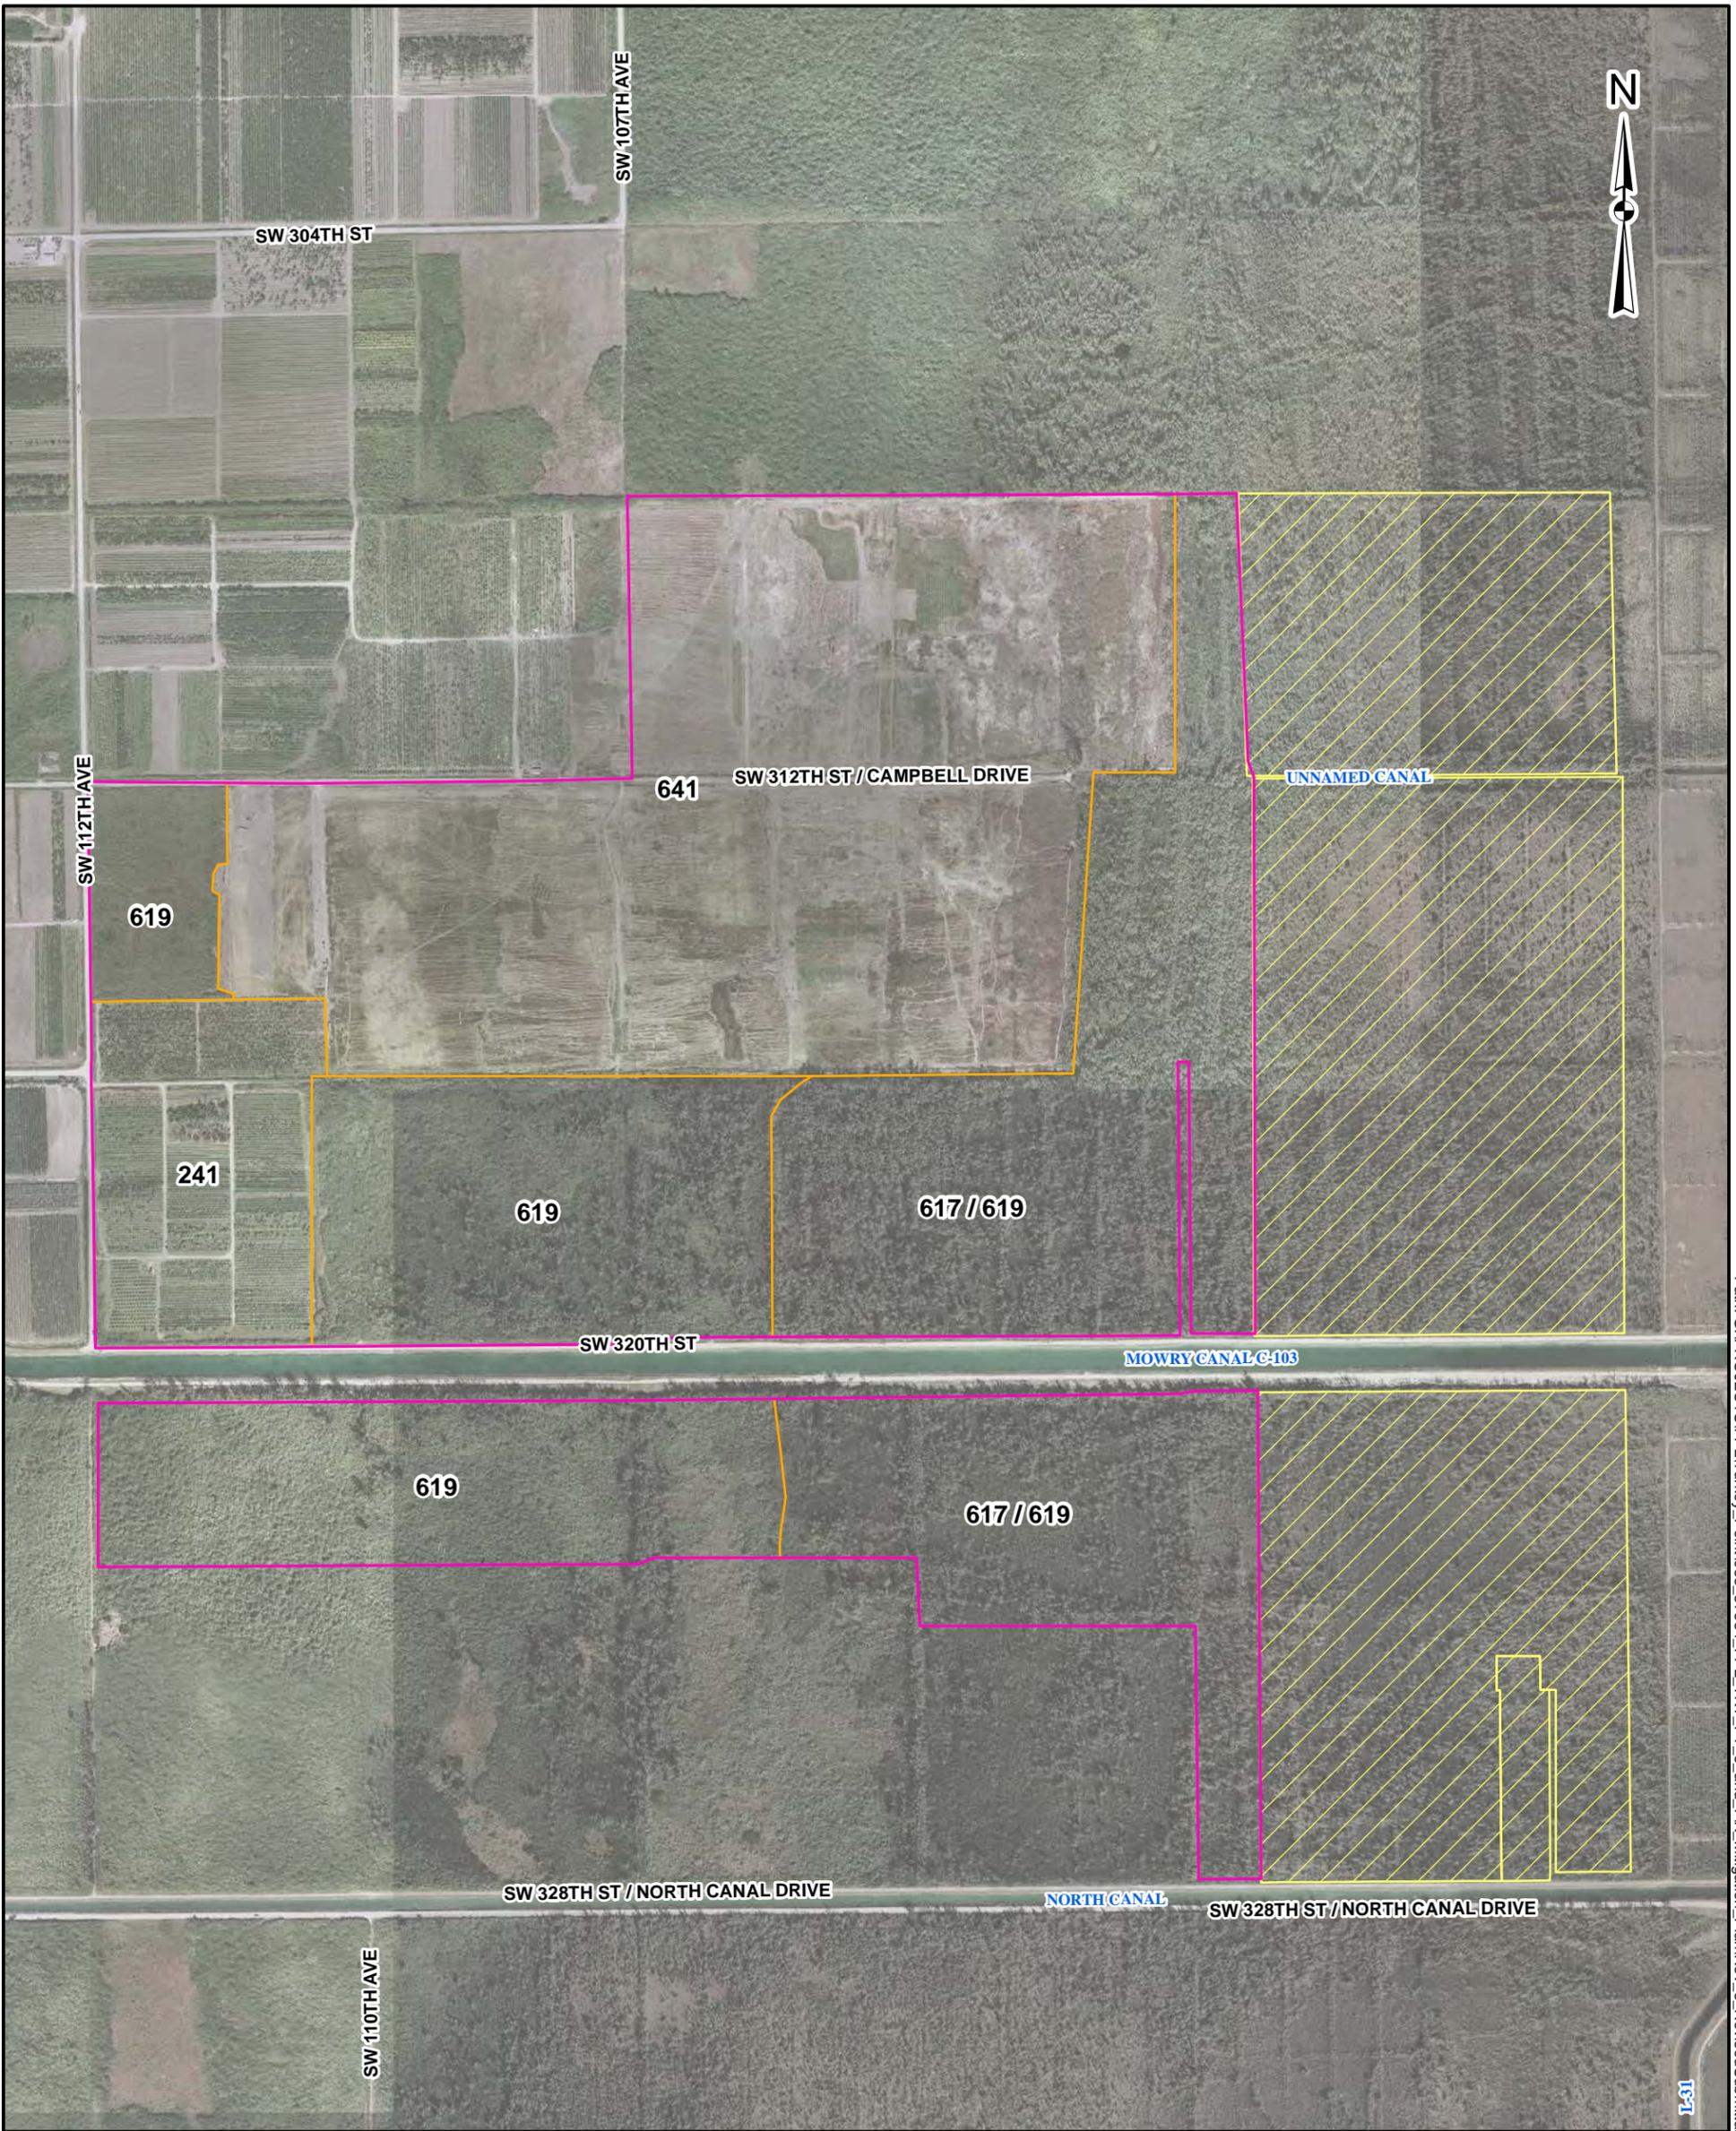
- SW 320th Street Restoration Site
- Habitat Classification
  - 241 - Tree Nurseries
  - 617 / 619 - Mixed Wetland Hardwoods / Exotic Wetland Hardwoods
  - 619 - Exotic Wetland Hardwoods
  - 641 - Freshwater Marshes
- Lands Previously Transferred to the State by FPL

Current land use/land cover within the SW 320<sup>th</sup> Street Restoration Site is illustrated in Figure 12. The southwestern, central, and northwestern portions of the site are classified as exotic wetland hardwoods (FLUCFCS 619) infested by the nuisance/exotic species Brazilian pepper and Australian pine. A parcel of planted palm tree nursery (FLUCFCS 241) is located within the western portion of the site, with associated perimeter drainage ditches. Forested wetlands within the eastern portion of the site are classified as mixed wetland hardwoods/exotic wetland hardwoods (FLUCFCS 617/619), vegetated with a variety of native species but extensively colonized by the exotic species Australian pine and Brazilian pepper. The central portion of the SW 320<sup>th</sup> Street Restoration Site includes an approximately 219-acre parcel of former palm tree nurseries that have been restored to freshwater marsh (FLUCFCS 641) and native buttonwood. Representative photographs are included in Appendix C; the existing vegetative community composition within each of these habitats is described below.

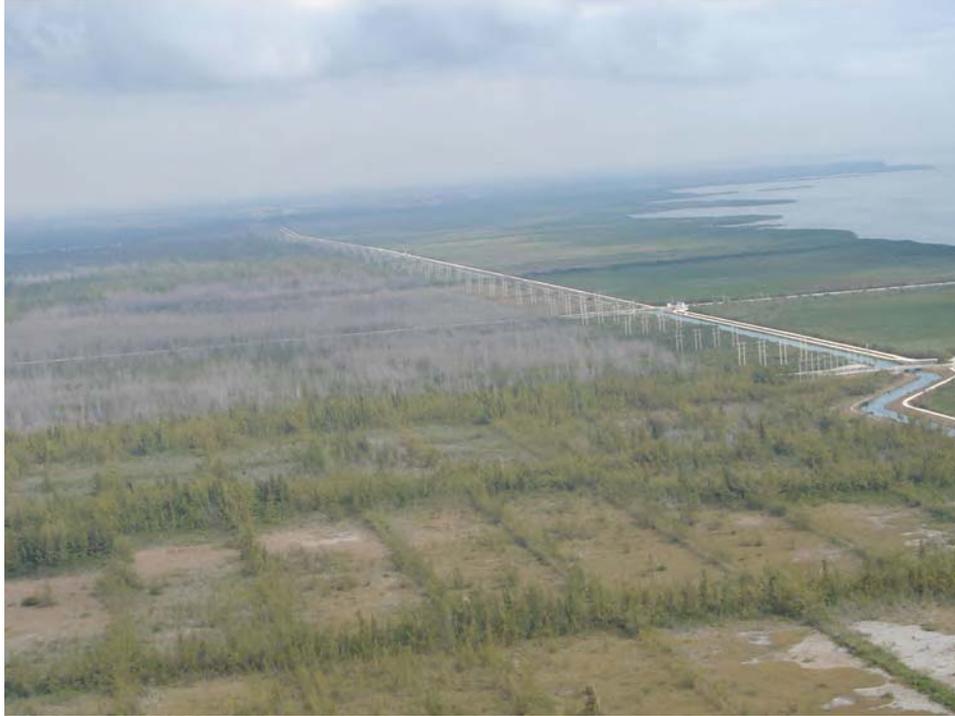
Photograph 1. Aerial view of Northwest Restoration Site, facing north. Sawgrass marsh historically impacted by network of mosquito ditches dominated by exotic Australian pine. Transmission corridor, L-31E Canal, and Biscayne Bay visible to east. Areas of exotic vegetation control on SFWMD parcels visible to the north, adjacent to C-103 Canal.

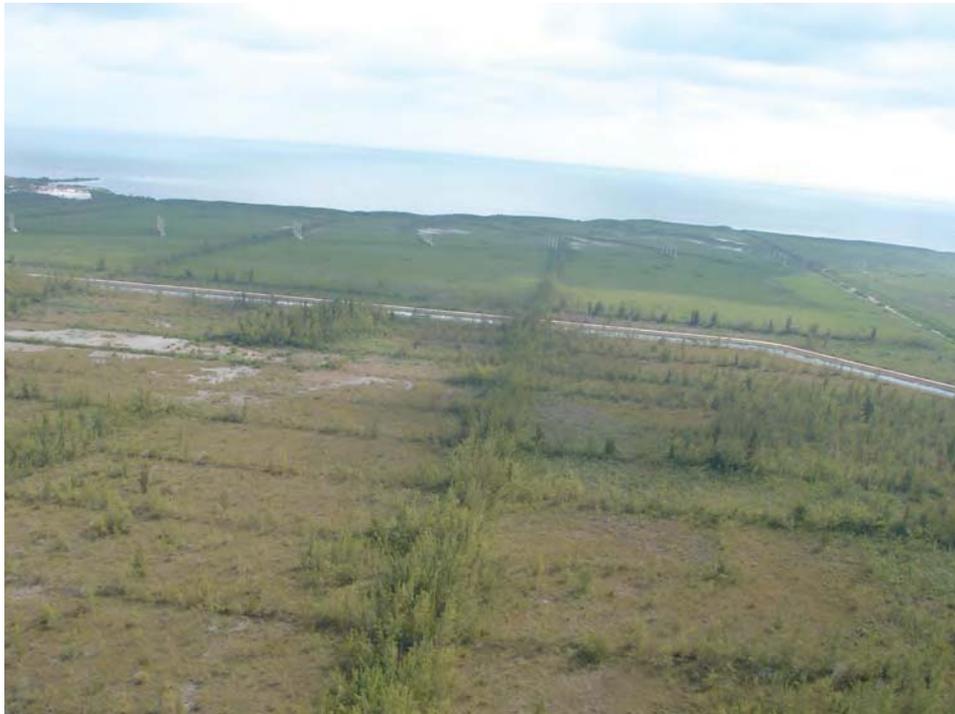
Photograph 2. Aerial view of Northwest Restoration Site, facing east. L-31E Canal and Biscayne Bay in background.

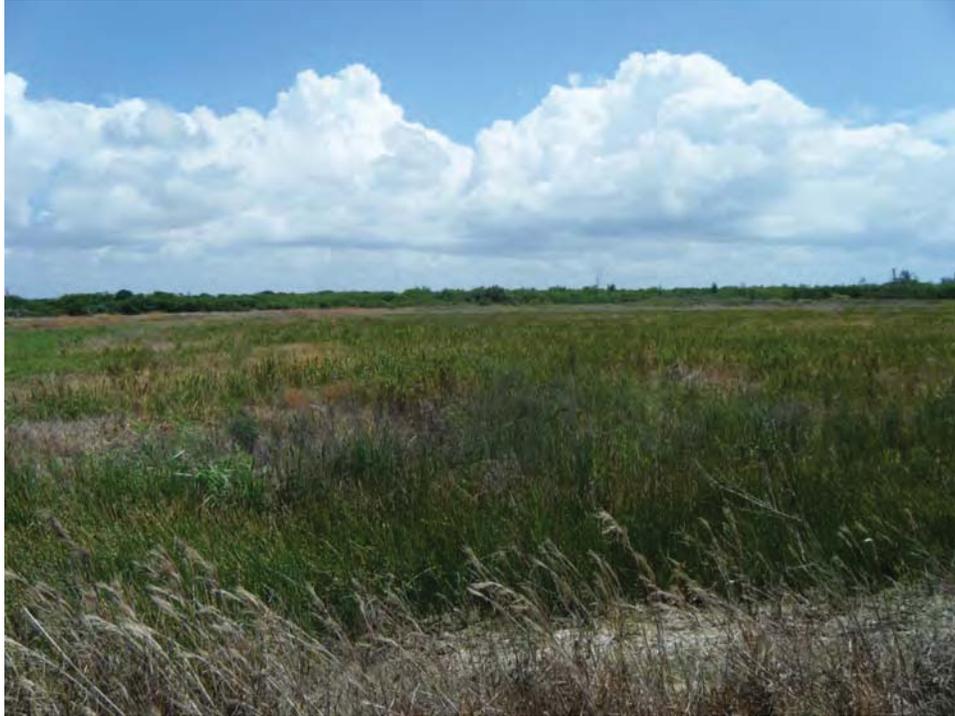
Photograph 7. SW 320<sup>th</sup> Street Restoration Site – former palm tree nursery restored to freshwater marsh. Knotted spikerush (*Eleocharis interstincta*) and bushy broomsedge (*Andropogon glomeratus*) in foreground; exotic wetland hardwoods in background.

The northern and central portion of the Site is comprised of approximately 219 acres of former palm tree nurseries that have been restored to freshwater marsh and buttonwood. A variety of herbaceous species occur within the marsh (Appendix C, Photograph 7), including several species of spikerush (*Eleocharis cellulosa*; *E. geniculata*; *E. interstincta*), arrowhead (*Sagittaria lancifolia*), giant leather fern (*Acrostichum danaeifolium*), southern amaranth (*Amaranthus australis*), bushy bluestem (*Andropogon glomeratus*), spangletop (*Leptochloa nealleyi*; *L. fusca fascicularis*), Mexican primrose willow (*Ludwigia*

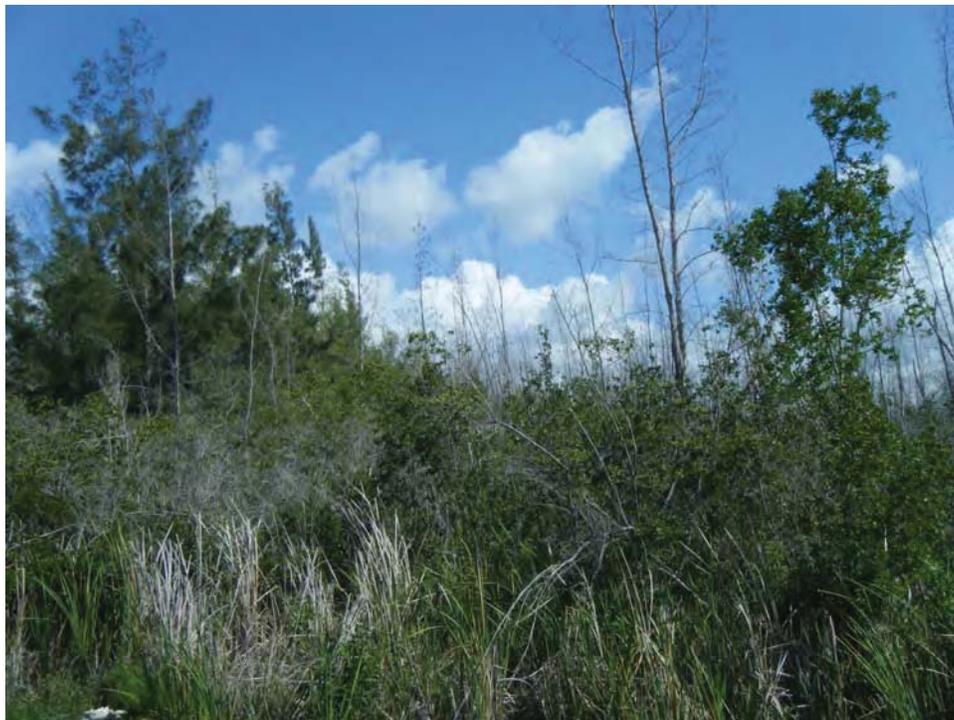
Photograph 10. SW 320<sup>th</sup> Street Restoration Site – mixed wetland hardwoods/exotic wetland hardwoods on eastern edge of Site adjacent to C-103 Canal, facing north. SFWMD parcel with treated Australian pine to east, untreated Australian pine to west.

The eastern portion of the SW 320<sup>th</sup> Street Restoration Site supports native mixed wetland hardwoods interspersed with exotics, including Australian pine, Brazilian pepper, and shoebutton ardisia. The canopy is comprised of buttonwood, white mangrove, dahoon holly, cocoplum, Australian pine, wax myrtle, myrsine, and poisonwood, with understory vegetation including sawgrass, camphorweed, arrowhead, leather fern, mangrove vine, nettletree, spikerush, and cattail. The eastern edge of the SW 320<sup>th</sup> Street Restoration Site abuts SFWMD parcels of mixed wetland hardwoods currently being treated for Australian pine and Brazilian pepper (Appendix C, Photograph 10).
