# Turkey Point

## Units 6 & 7

### Mitigation Plan Rev. 2 (USACE Supplement)

093-87652

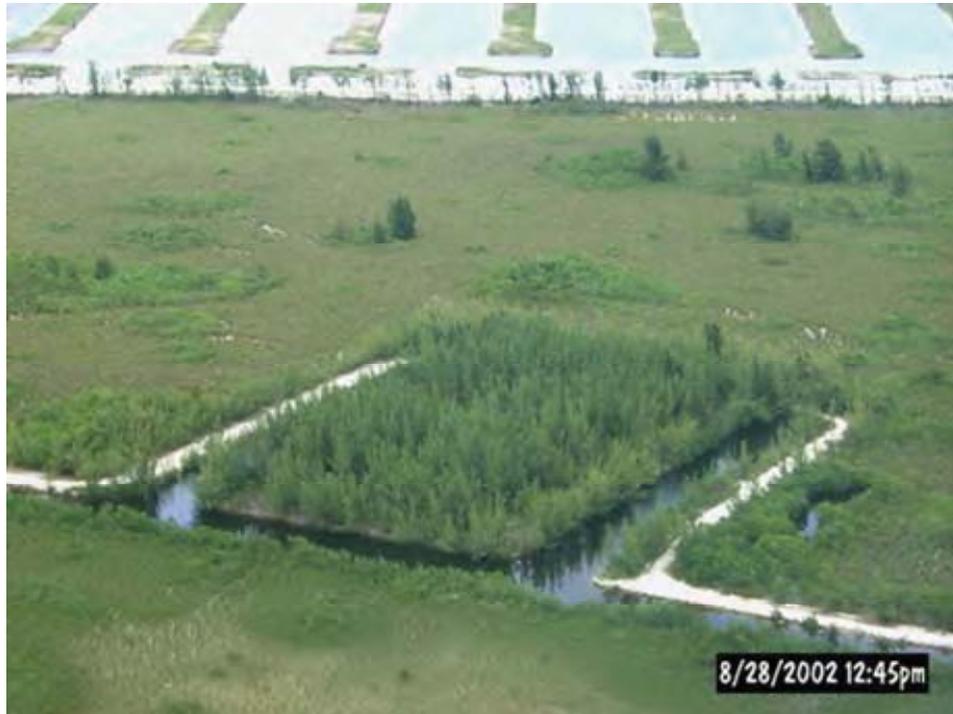
Photograph 11. Aerial photograph of Everglades Mitigation Bank crocodile sanctuary area prior to enhancement. Area dominated by the exotic species Australian pine. Industrial wastewater treatment facility in background.

The Sea Dade Canal Crocodile Sanctuary will be created in accordance with the methodology used to create the EMB crocodile sanctuary in 2008. Photographs of the crocodile sanctuary prior to enhancement and immediately following creation are presented in Appendix C (Photographs 11 and 12). This approximately 5-acre area was cleared of exotic vegetation, topographically graded to create freshwater ponds and nesting areas with a specific mixture of peat, marl, and sand to create ideal nesting substrate, and planted with native species of vegetation. The success of the design is evidenced through documented utilization of the area by a nesting female crocodile within the first year after construction.

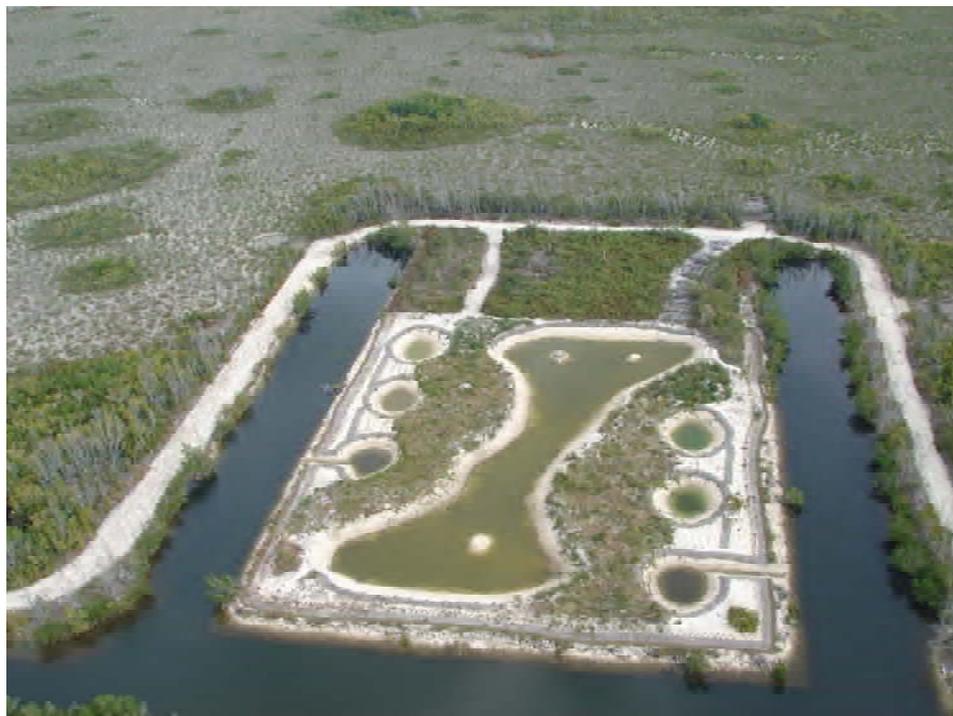
Photograph 12. Aerial view of Everglades Mitigation Bank crocodile sanctuary area following creation of crocodile habitat. Exotic species of vegetation replaced with natives, freshwater ponds excavated and perimeter of peat/marl/sand nesting substrate installed.
