Official Transcript of Proceedings
NUCLEAR REGULATORY COMMISSION

Title: Advisory Committee on Reactor Safeguards
 Metallurgy and Reactor Fuels Subcommittee

Design and Functions of the Baffle-former Assembly

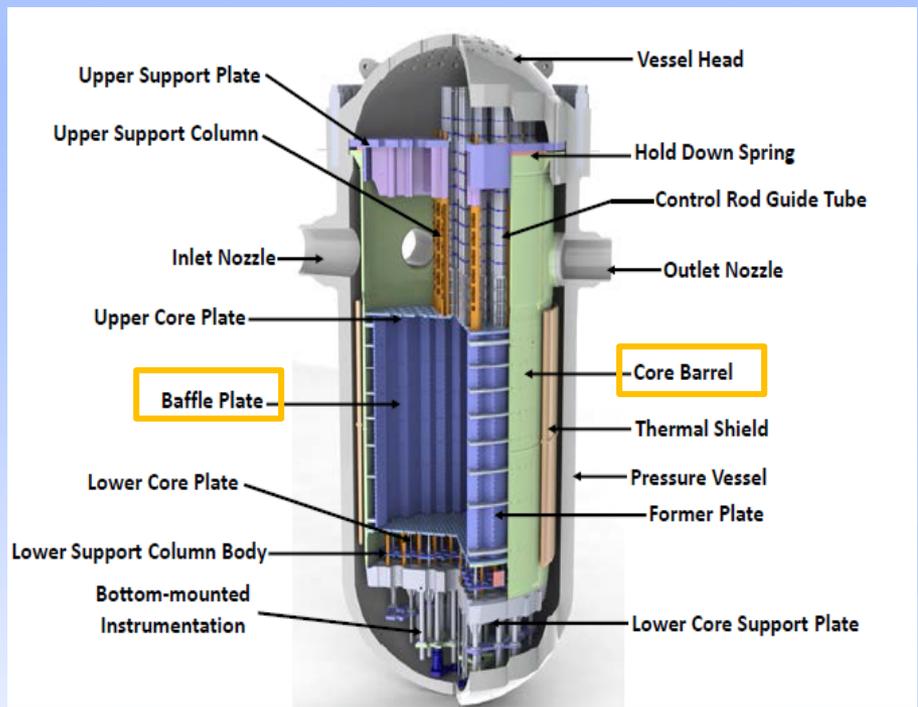
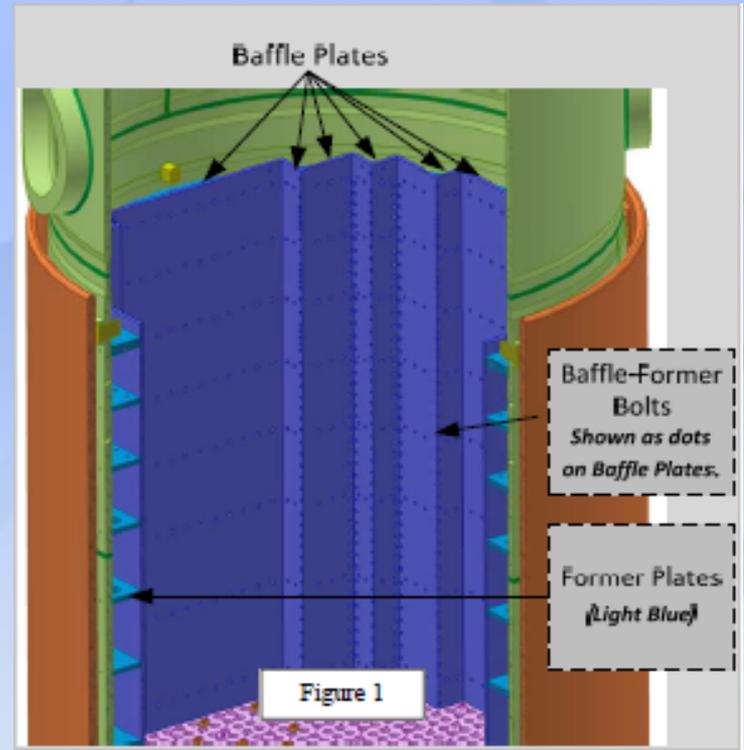
Function of baffle-former assembly is to direct coolant flow through the core. It also provides lateral support to the core during a seismic event or loss-of-coolant accident (LOCA).

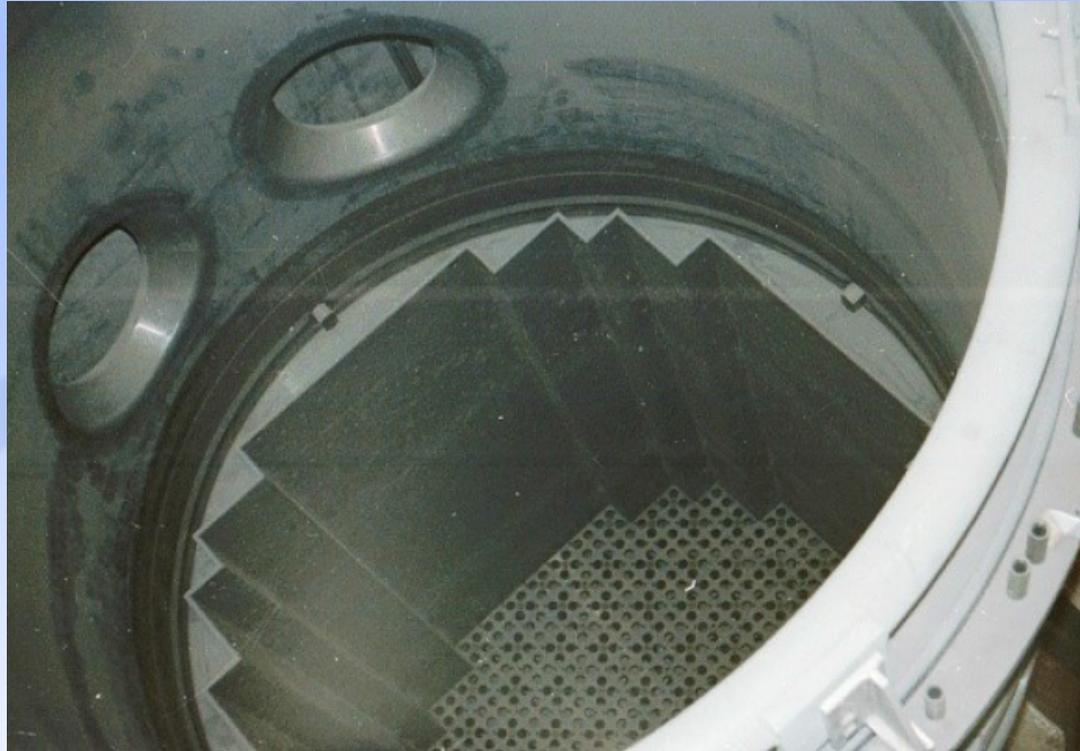
Design and Functions of the Baffle-former Assembly

Looking down into the core barrel of a Westinghouse-
design PWR

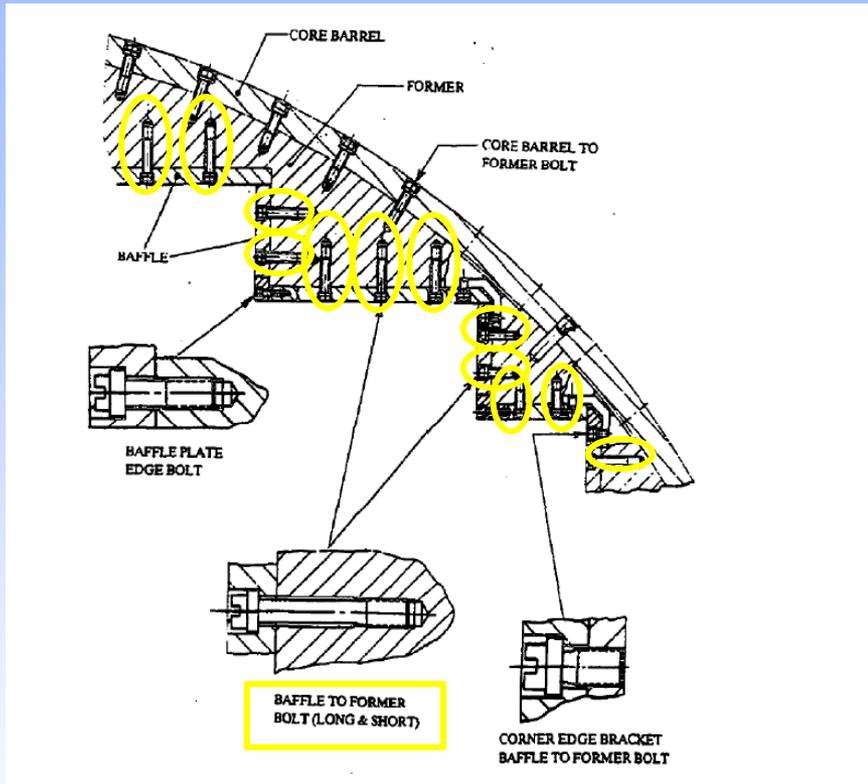
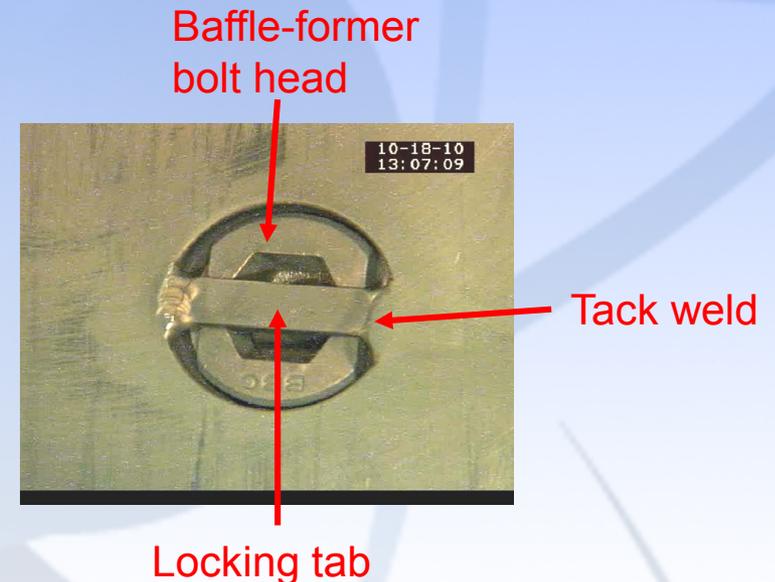
Design and Functions of the Baffle-former Assembly - Design of Baffle-former bolts

- Stainless steel bolts are 5/8" dia. x ~2" long and attach the baffle plates to the former plates to form the baffle-former assembly.

- **Westinghouse (W) plants:**
 - **Type 347 stainless steel**
 - Most older Westinghouse plants
 - Bolt design has sharper head-to-shank radius and shorter shank than in Type 316 cold-worked bolts.
 - **Type 316 cold-worked stainless steel**
 - Newer Westinghouse plants
 - All replacement bolts
- **Other NSSS designs**
 - B&W plants use Type 304
 - CE plants use annealed Type 316 (2 plants – others have welded core shroud).

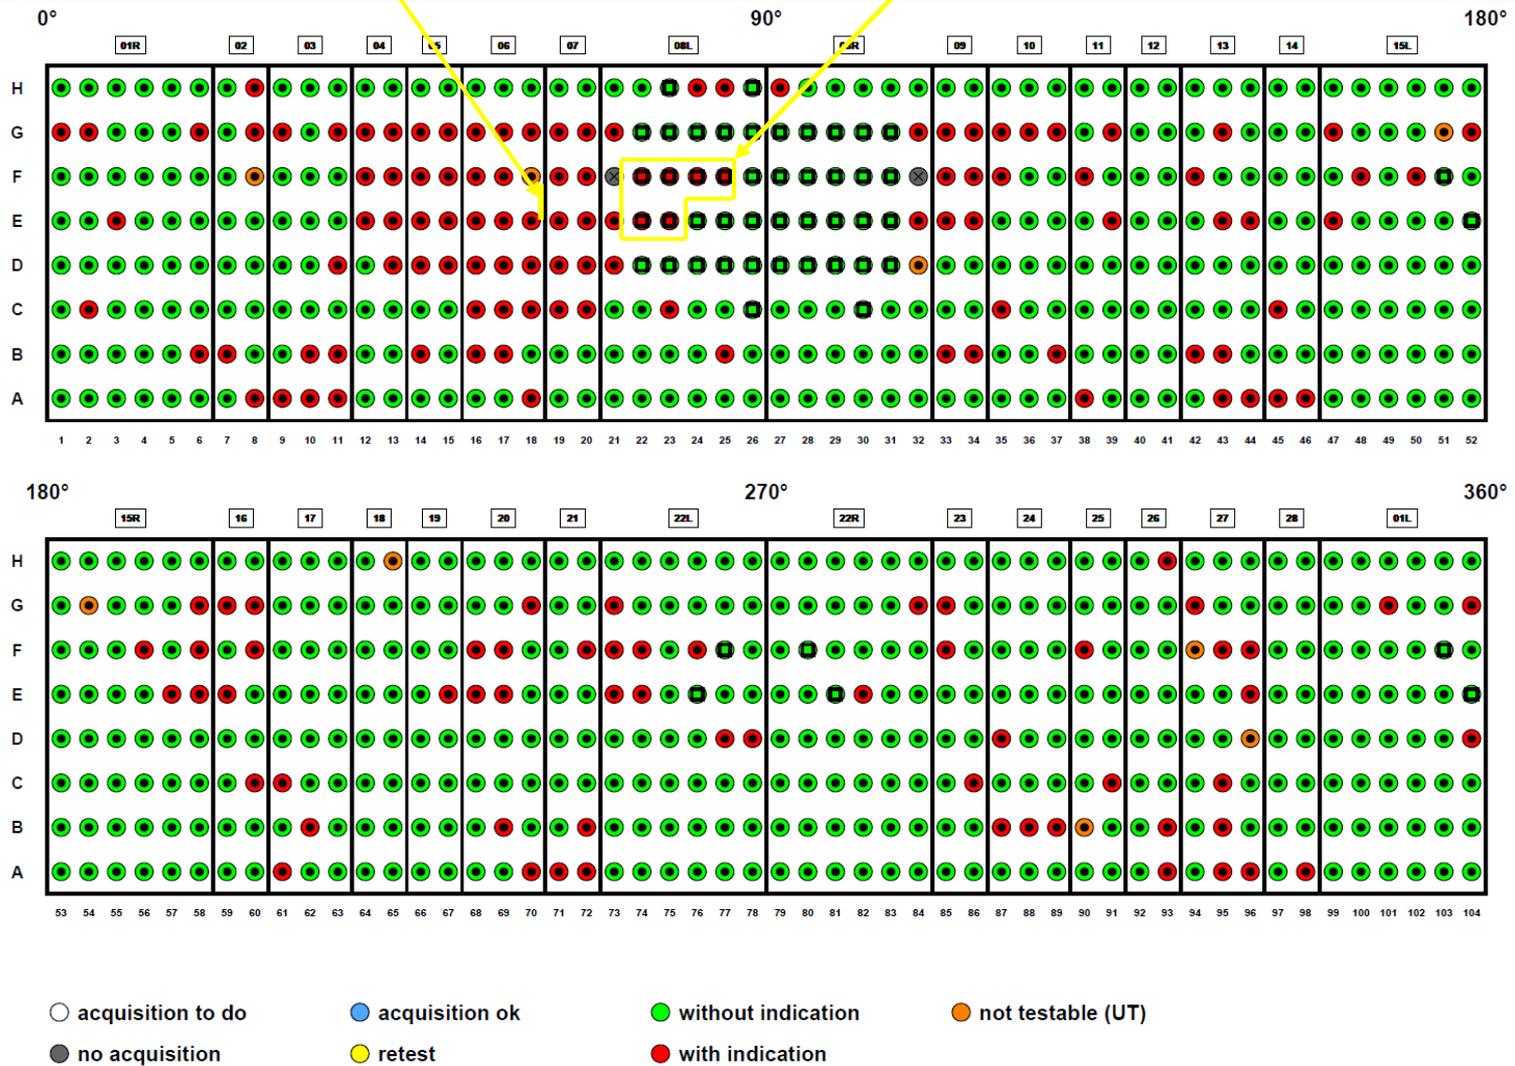
As-Found Condition of D.C. Cook, Unit 2 Baffle-Former Bolts Fall, 2016 Refueling Outage

Location of Degraded Edge Bolts

Degraded Replacement Bolts

- **During October 2016, D.C. Cook, Unit 2 performed UT examination of baffle-former bolts (832 total) on accelerated schedule in accordance with MRP interim guidance.**
- **Total of 179 potentially degraded bolts**
 - 170 with UT indications
 - 9 untestable bolts
- **2 vacant bolt locations from 2010**
- **Six (6) replacement bolts installed in 2010 had indications.**
- **At least one vacant bolt location correlated with a damaged fuel assembly.**
- **Visual examination of baffle-edge bolts found 5 degraded bolts.**

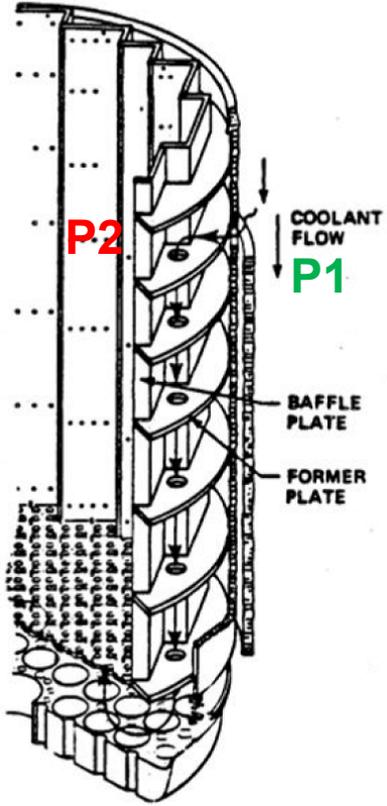
DOWNFLOW CONFIGURATION

$$P1 > P2$$

Tries to force baffle plate inward = higher stress on bolts

Factors Influencing Baffle-Former Bolt Degradation - "Downflow" vs. "Upflow"

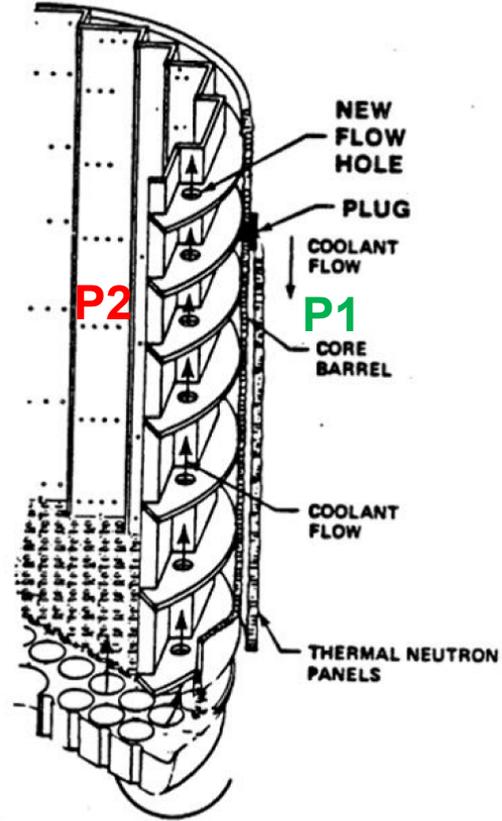
UPFLOW CONFIGURATION

$$P1 \approx P2$$

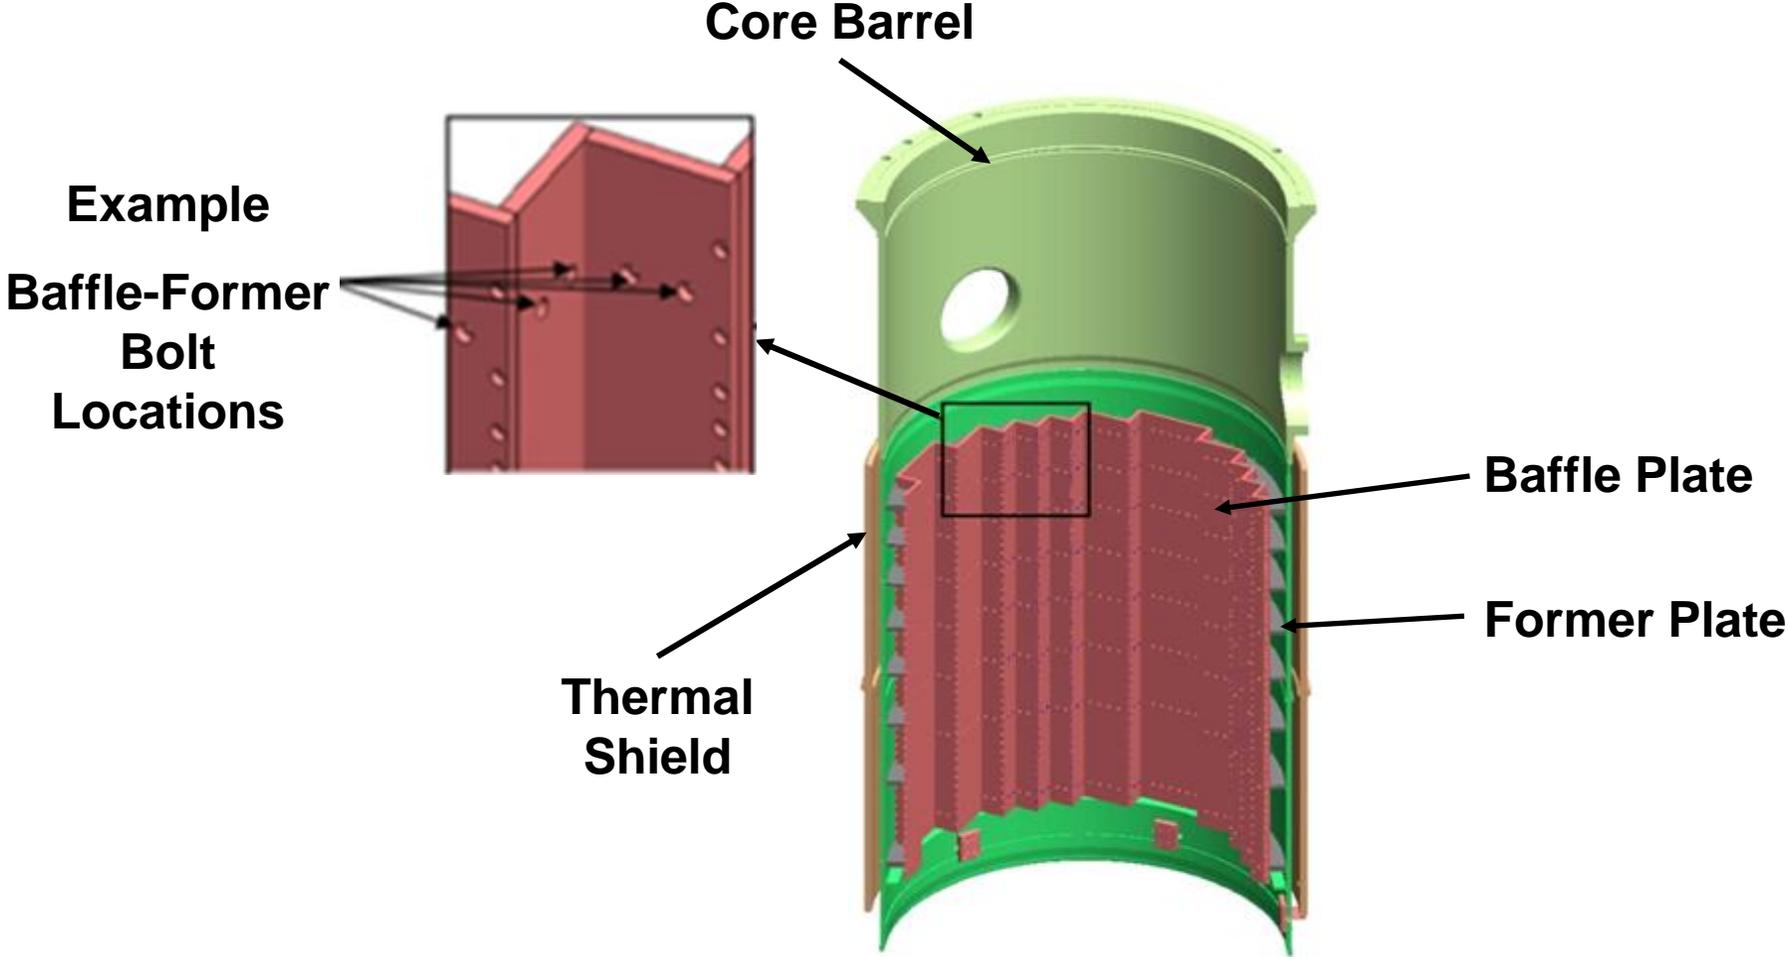
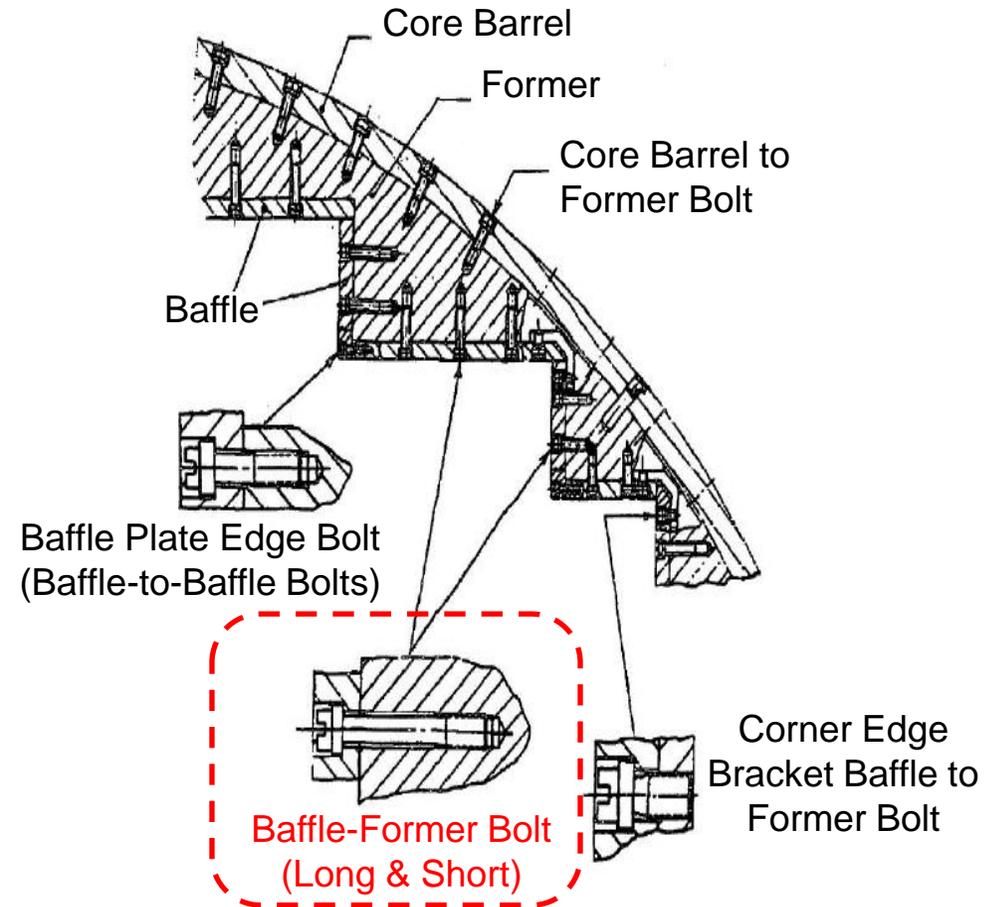
Baffle-Former Assembly Details

- Core barrel, baffle and former plates
 - Type 304 austenitic stainless steel material
- Baffle-Former Bolts (BFBs)
 - Attach the baffle plates to the former plates in the reactor lower internals assembly
 - Type 347 or Type 316 cold worked austenitic stainless steel material
 - Bolt head designs and shank lengths vary from plant-to-plant

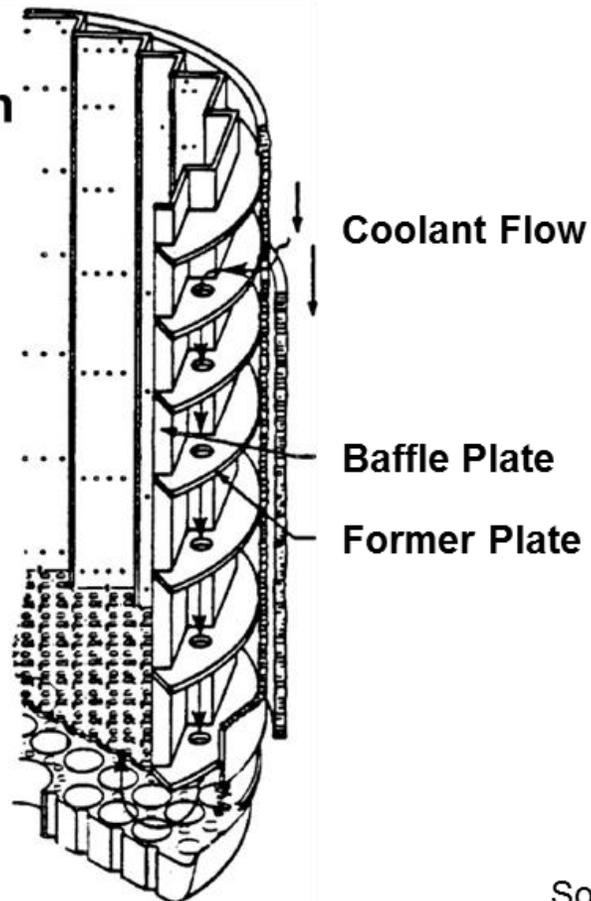
Downflow Configuration

Large Differential Pressure (ΔP) Across the Baffle Plate -> greater BFB bolt loads

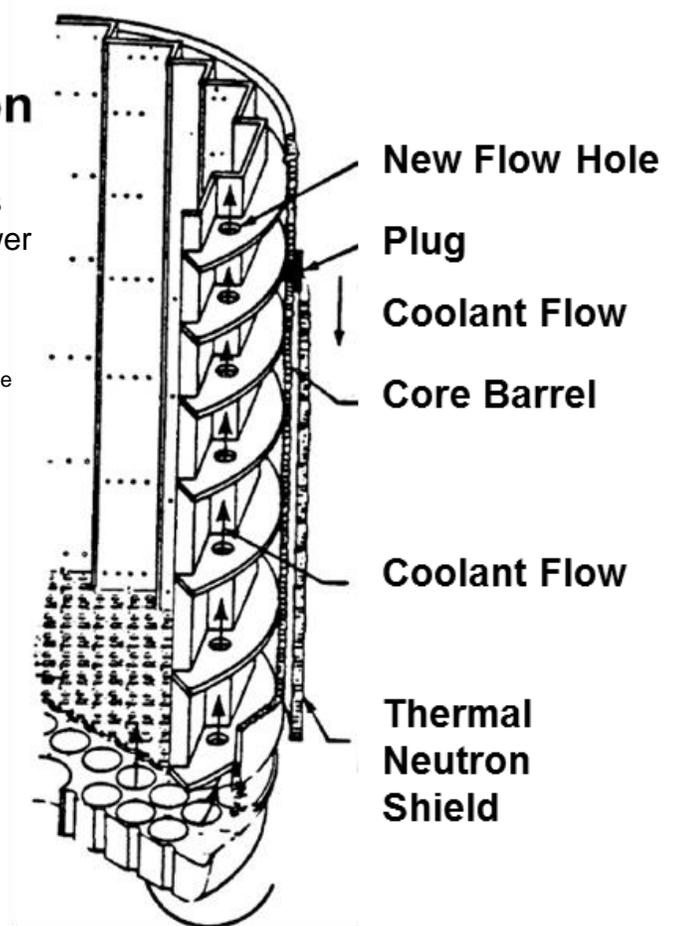
Upflow Configuration

Small Differential Pressure (ΔP) across the baffle plate -> lower BFB bolt load

*Figure shows modification made for Upflow Conversion

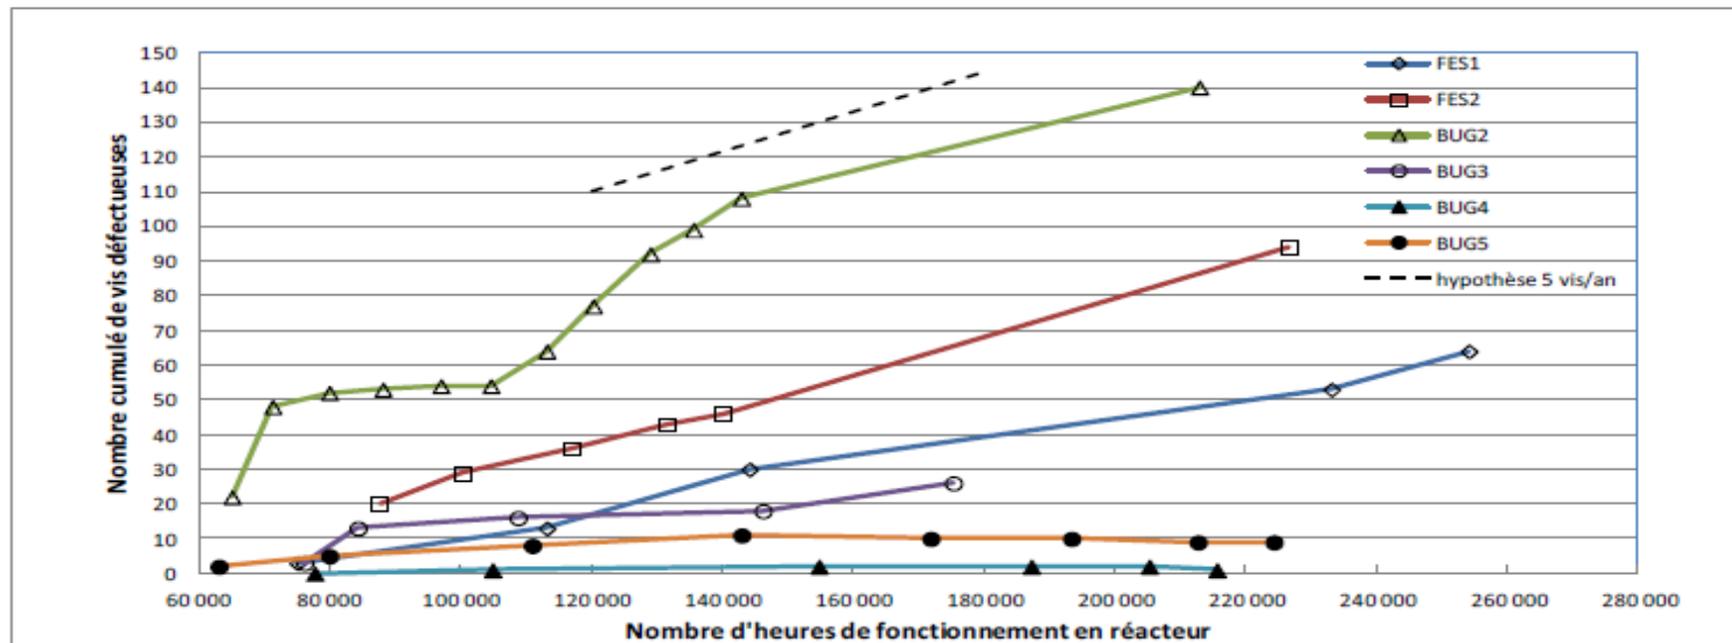
Overall BFB Timeline – CP0 Units

- X-axis: number of operating hours
 - Y-axis: cumulative number of bolts found ‘failed’/‘unconclusive’
 - ----- : evolution trend, assuming 5 failed bolts per year
- BUG2-FES2-FES1-BUG3: 4/6 CP0 units are ‘affected’**
BUG5-BUG4: 2/6 CP0 units are ‘unaffected’

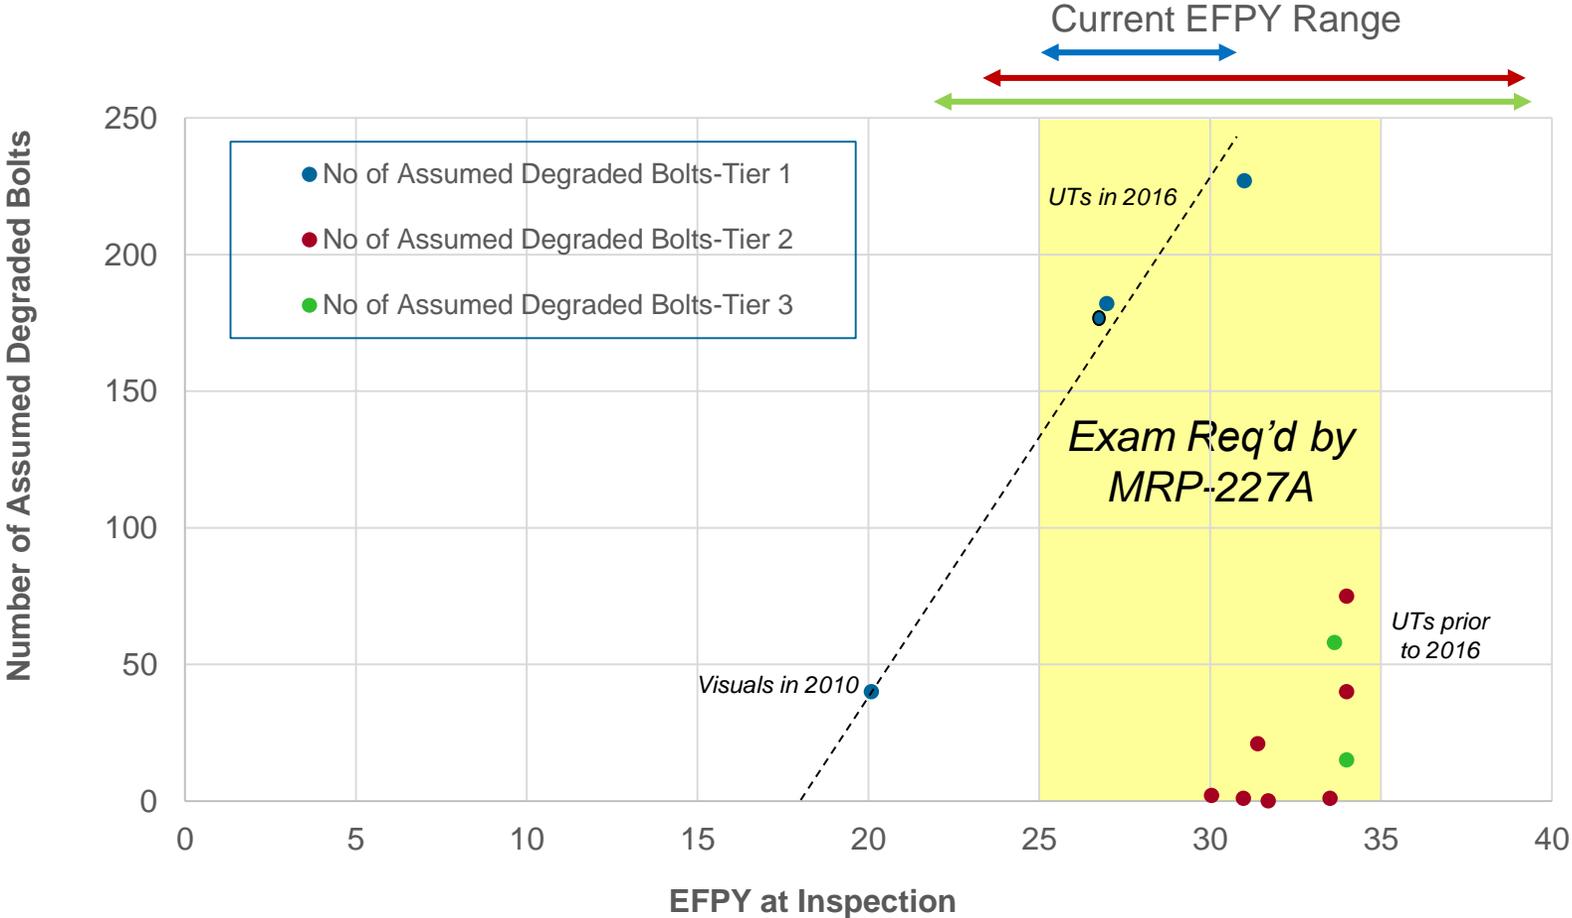
US Trends – BFB Focus Group Industry OE Database

- These three plants share a common plant design configuration (4-loop downflow), bolt design, and bolt material
- Bolts with visual or UT indications tend to be clustered
- Distributions seem to indicate the presence of a mechanism causing adjacent bolts to become more susceptible to failure
- Assessing impact of new findings from DC Cook 2 exams:
 - Replacement 316 CW BFBs (6) from 2010 event with UT indications
 - Visually degraded edge bolts (5) on one panel, in the center of a large area/cluster of BFB failures

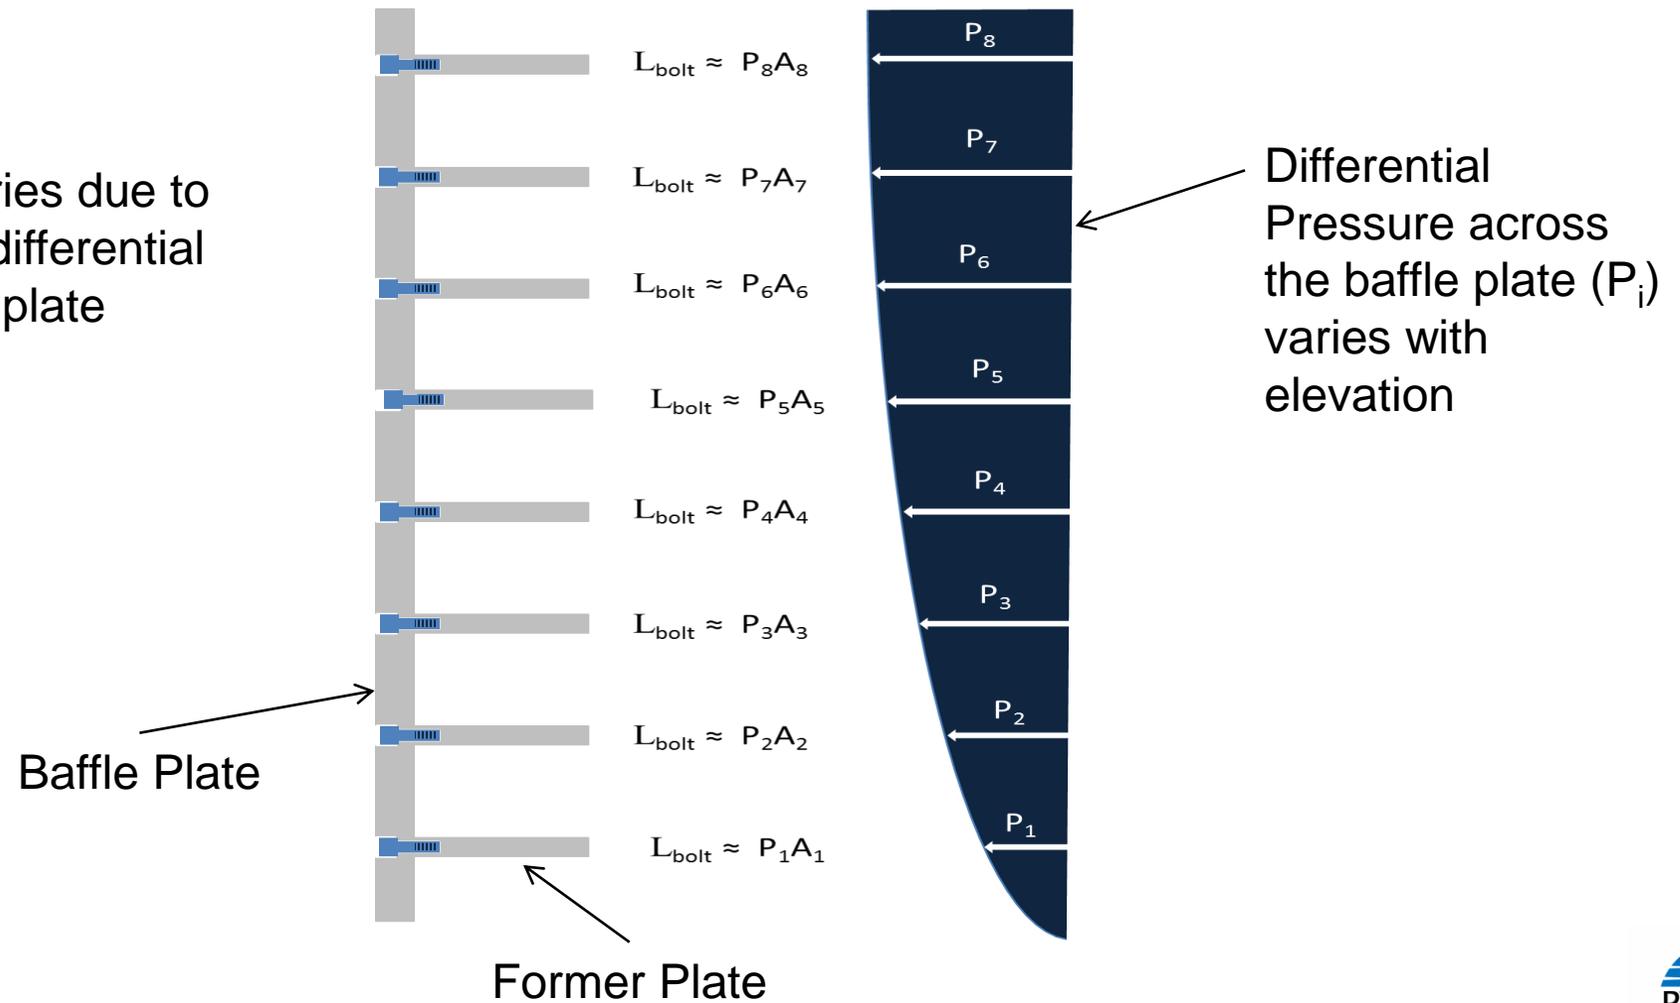
Vertical Stress Variation in Downflow Design

Bolt load (L_{bolt}) varies due to varying pressure differential across baffle plate

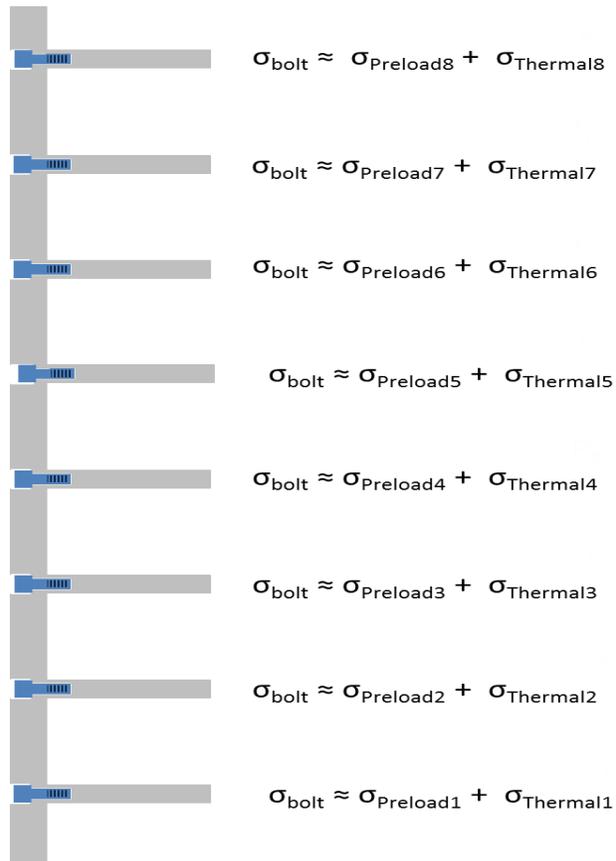
0 Failed Bolts

Stress Redistribution to Adjacent Bolts - Secondary

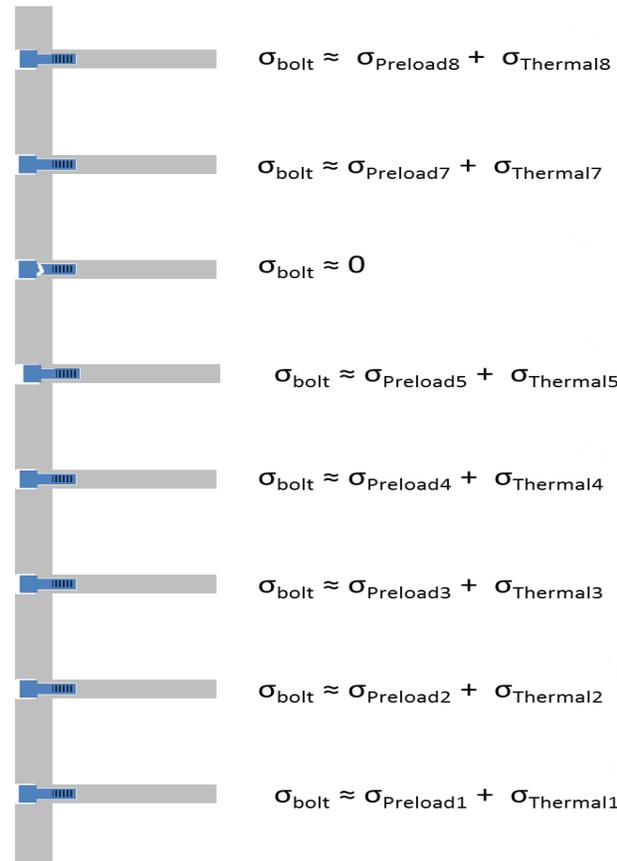
1 Failed Bolt

Secondary stresses predominant in early life (bolt preload)

Irradiation Induced Stress Relaxation diminishes secondary stresses over time

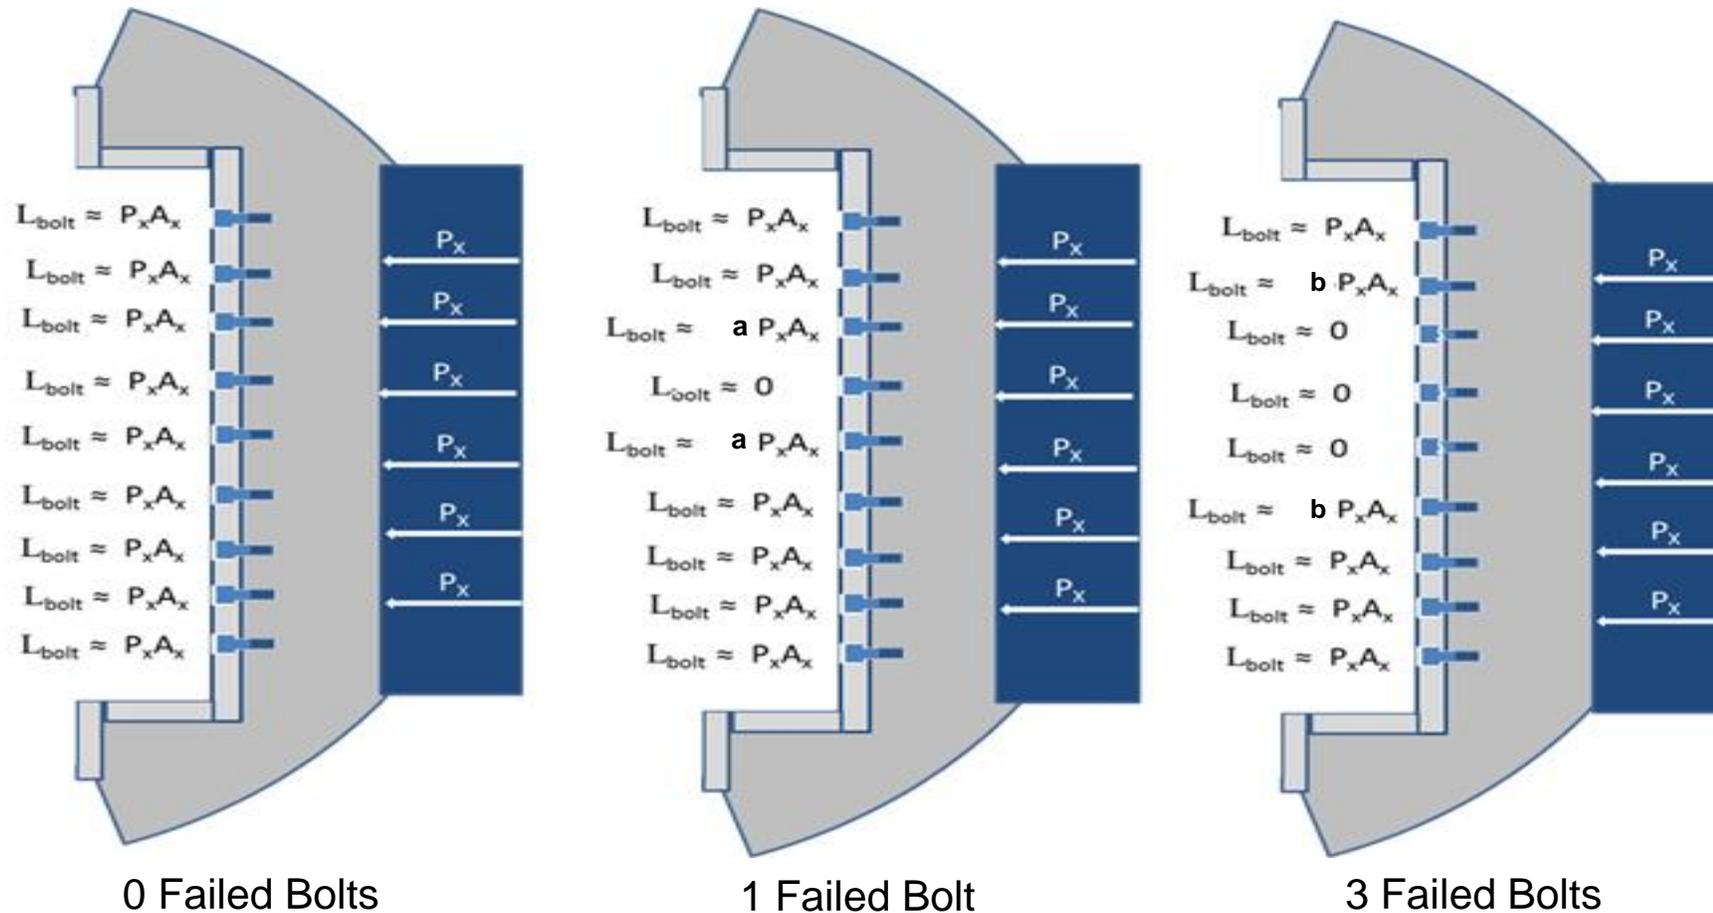
Stress Redistribution to Adjacent Bolts - Primary

Primary stresses dominate after irradiation stress relaxation occurs.

Stress redistributes as bolts fail.

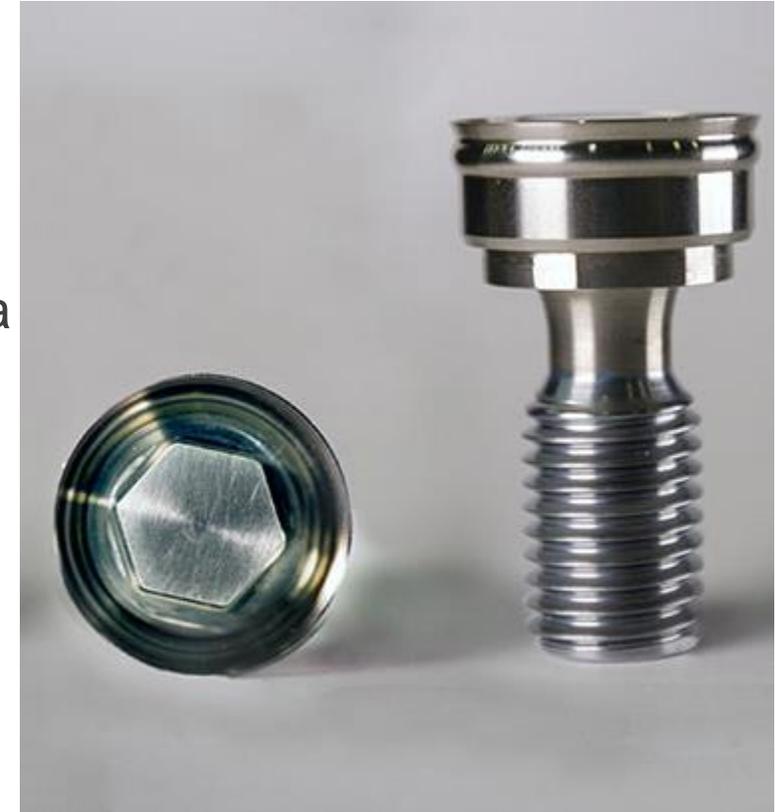
Westinghouse Replacement Bolts

- Replacement bolt design improvements to reduce impact of factors influencing bolt degradation
 - Cold Worked Type 316
 - Past operating experience using this material for baffle-former bolts and guide tube support pins has generally been positive. However, insufficient direct comparative data exists at this point to make a definitive conclusion
 - Semi-Parabolic head-to-shank transition fillet radius to reduce stress concentration and increase flexibility
 - Improved fatigue resistance
 - Reduced susceptibility to IASCC initiation
- Additional design improvements made for installation efficiency and ease of examination
