U.S. Nuclear Power Industry

# Emergency Classification Notifications

Statistics, Trends & Operating Experience

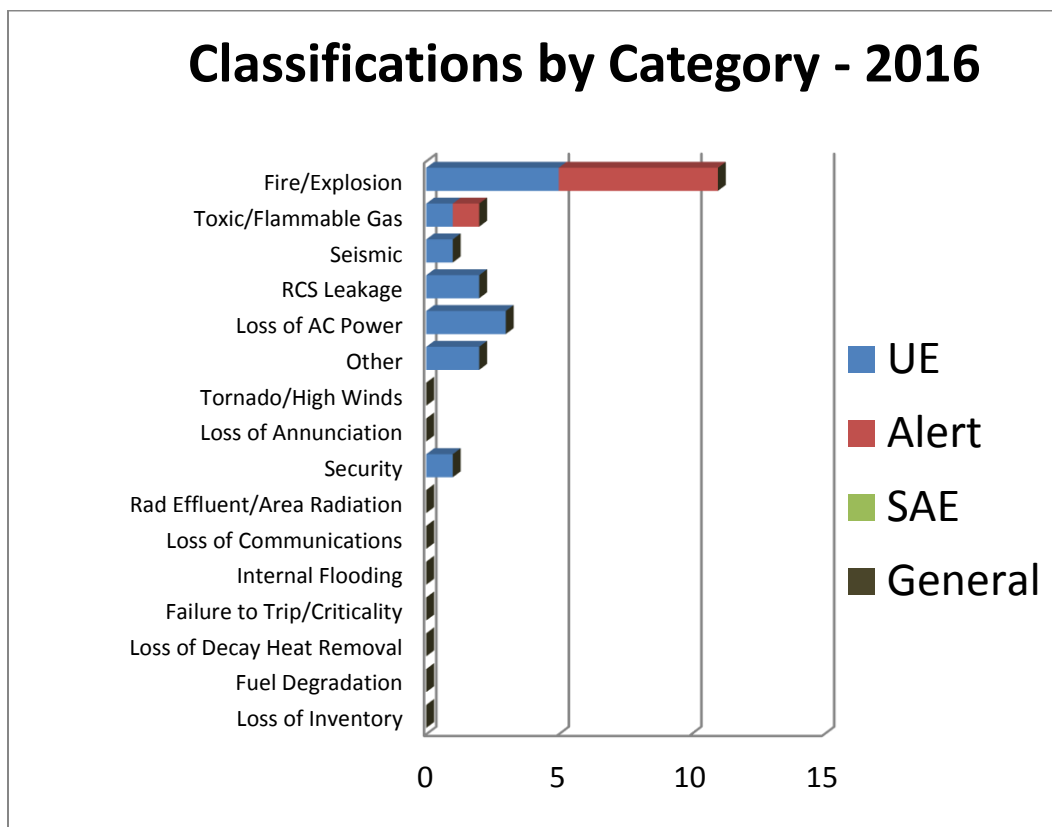
During 2016, there were fifteen (15) Unusual Event and seven (7) Alert emergency classification notifications made to the NRC. **Figure 1** depicts the number of emergency classification notifications made in 2016 by category. The categories in Figure 1 are those, which we have tracked since the inception of our annual report in 2008. **Figure 2** depicts total emergency classification notifications made by category over a ten year period.<sup>1</sup> The distribution of emergency classifications for the year 2016 deviates somewhat from the cumulative totals, by category, over the ten-year period shown in Figure 2. Reasons include:

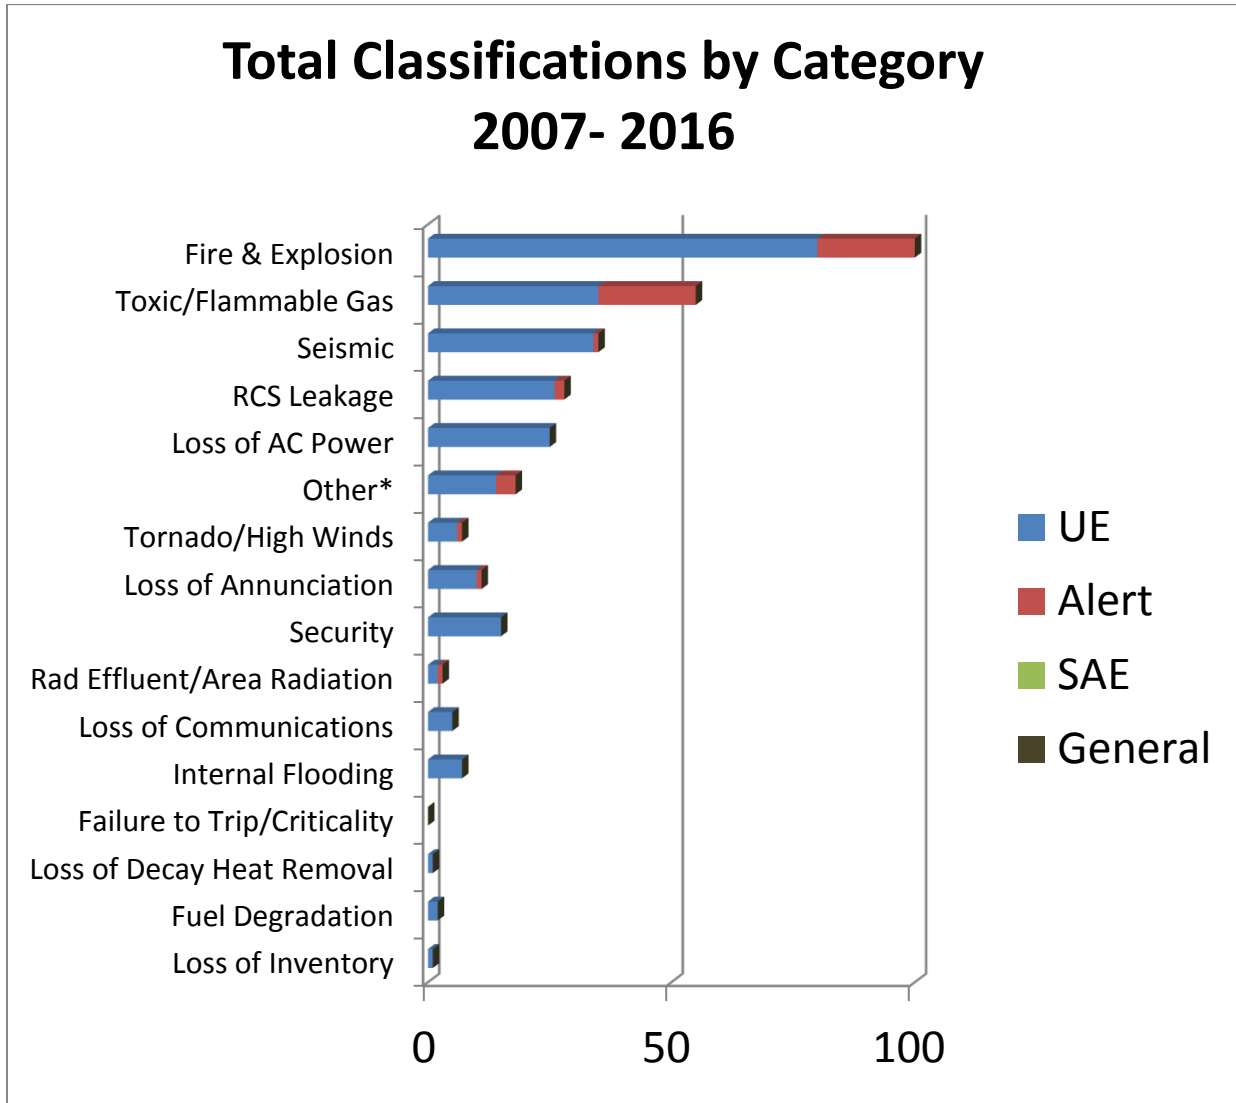
**Figure 2**

\* The **Other** category includes reported events such as: high and low ultimate heat sink/intake levels, Containment operability issues, fuel handling incidents, and Emergency Director judgment.

- There continues to be a significant reduction in hazardous gas event classifications over the previous five-year period.
- The lack of hurricane and seismic activity in the US has again significantly reduced natural-event-based classifications.
- Three “loss of AC power” events in 2016 following a year with no loss of AC electrical power-based classifications.

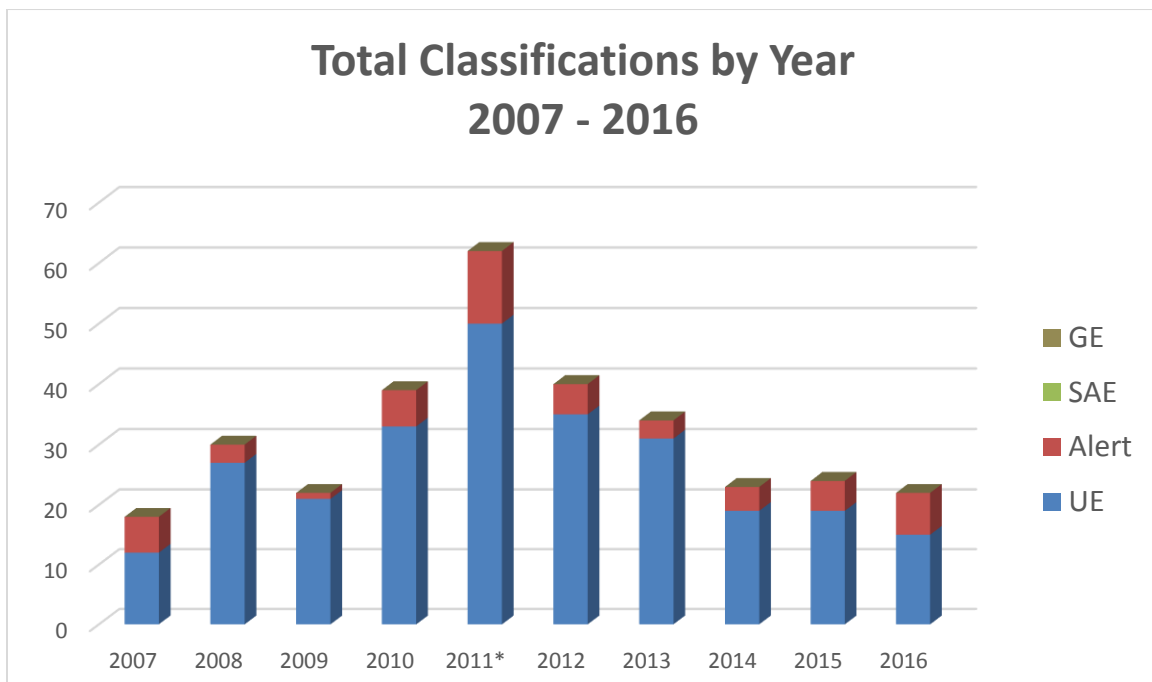
**Figure 3** depicts total number of emergency classifications reported to the Nuclear Regulatory Commission per year for the years 2007 through 2016. The 2016 total (22 declared events) represents the fourth year in a row that total classifications are significantly below the previous 10-year historical average (~34 declared events per year).

\* Sixteen (16) Unusual Events and one (1) Alert were declared on 8/23/11 due to an east coast seismic event.
