Tennessee Valley Authority, Sequoyah Nuclear Plant, P.O. Box 2000, Soddy Daisy, Tennessee 37384

Sequoyah Nuclear Plant, Unit 1
Renewed Facility Operating License No. DPR-77
NRC Docket No. 50-327

Subject: Unit 1 Cycle 21 - 180-Day Steam Generator Tube Inspection Report

Enclosure:
Unit 1 Cycle 21 180-Day Steam Generator Tube Inspection Report

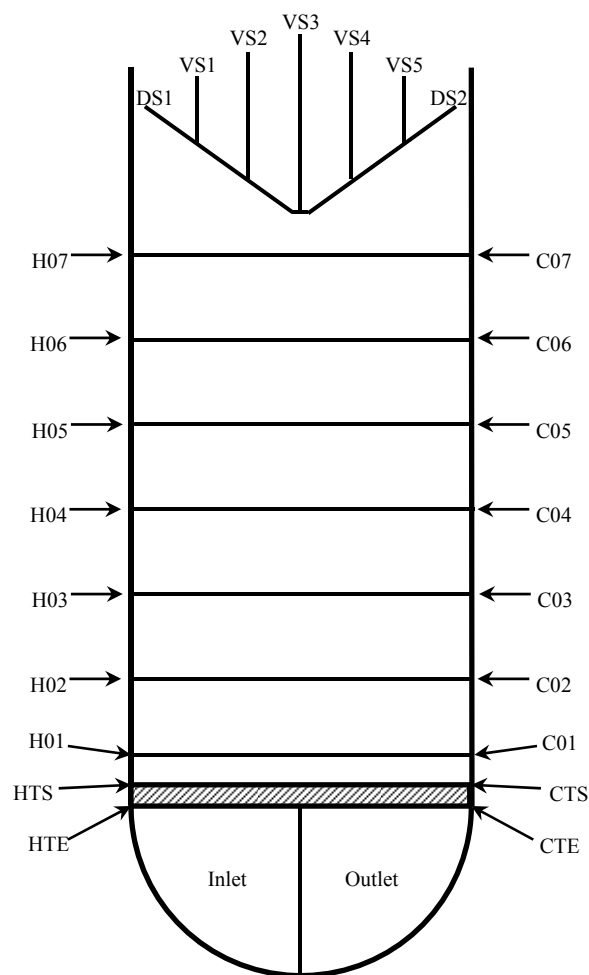
Figure 1-1: Tube Support Arrangement for Sequoyah Unit 1 Model 57AG Replacement Steam Generators

- Notes: VS = Vertical Strap
DS = Diagonal Strap
HTS/CTS = Hot/Cold Tubesheet (designates top of tubesheet)
HTE/CTE = Hot/Cold Tube End
Horizontal supports are a lattice grid design

The original steam generators at SQN1 were replaced in 2003 with Westinghouse Model 57AG SGs which have thermally treated Alloy 690 tubing. The U1R21 inspection was the fourth in-service inspection of the replacement SGs. Prior to the U1R21 inspection, the replacement SGs had operated for nine fuel cycles since replacement. The replacement SGs had operated for three fuel cycles since the previous inspection at U1R18. Figure 1-1 below provides the arrangement and location designation of the tube support structures for the SQN1 SGs.
