U.S. NUCLEAR REGULATORY COMMISSION
REGION I

Report No. 50-220/88-02

Facility Name: Nine Mile Point 1

Inspection Summary: Inspection on January 11-14, 1988 (Report No. 50-220/88-02)

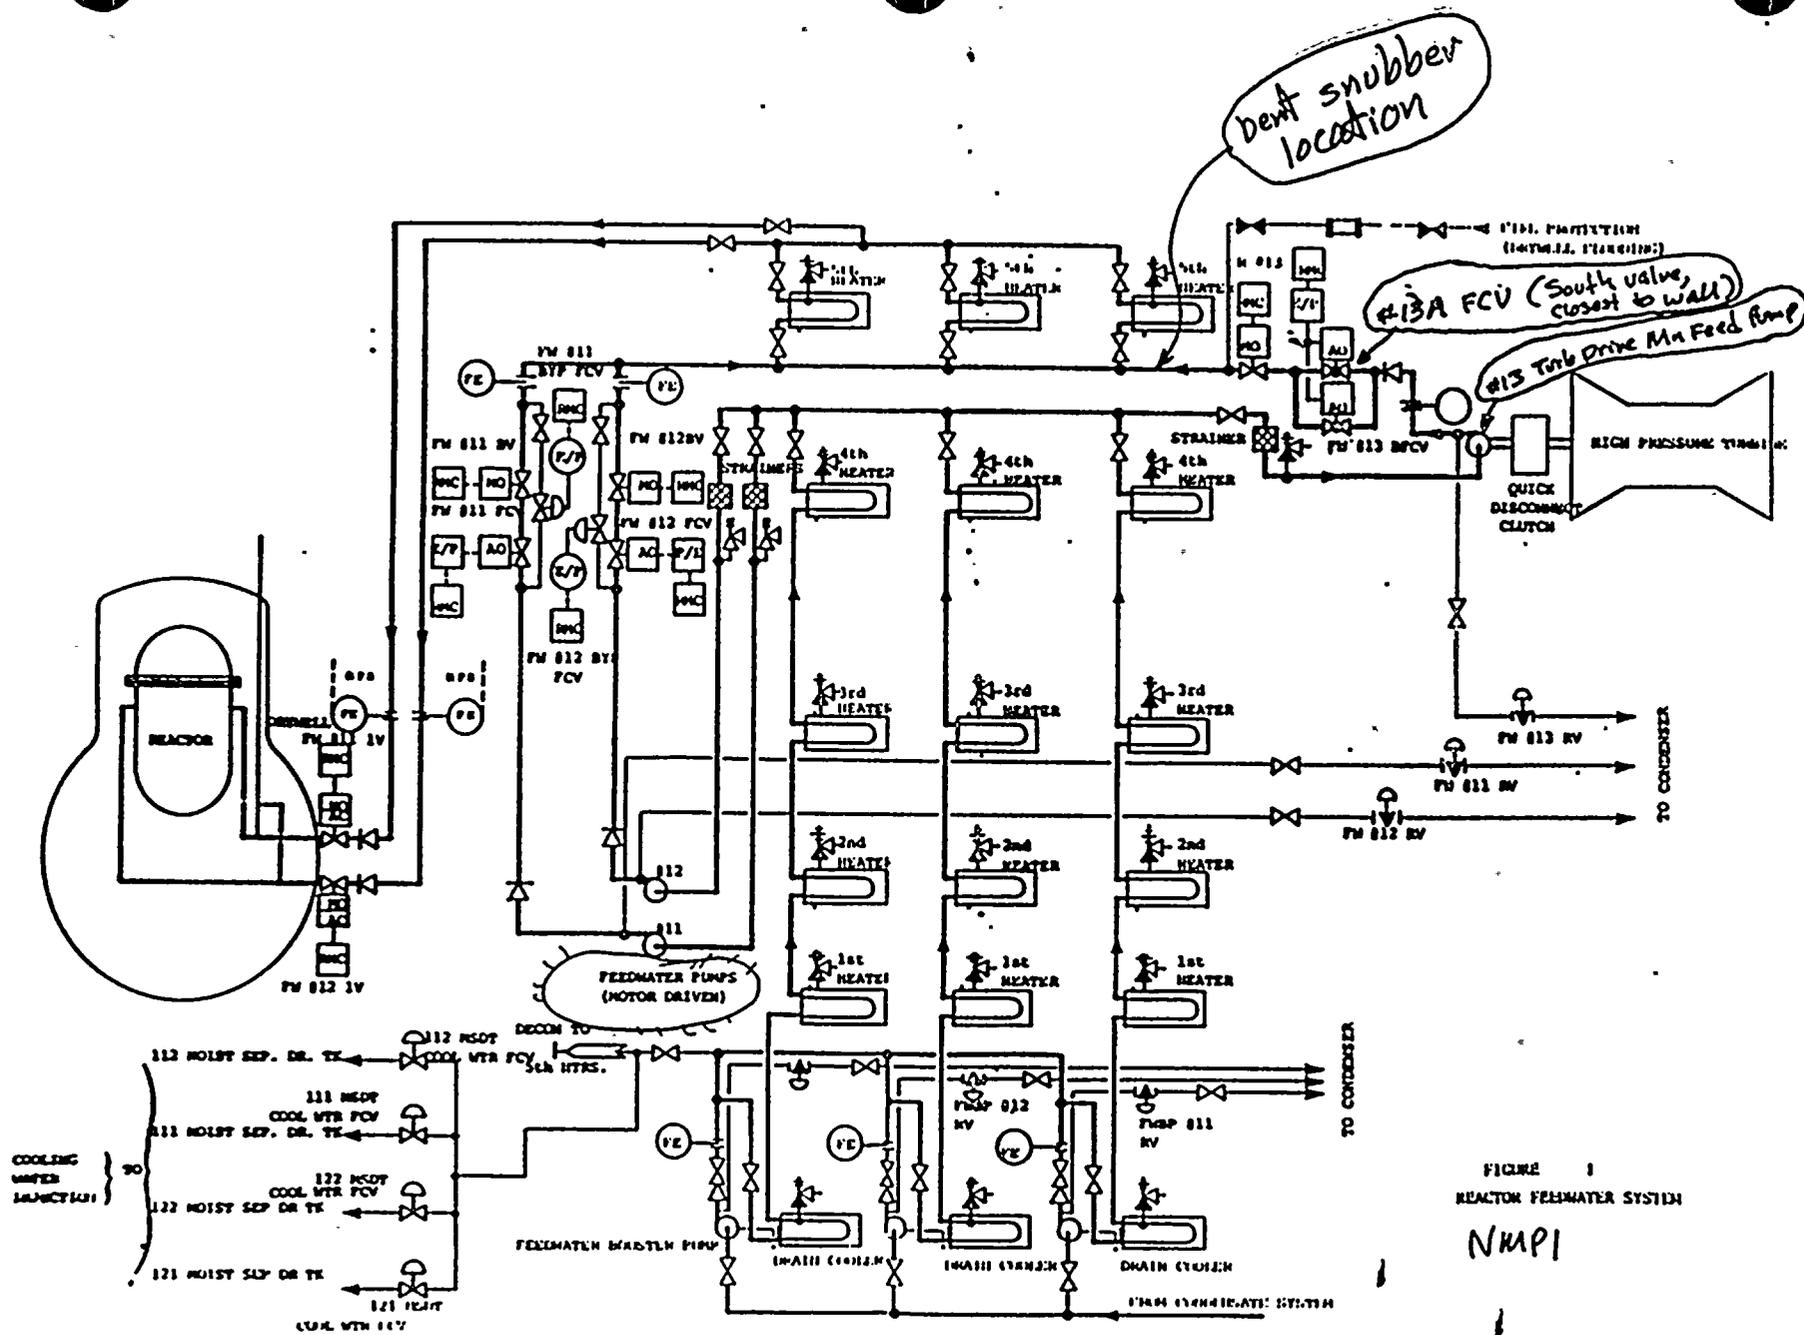
FIGURE 1
REACTOR FEEDWATER SYSTEM

The feedwater system consists of three motor driven, 50% capacity horizontal centrifugal feedwater booster pumps and three horizontal centrifugal reactor feedwater pumps. The feedwater booster pumps are supplied by three 50% capacity condensate pumps and discharge to three parallel strings of low pressure feedwater heaters. The discharge of the low pressure feedwater heaters flows to the reactor feedwater pumps. One feedwater pump (#13) is rated at 6,400,000 lbm/hr and is driven from the shaft of the units' high pressure main turbine through a quick disconnect clutch and step-up gear. The other two reactor feedwater pumps (#11 and #12) are each rated at 1,900,000 lb/hr and are electric motor driven through step-up gears. The feedwater pumps discharge through flow control valves, one per each motor-driven pump and two parallel control valves for the turbine driven feedwater pump. The #13 pump valves are a nominal 10" body, 8" trim with a 1" valve stem. #11 and #12 pump valves are an 8" body, 6" trim, also with a 1" valve stem. The discharge of the reactor feedwater pumps flows through three parallel high pressure feedwater heaters to the reactor.

NINE MILE POINT 1 FEEDWATER SYSTEM SCHEMATIC
