**RECORDER B22 - R623B  
PAM - POST ACCIDENT MONITORING  
8/02/91 - 8/13/91**

**REACTOR PRESSURE AND LEVEL**

# Nine Mile Point Unit 2 Reactor Pressure and Water Level vs Time

Data from August 13, 1991 Site Area Emergency

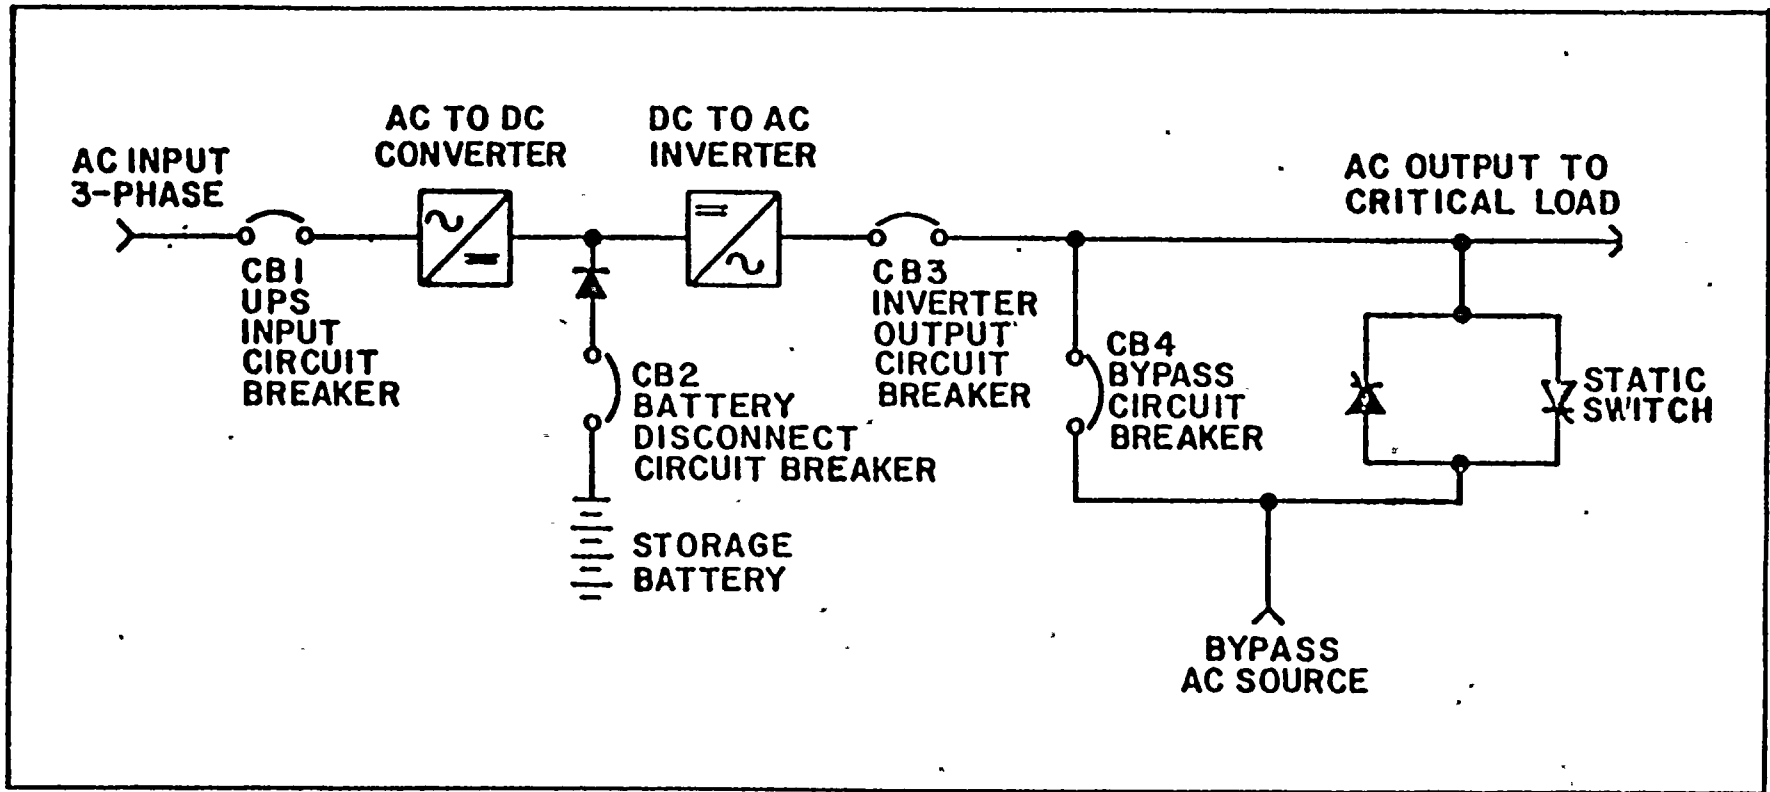
Figure 1-1. A Simplified One-Line Diagram of an UPS System.

The Exide Uninterruptible Power Supply (UPS) protects a critical electrical load by providing emergency backup power for a specified minimum time period whenever utility service is interrupted. The UPS system consists of a solid-state rectifier/charger, a static inverter with internal controls, synchronizing equipment, protective devices, and an industrial-type storage battery as a source of backup power. See Figure 1-1 for a one-line diagram of the UPS system.

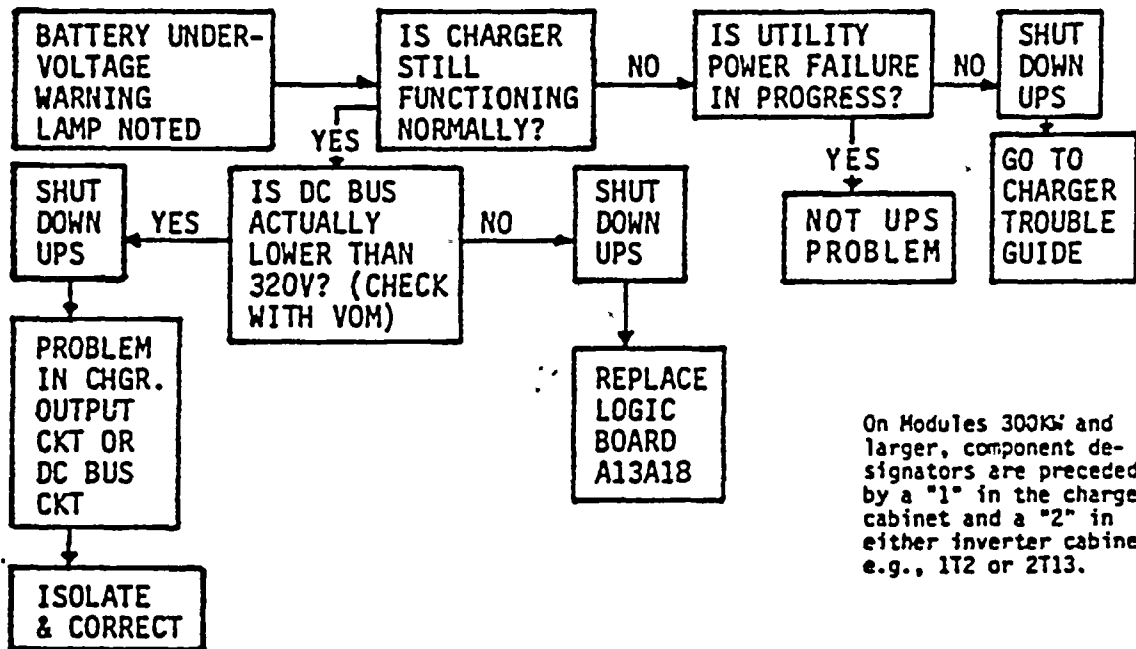
#### 3.2.4.3.1. Battery Undervoltage Warning (Nonstorage)

This circuit monitors the same DC reference voltage as the circuits that are incorporated for DC UNDERVOLTAGE and DC OVERVOLTAGE. An alarm is given when the DC bus voltage falls to a set value, which means that the battery will support the load for approximately 5 minutes before reaching the specified limit. The set battery undervoltage is  $77.8\% \pm 2\%$  of float voltage.

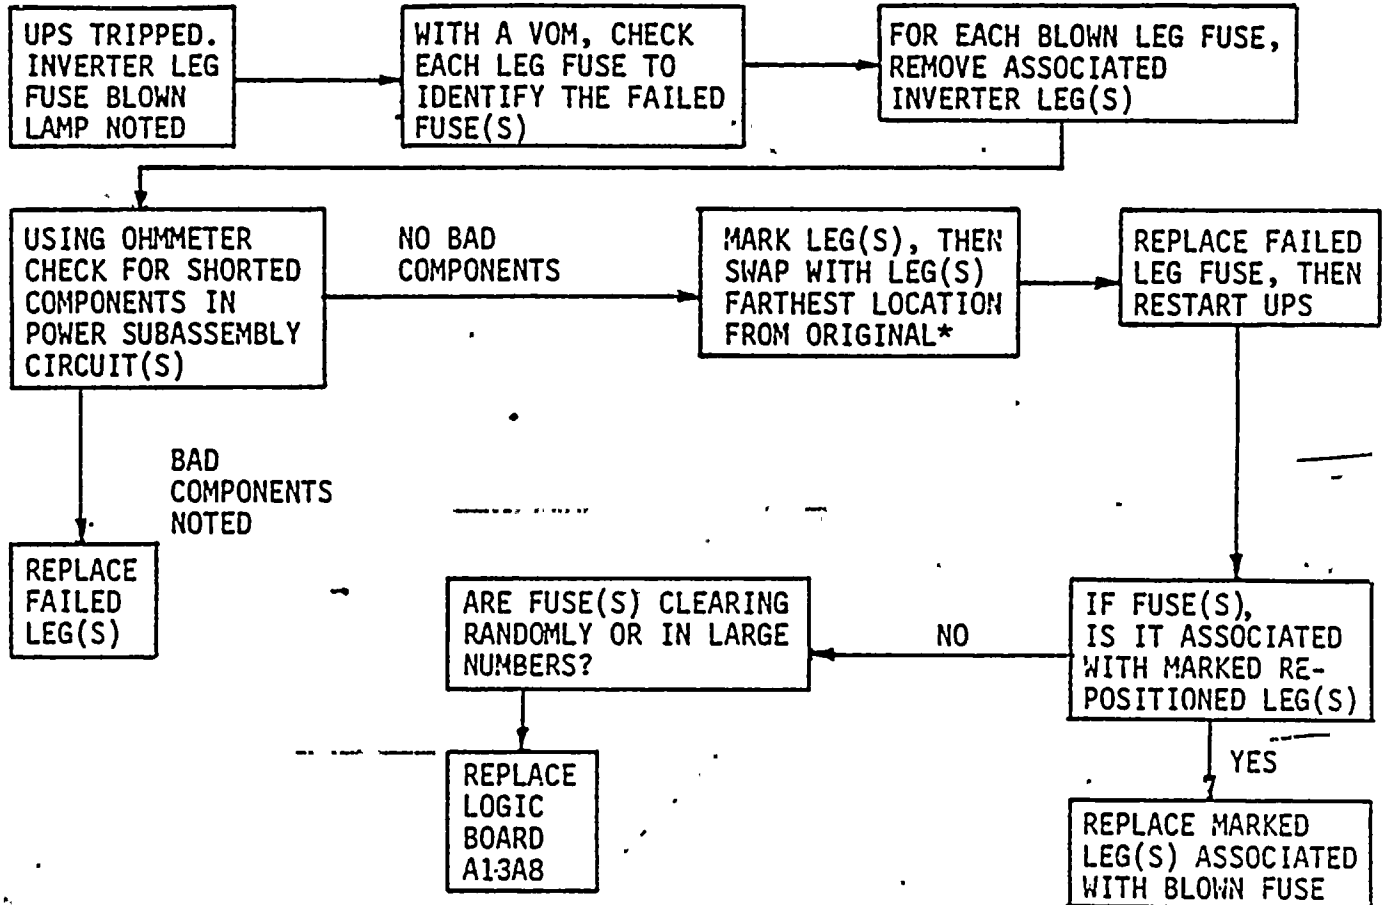
## 3.2.4.3.4 Inverter Leg Fuse Blown (Stored). See Caution, Section 3.2.3.3.

\*For modules 100 KW and up, each leg fuse protects a "leg pair." Since each power fuse isolates two legs, it is difficult to tell which leg is at fault if no internal components are obviously defective. One method of isolation is the moving of the legs to different locations. As an example assume that the fuse supplying legs A5 and A6 cleared, and no internal components are found faulty. First mark both legs, then remove legs A1 and A12. Insert leg A5 into position A1 and leg A6 into position A12. Insert leg A1 into position A5 and leg A12 into position A6. Replace fuses and restart the UPS. Now, if the fuse supplying positions A1 and A2 clears, you can conclude that leg A5 is defective and if the fuse supplying positions A11 and A12 clears you can conclude that leg A6 is defective.

This circuit annunciates the loss of one or more leg fuses by sensing abnormal voltage across the fuses, tripping the UPS and storing this alarm if the fuse voltage exceeds 70 V.

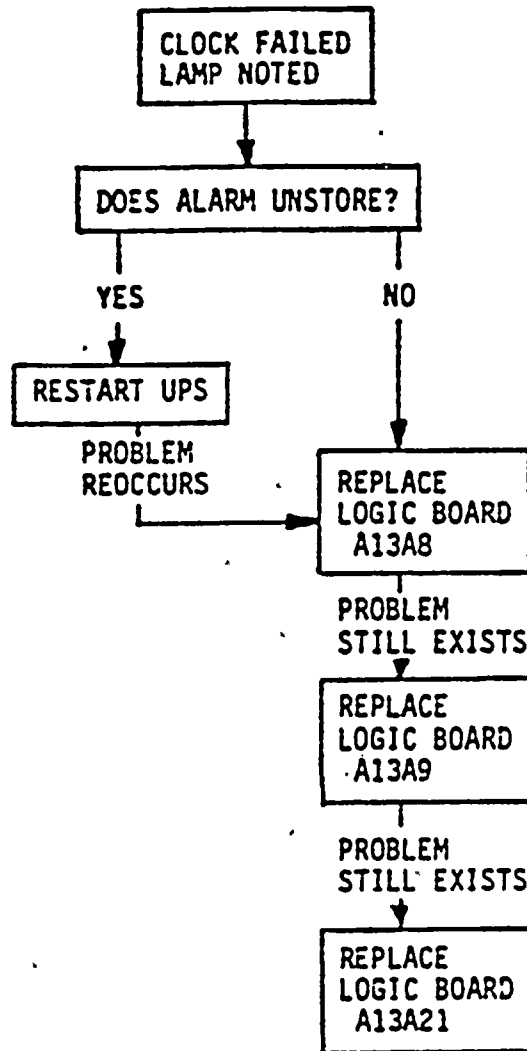
3.2.4.3.7 Clock Failed (Stored) . See Caution, 3.2.3.3.

On Modules 300K and larger, component designators are preceded by a "1" in the charger cabinet and a "2" in either inverter cabinet; e.g., 1T2 or 2T13.

This circuit monitors the clock timing signals. Deviation, such as a missing clock pulse, results in an immediate trip signal.

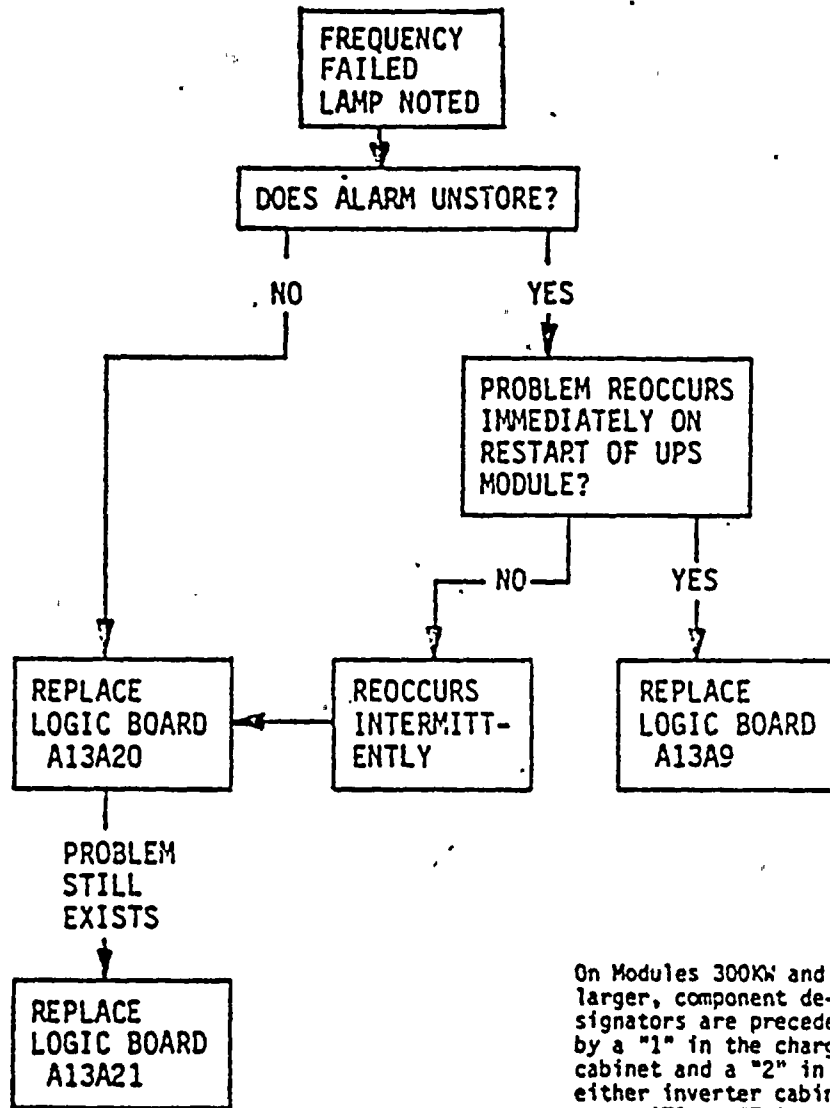
3.2.4.3.8 Frequency Failed (Stored). See Caution, Section 3.2.3.3.

On Modules 300KW and larger, component designators are preceded by a "1" in the charger cabinet and a "2" in either inverter cabinet; e.g., 1T2 or 2T13.

This circuit monitors the Inverter output frequency and is active whenever the output voltage is within normal limits. While being adjustable, this circuit is factory set normally to input frequency  $\pm 1.5$  Hz.

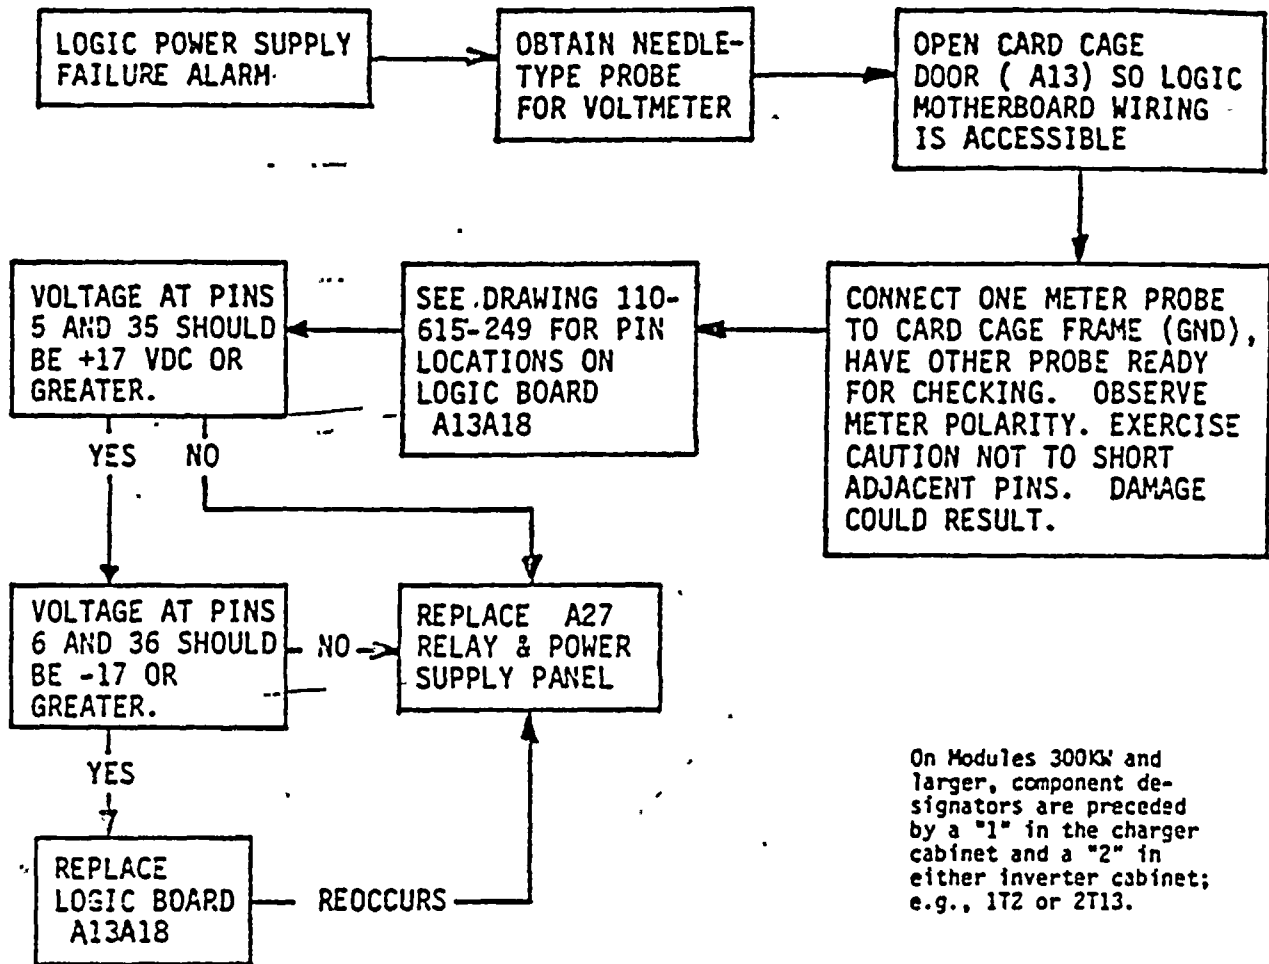
3.2.4.3.10 Logic Power Supply Failure (Nonstored). See Caution, Sect. 3.2.3.3.

This circuit monitors the positive and negative 20 VDC power supplies located on the A27 panel. Monitoring and tripping are performed on the A13A18 logic card.

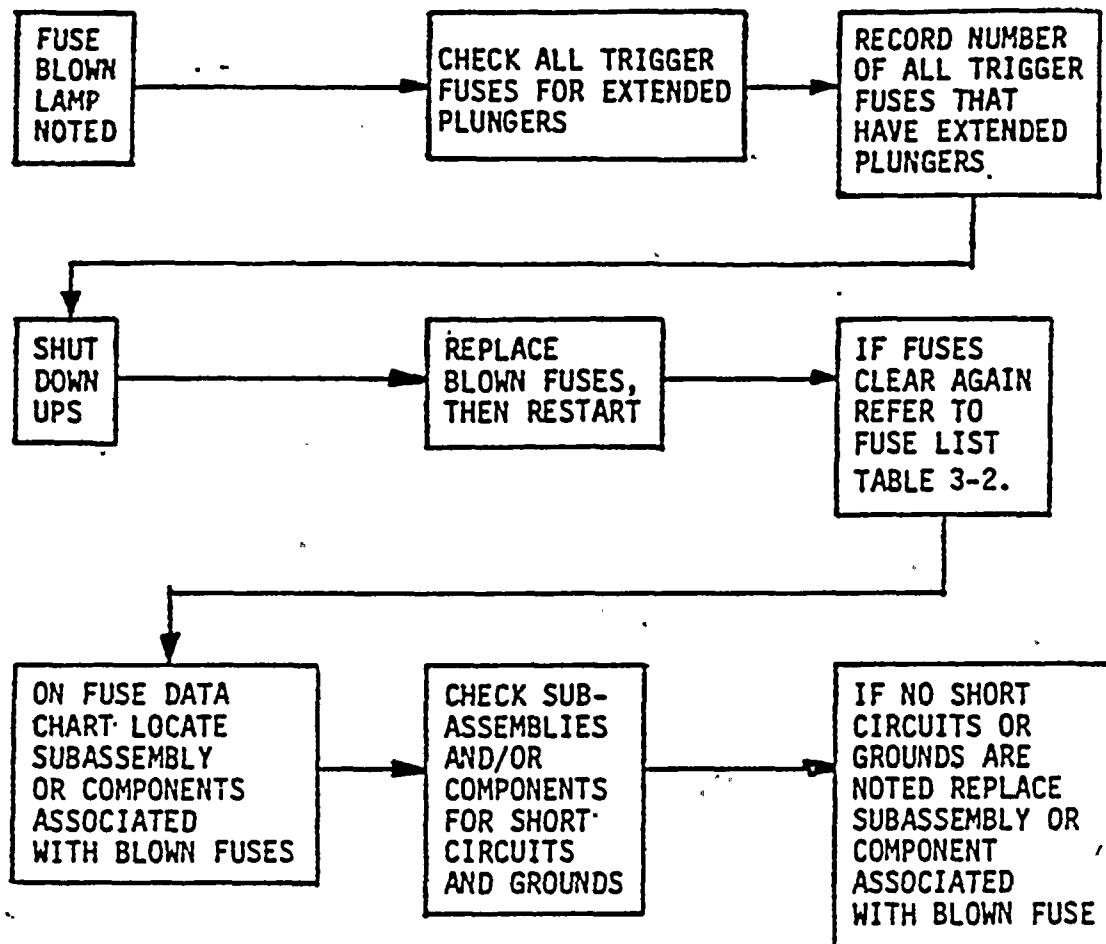
## 3.2.4.3.11 Fuse Blown (Nonstored). See Caution, Section 3.2.3.3.

On Modules 300Kw and larger, component designators are preceded by a "1" in the charger cabinet and a "2" in either inverter cabinet; e.g., 1T2 or 2T13.

All switches used in the "Fuse Blown" annunciation circuit are wired in parallel. The summing points for all are the A13A1 and A13A21 cards; so if this alarm is noted and no blown fuses are found, replacement of the A1 and A21 cards is indicated.

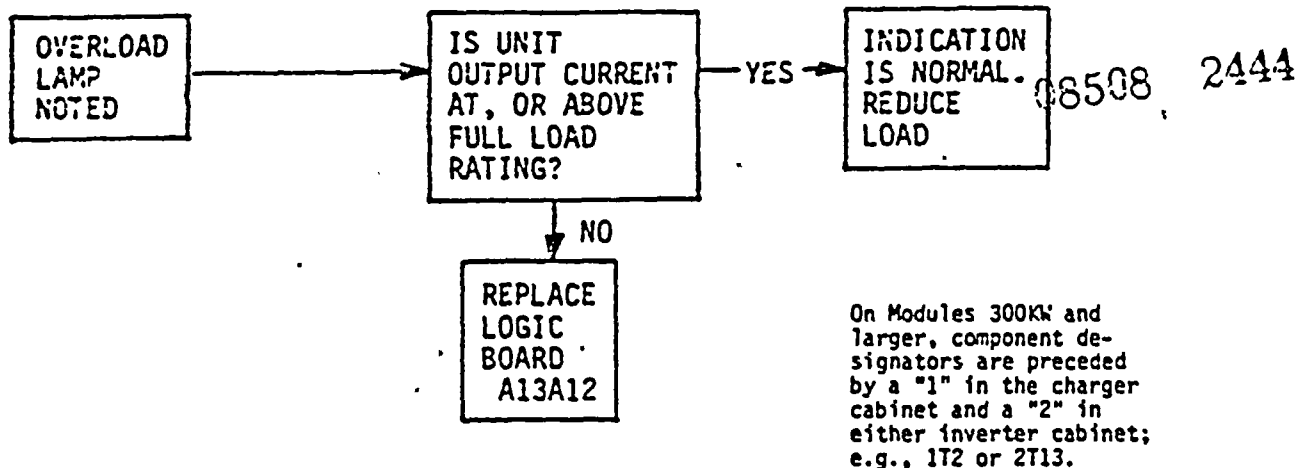
3.2.4.3.12 Overload (Storage). See Caution, Section 3.2.3.3.

This circuit monitors output current via current transformers in the inverter output circuit. The indicator will light if output current rises to a value above full load. The A13A12 logic board monitors and sends out the command to annunciate. Time at overload is monitored by the A13A21 logic board; if this alarm is not corrected, the UPS is tripped in approximately 12 min.

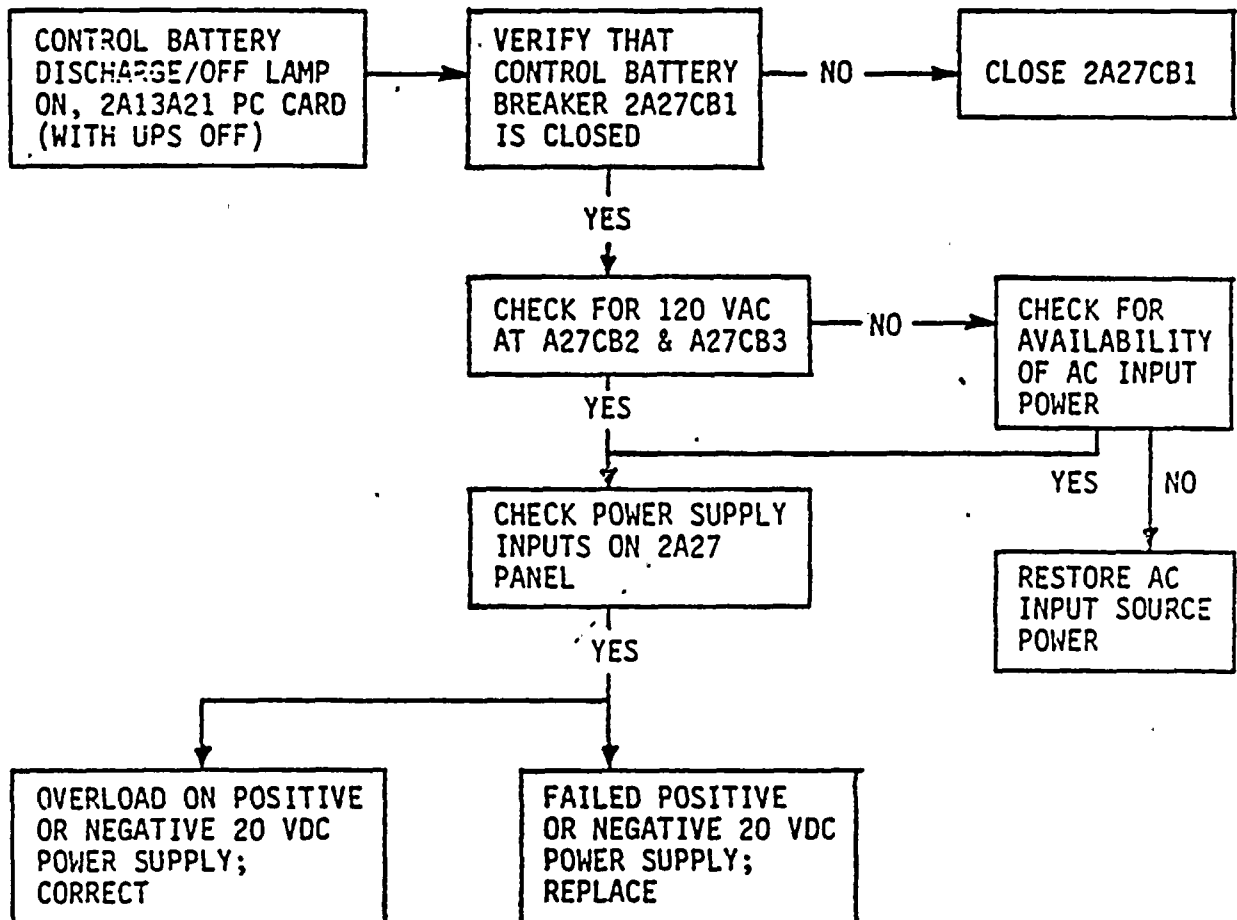
## 3.2.4.3.18 Control Battery Discharge/Off (nonstored). See Caution, Section 3.2.3.3.

Zener diodes A27A1VR1 and VR2, in series with relay coils A27A1K4 and K8 and fed by the utility or alternate source, monitor the output of power supplies PS3 and PS4. Zener diodes A27A1VR3 and VR4, in series with relay coils A27A1K12 and K14 and fed by the inverter output, monitor power supplies PS1 and PS2. Logic power supply breaker A27CB2 controls the input to PS1 and PS2, and A27CB3 controls the input to PS3 and PS4. Circuit breaker A27CB1 disconnects the battery from the logic power bus. A control battery discharge signal occurs if both A27CB2 and A27CB3 are open or are not supplying power and if A27CB1 control battery breaker is open.

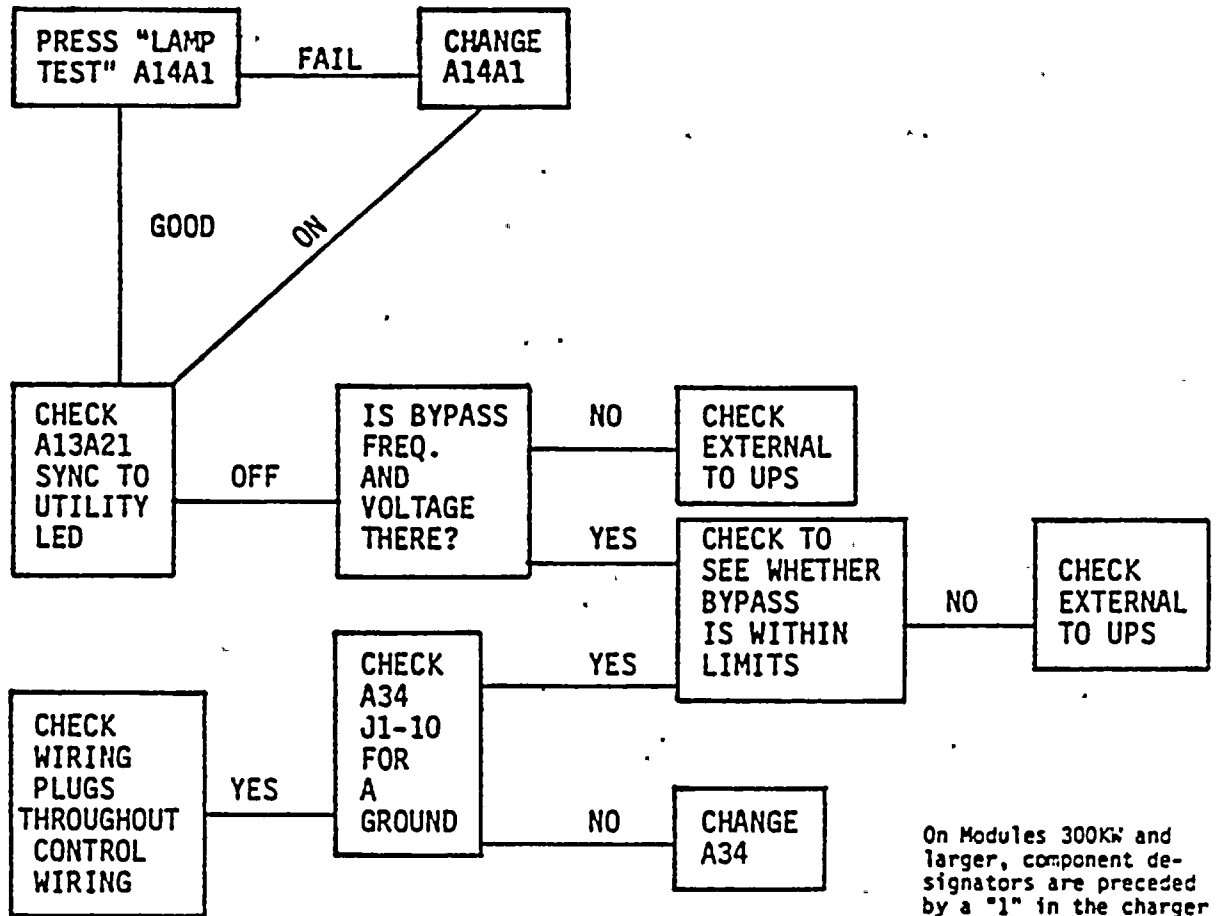
3.2.4.3.19 Utility Sync OK LED Off

On Modules 300KW and larger, component designators are preceded by a "1" in the charger cabinet and a "2" in either inverter cabinet; e.g., 1T2 or 2T13.

Lamp "ON" indicates that the UPS is receiving a sync-to-utility command. Command exists when the bypass source is within voltage and frequency limits and the critical load bus is within a close phase difference with the bypass source.
