GERIS 2000
ULTRASONIC INSPECTION OF
FEEDWATER NOZZLES

January 8, 1996

GENERAL ELECTRIC
NUCLEAR ENERGY
12200 Herbert Wayne Ct, Suite 100
Huntersville, N.C. 28078

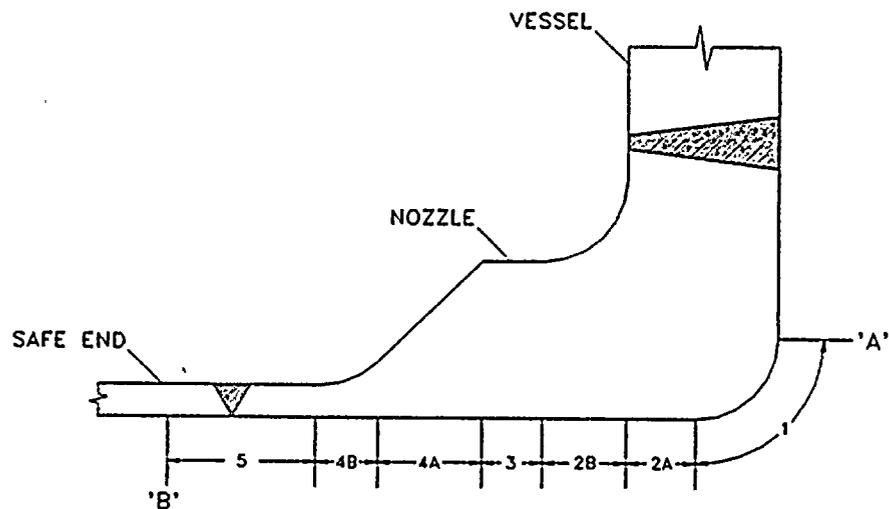
Figure 1 - Feedwater Nozzle Examination Zones

GE has developed a program using the GE Reactor Inspection System 2000 (GERIS 2000), and has significantly improved flaw detection and characterization. The UT techniques have been developed and tested on full-size Reactor Pressure Vessel (RPV) nozzle mockups of various sizes and designs. Notches and crack implants in these mockups, located in various zones along the nozzle inner-radius and bore, range in depth from 0.105" to 0.750". Figure 1 shows the various inspection zones of the nozzle inside surfaces.

For scanning nozzle examination Zones 1 and 2A as shown in Figure 1, the nozzle-mounted scanner (Figure 4), mounted on a channel track clamped around the nozzle OD cylindrical surface, provides the means of performing a remote ultrasonic examination. The nozzle device includes the nozzle tractor, scanner arm and transducer package.

As discussed earlier and shown in Figure 1, the inner-radius and bore are divided into different inspection zones. To effectively examine these zones, specially developed techniques are used where examinations are performed from the vessel plate, nozzle OD blend radius, nozzle OD and nozzle taper.

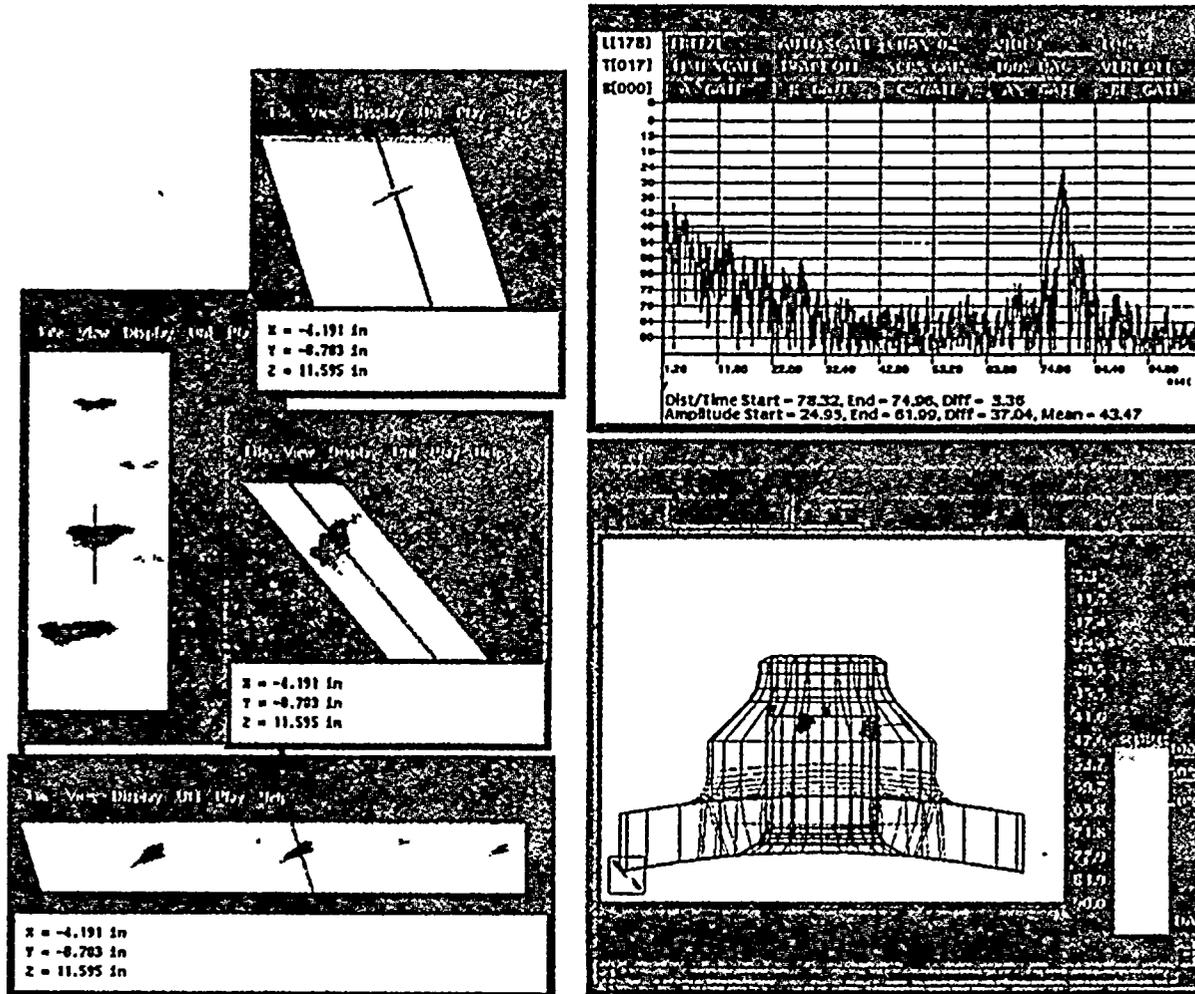
Figure 2 - GERIS 2000 Data Analysis Displays

The data analysis software includes a 3-D graphics package that superimposes peak UT data points on a nozzle image. Refer to Figure 2. Data may be viewed from various orientations and magnifications. Access to digitized RF A-scan data is available for viewing any selected data point, which greatly aids in the classification and evaluation of UT data. In the A-scan display shown in the upper-right hand corner of , the amplitude (height) of the returned signal is shown on the vertical axis, and the relative time-of-flight is shown on the horizontal axis. The signal amplitude is affected by the relative orientation of the UT beam direction and the flaw aspect. The locations of the various flaws are indicated on the plan view of the nozzles, and the relative amplitude of the returns are color-coded for ease of interpretation.

In addition, the workstation displays peak-amplitude-UT data superimposed on a 3-D wire-frame model of the nozzle or component being examined (see Figure 2). Three-dimensional graphic tools include component viewing at any perspective or magnification. These capabilities assist in accurate UT data evaluation by analysis personnel. An on-line data base of transducer/scanner position, UT and A-scan data can be accessed during data analysis.

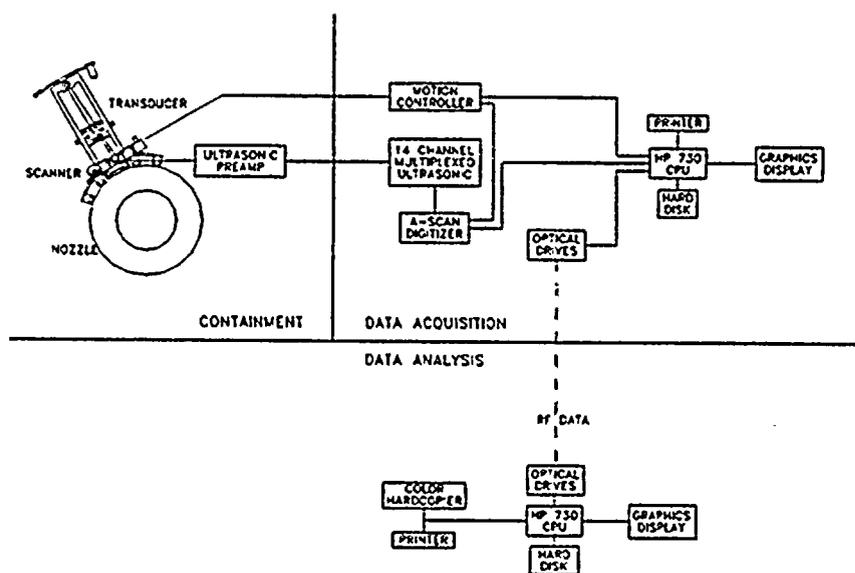
Figure 3 - GERIS 2000 Nozzle Inspection System

Referring to Figure 3, an automated scanner moves UT transducers radially and circumferentially around the outside surface of a nozzle and the adjacent surface of the RPV. The UT data is collected and stored in a digital format. The complete RF waveform is digitized and recorded on optical disks.

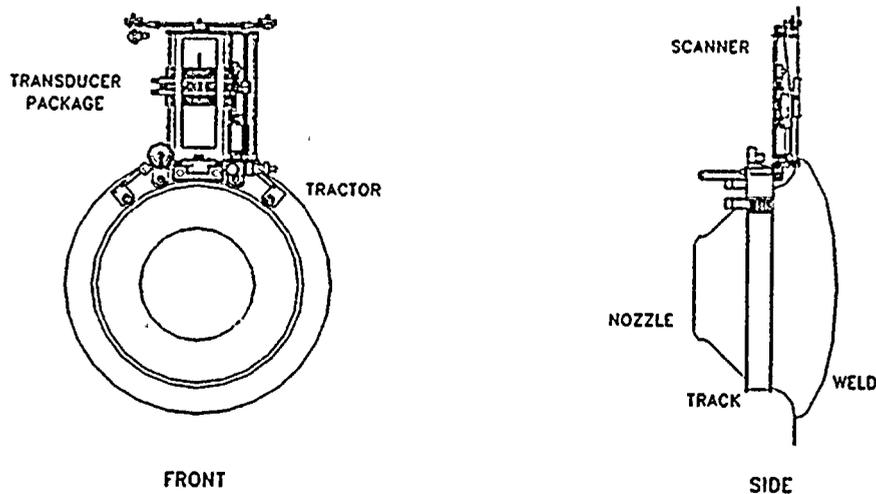
Figure 4 - Nozzle-Mounted Scanner

The nozzle tractor has a main body with two motor-driven magnetic wheels and two hinged-end sections, each with one motor-driven magnetic wheel assembly. A pendulum and resolver are mounted on the main body to give the angular position of the nozzle tractor. The reciprocating scanner arm is attached to the nozzle tractor and extends perpendicular to the nozzle track for scanning the nozzle-to-vessel welds and nozzle inner-radius.

The scanner arm consists of a frame, stepping motors, a worm-gear-driven resolver, and a ball-screw-driven plate that holds the ultrasonic transducer package. The scanner arm is held to the vessel wall with two spring-loaded guide rods on the inboard end and two magnetic wheels mounted at the outboard end of the scanner arm.

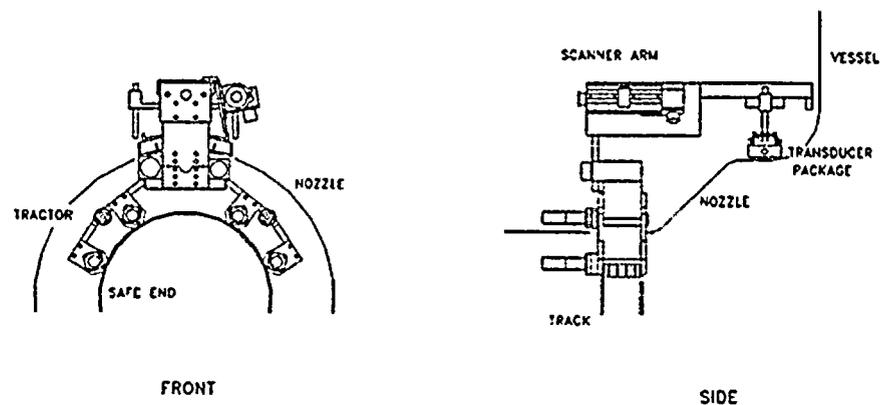
Figure 5 - Safe-End Mounted Scanner

The safe-end mounted scanner (Figure 5) attaches to a channel track clamped around the nozzle safe-end, and provides the means of performing a remote ultrasonic examination of the nozzle inner bore surface. The safe-end mounted scanner is designed for scanning nozzle examination Zones 2B, 3, 4A and 5.

The safe-end mounted tractor consists of a main body with two motor-driven magnetic wheels and two hinged-end sections, each with motor-driven magnetic wheel assemblies. A pendulum and resolver are mounted on the main body to give the angular position of the tractor. The reciprocating scanner arm is attached to the tractor and extends perpendicular to the safe-end track for scanning the nozzle-bore region.
