## **SUPPLEMENT 1 NINE MILE POINT 1 SEISMIC ANALYSIS, CORE SHROUD REPAIR MODIFICATION**

**GENE B13-01739-03  
Supplement 1  
Class III  
August 1996**

**Supplement 1  
Nine Mile Point 1  
Seismic Analysis, Core Shroud  
Repair Modification**

**Niagara Mohawk Power Corporation  
Nine Mile Point Unit 1**

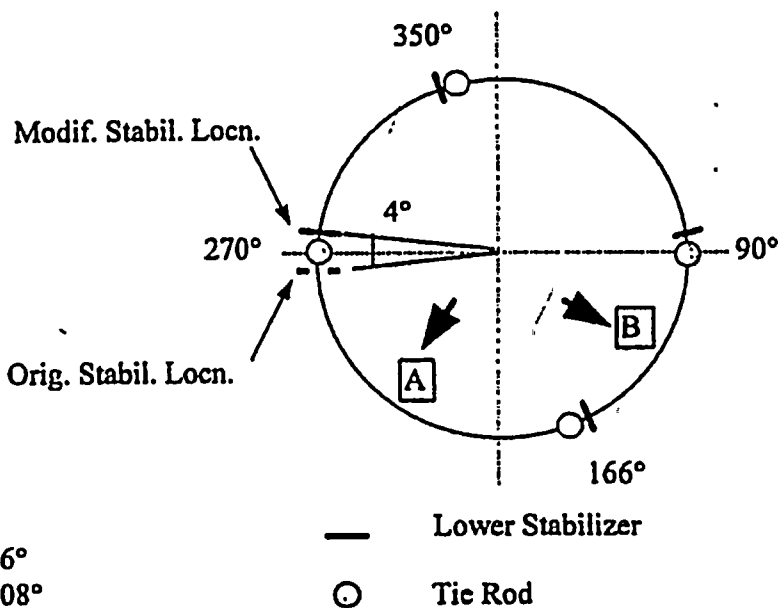
The as-built locations of the tie rods are at azimuths 90°, 166°, 270°, and 350°. The lower stabilizer is attached to one side of the tie rod assembly (consistent side) at all four tie rod locations. The lower stabilizer at the 270° tie rod location, however, was found to be contacting the RPV at the bend radius of the recirculation pipe nozzle, resulting in partial bearing against the RPV. In order to remedy this, the lower stabilizer spring at this tie rod location is proposed to be removed and re-attached to the 'other' side of the tie rod assembly. This would result in the lower stabilizers being apart as follows:

90° ~ 166°	= 76°
166° ~ 274°	= 108°
274° ~ 350°	= 76°
350° ~ 90°	= 100°

Minimum Angle Spread	=	76°
Maximum Angle Spread	=	108°

The nominal lower stabilizer stiffness used in seismic analysis is based on 90° spread. The minimum angle spread of 76° (Load direction B) results in upper bound net stabilizer stiffness and the maximum angle spread of 108° (Load direction A) results in lower bound net stabilizer stiffness. Analysis was performed to assess the impact of the variation of the lower stabilizer stiffness (bounded by these upper and lower bound stabilizer stiffnesses) on the hardware seismic loads and displacements.
