U.S. NUCLEAR REGULATORY COMMISSION

Docket/Report Nos.: 50-220/97-01
50-410/97-01

Facility: Nine Mile Point, Units 1 and 2

Dates: January 12 - February 22, 1997

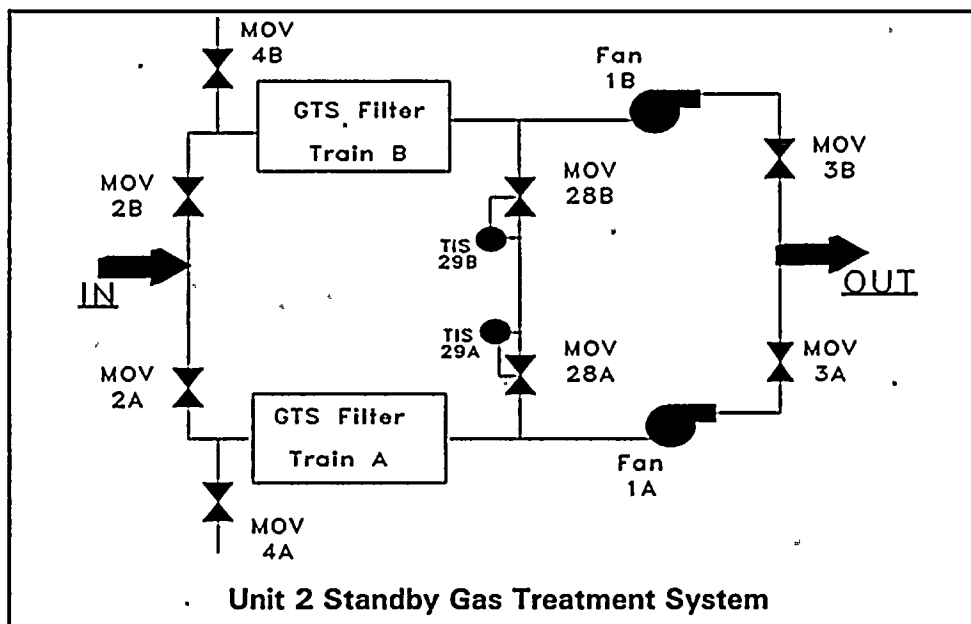
System Description

The design bases of the GTS, according to the Unit 2 UFSAR, Section 6.5.1, include: limiting the release of radioactive gases to the environment in the event of a LOCA condition; maintaining a negative pressure in the reactor building under accident conditions; and providing redundant filter trains so that damage to one train does not cause damage to the other. These functions are accomplished by processing the air from the reactor building and/or primary containment before discharging it to the environment via the main stack. (Refer to the partial system drawing below.) The GTS consists of two redundant and physically separated divisions, each containing a filter train, a fan, and associated valving. The filter train assembly includes: a moisture separator; an electric heater to lower humidity; a prefilter; a high efficiency particulate air (HEPA) filter; a charcoal adsorber to remove radioactive iodine and particulates; and a second HEPA filter.

Decay heat is generated as a result of radioisotope retention in the charcoal portion of the filter train. In a post-accident scenario, when both trains automatically initiate, Operating Procedure N2-OP-61B, "Standby Gas Treatment System," Revision 7, allows one train to be secured. If the temperature in the charcoal
