SUBJECT: Forwards final internal review program rept. Rept updates status repts submitted on 840731, (DCL-84-276) & 841019, (DCL-84-322). Rev 2 to Tables 1, 2 & 3 supersedes previous submittals.

Re: Docket No. 50-323
Diablo Canyon Unit 2
Internal Review Program Final Report

Diablo Canyon Unit 2
Internal Review of Unit 1
Verification Program Results

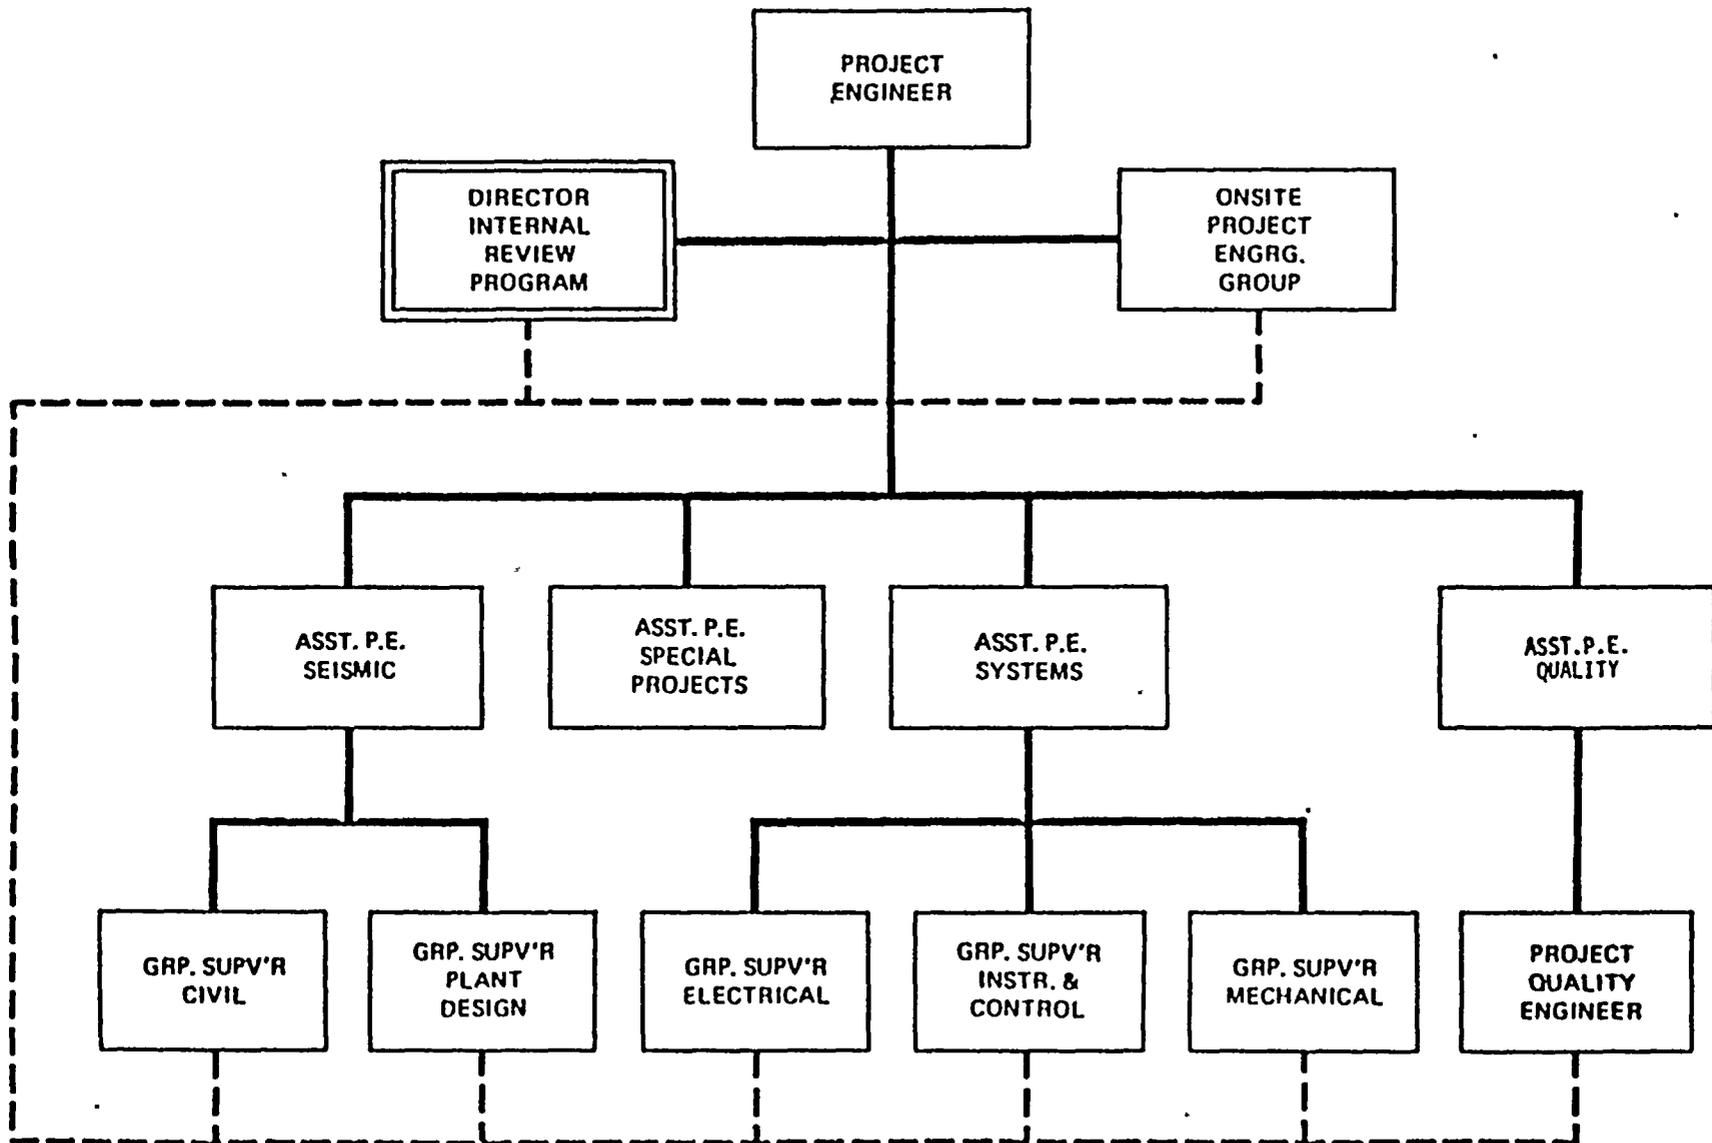
Figure 2
 DIABLO CANYON PROJECT
 UNIT 2 ORGANIZATION

————— REPORTING RELATIONSHIP
 - - - - - PROGRAM DIRECTION

The Unit 2 engineering organization is directed by a Project Engineer who is supported by five Assistant Project Engineers (APEs) (see Figure 2). The APEs are responsible for work done in the following areas: (1) seismic design, (2) system design, (3) special projects, (4) quality engineering, and (5) the Unit 2 IRP.

To support the IRP for Unit 2, engineering group supervisors and discipline group leaders interface directly with the Program Director in the Project matrix organization (see Figure 2). These individuals are responsible to the Program Director for the technical review and resolution of Unit 1 design verification program issues applicable to Unit 2. The IRP has available to it the technical resources of both Unit 1 and Unit 2 engineering organizations.
