Commonwealth Edison Company

Subject: Additional Information concerning isolation of the primary system on reactor vessel high water level - Dresden Units 2 and 3

HIGH WATER LEVEL ISOLATION

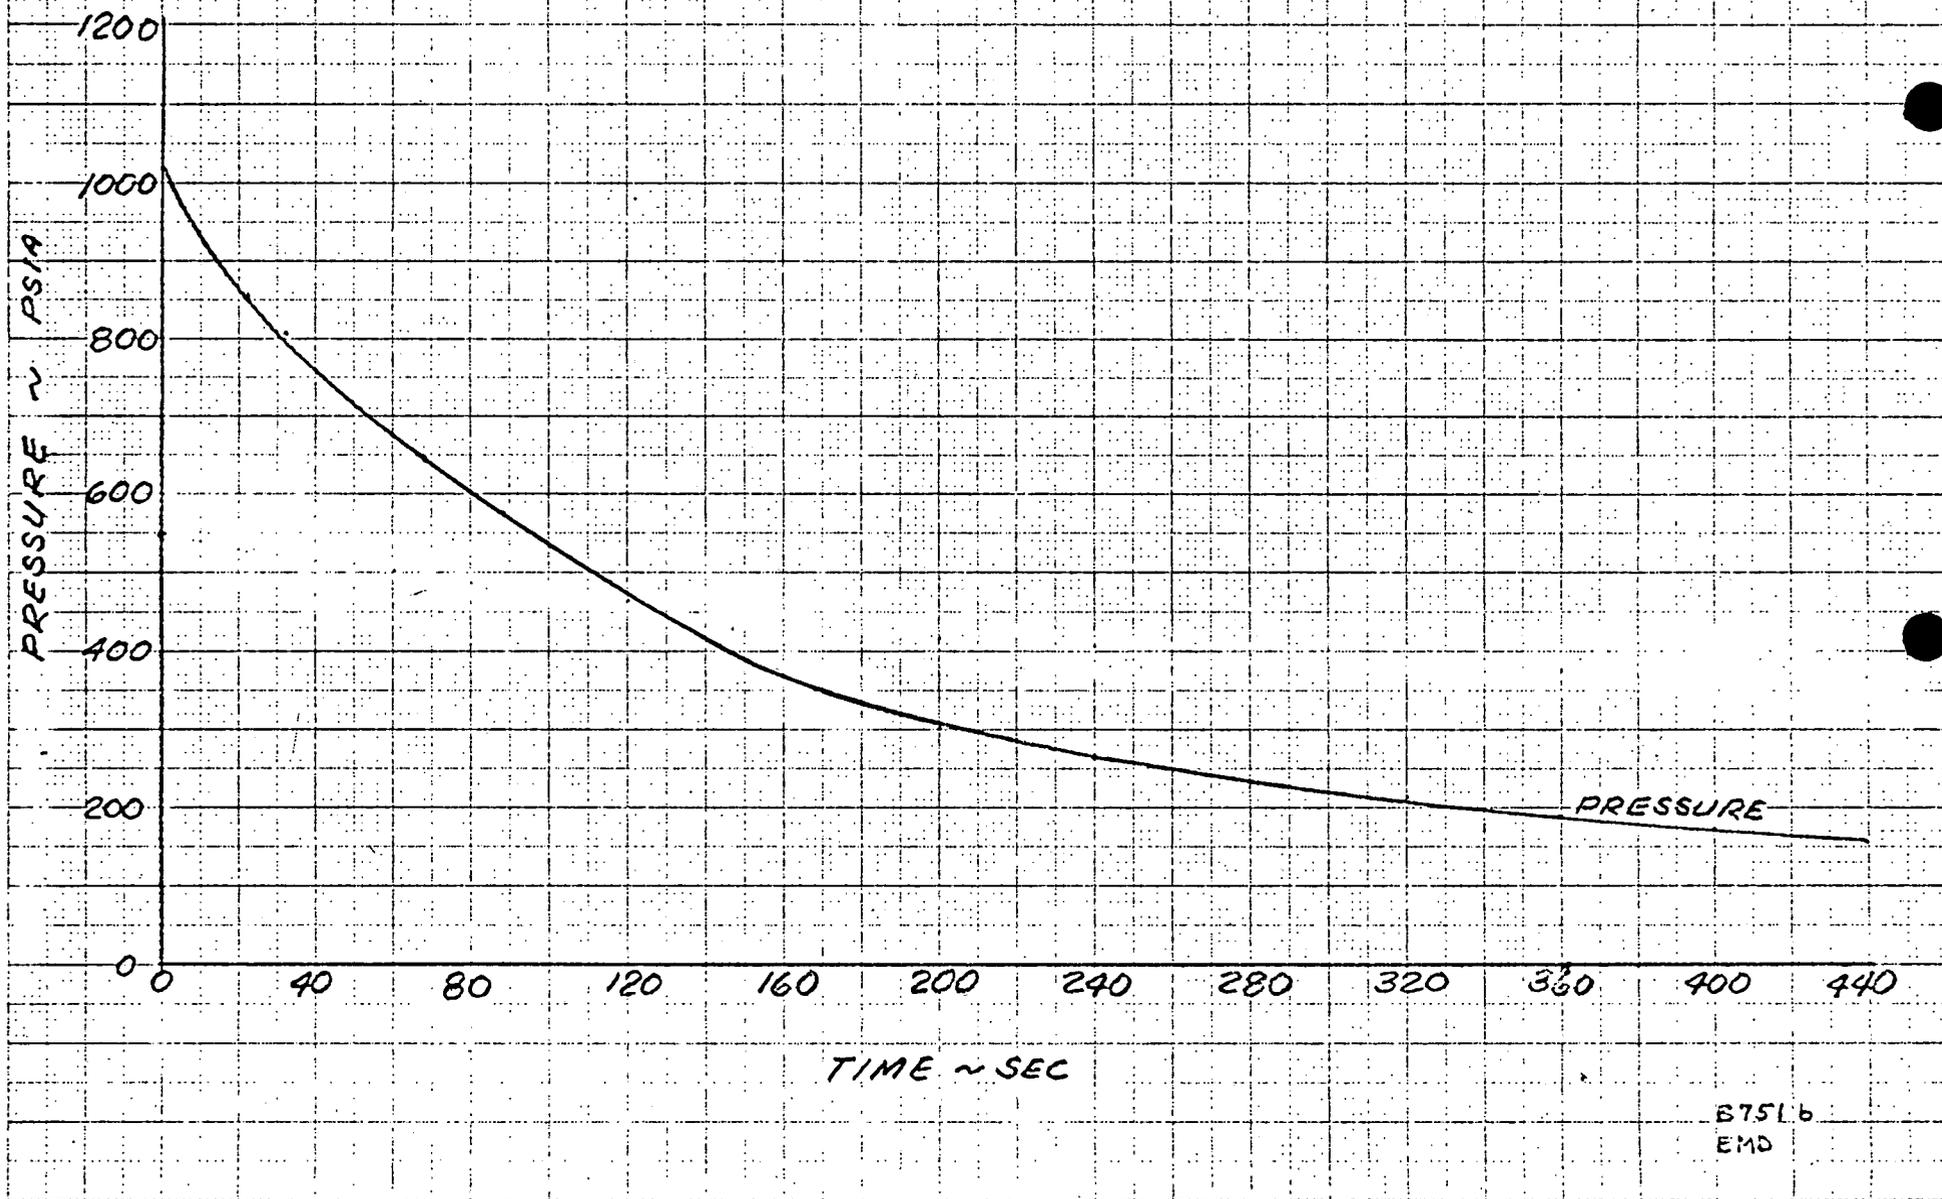
FIGURE 1 REACTOR PRESSURE

DRESDEN 2 & 3 AND QUAD CITIES 1 & 2 BYPASS
FAILURE (40% BYPASS) IN STARTUP/SHUTDOWN MODE
WITH FEEDWATER FLOW

The attached curves represent the reactor pressure (Figure 1), temperature (Figure 2), and actual water level (Figure 3) transients that would result from a vessel blowdown through the steam bypass system due to a pressure regulator failure if there were no high level isolation trip. The temperature of the steam and fluid in contact

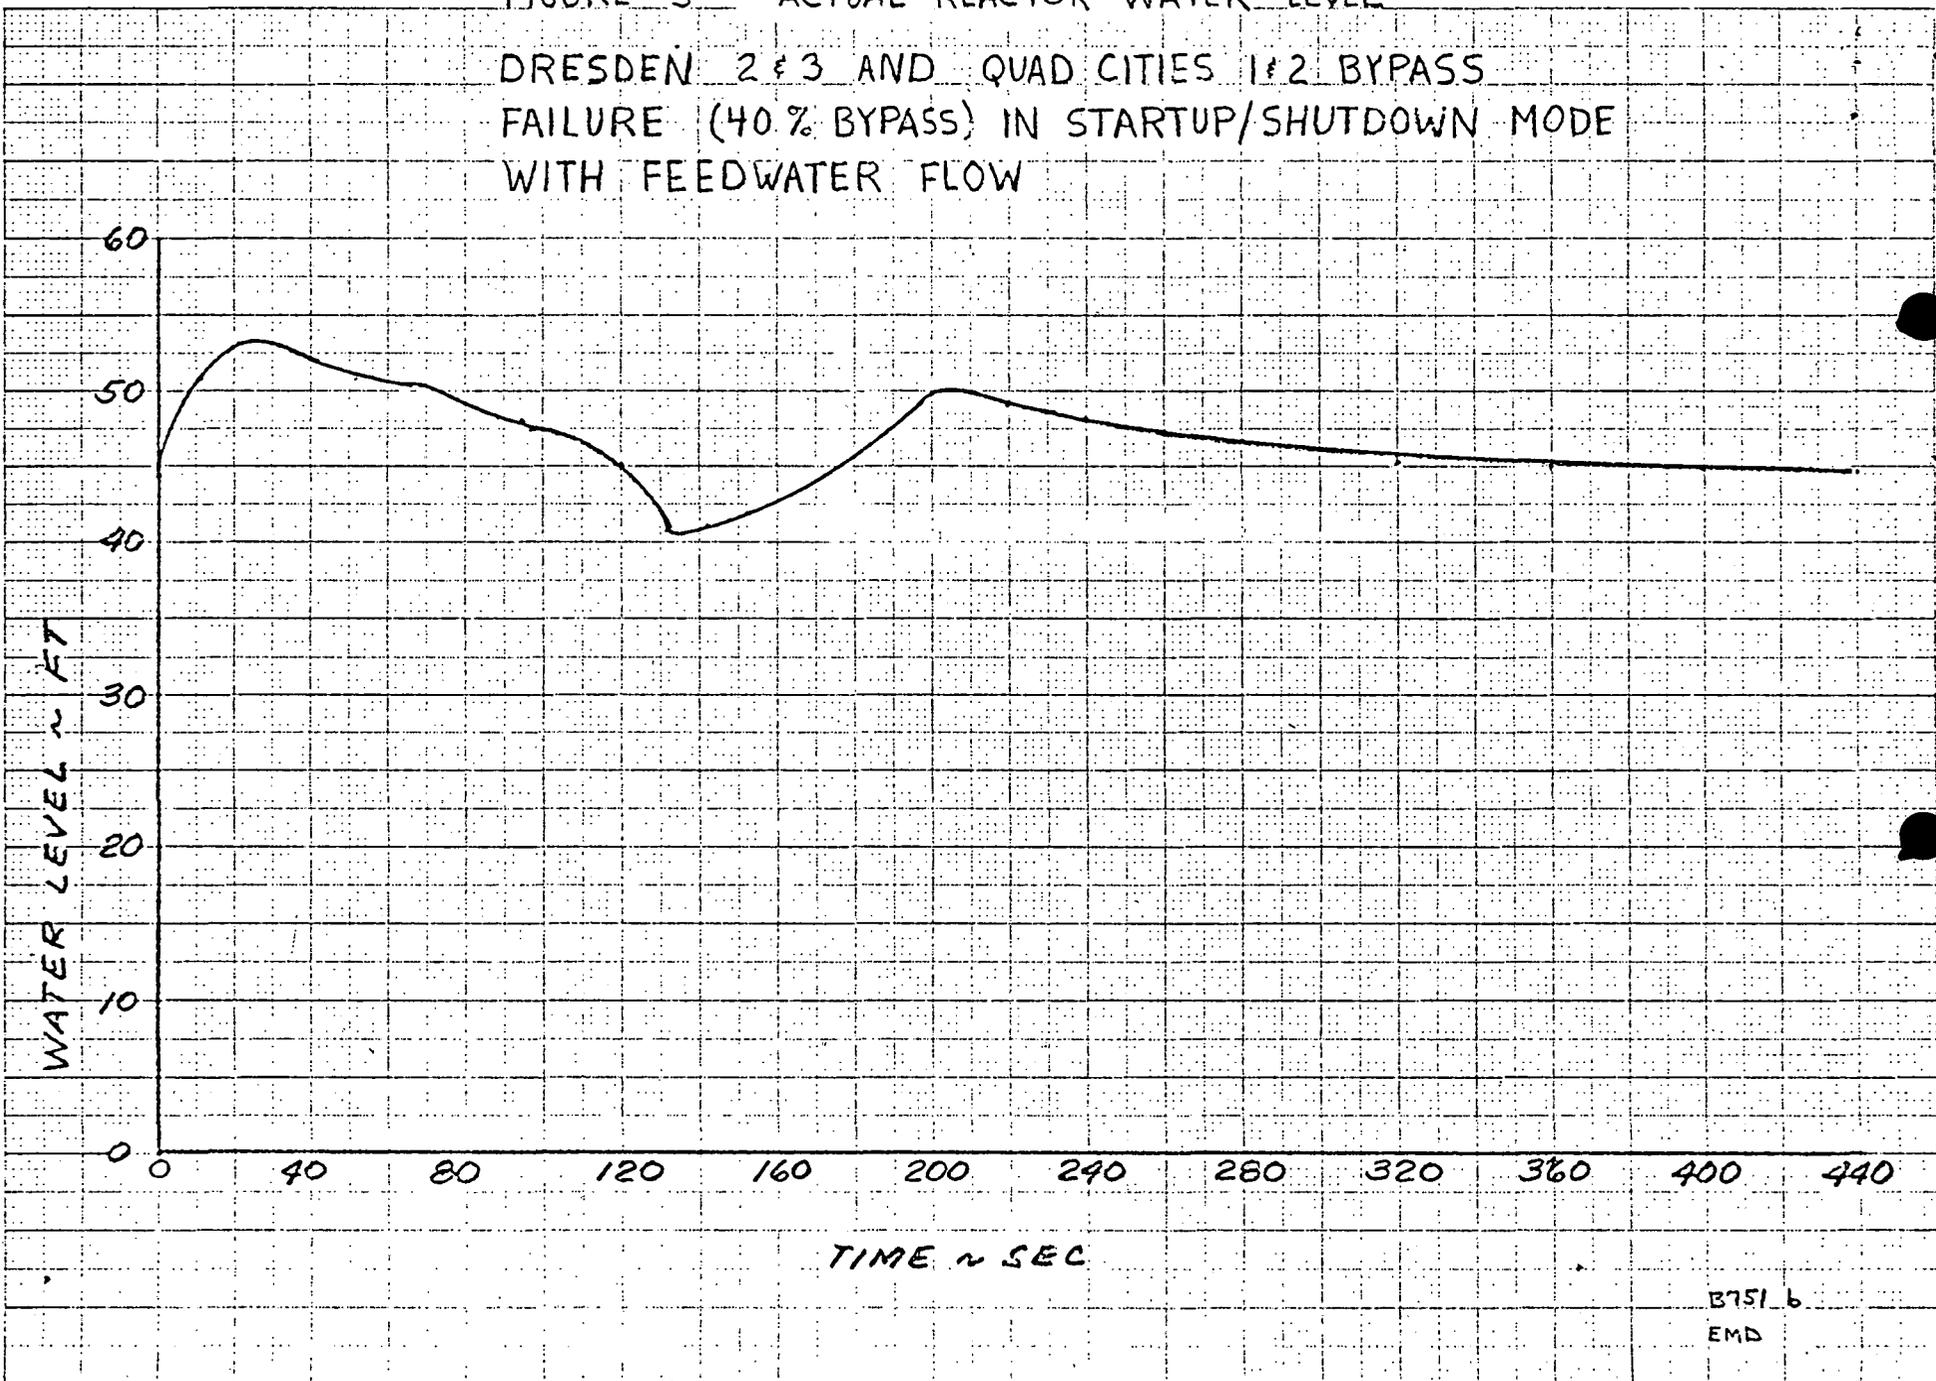
FIGURE 3 ACTUAL REACTOR WATER LEVEL

DRESDEN 2 & 3 AND QUAD CITIES 1 & 2 BYPASS
FAILURE (40% BYPASS) IN STARTUP/SHUTDOWN MODE
WITH FEEDWATER FLOW
