Commonwealth Edison Company

Subject: Additional Information concerning isolation of the primary system on reactor vessel high water level - Dresden Units 2 and 3

HIGH WATER LEVEL ISOLATION

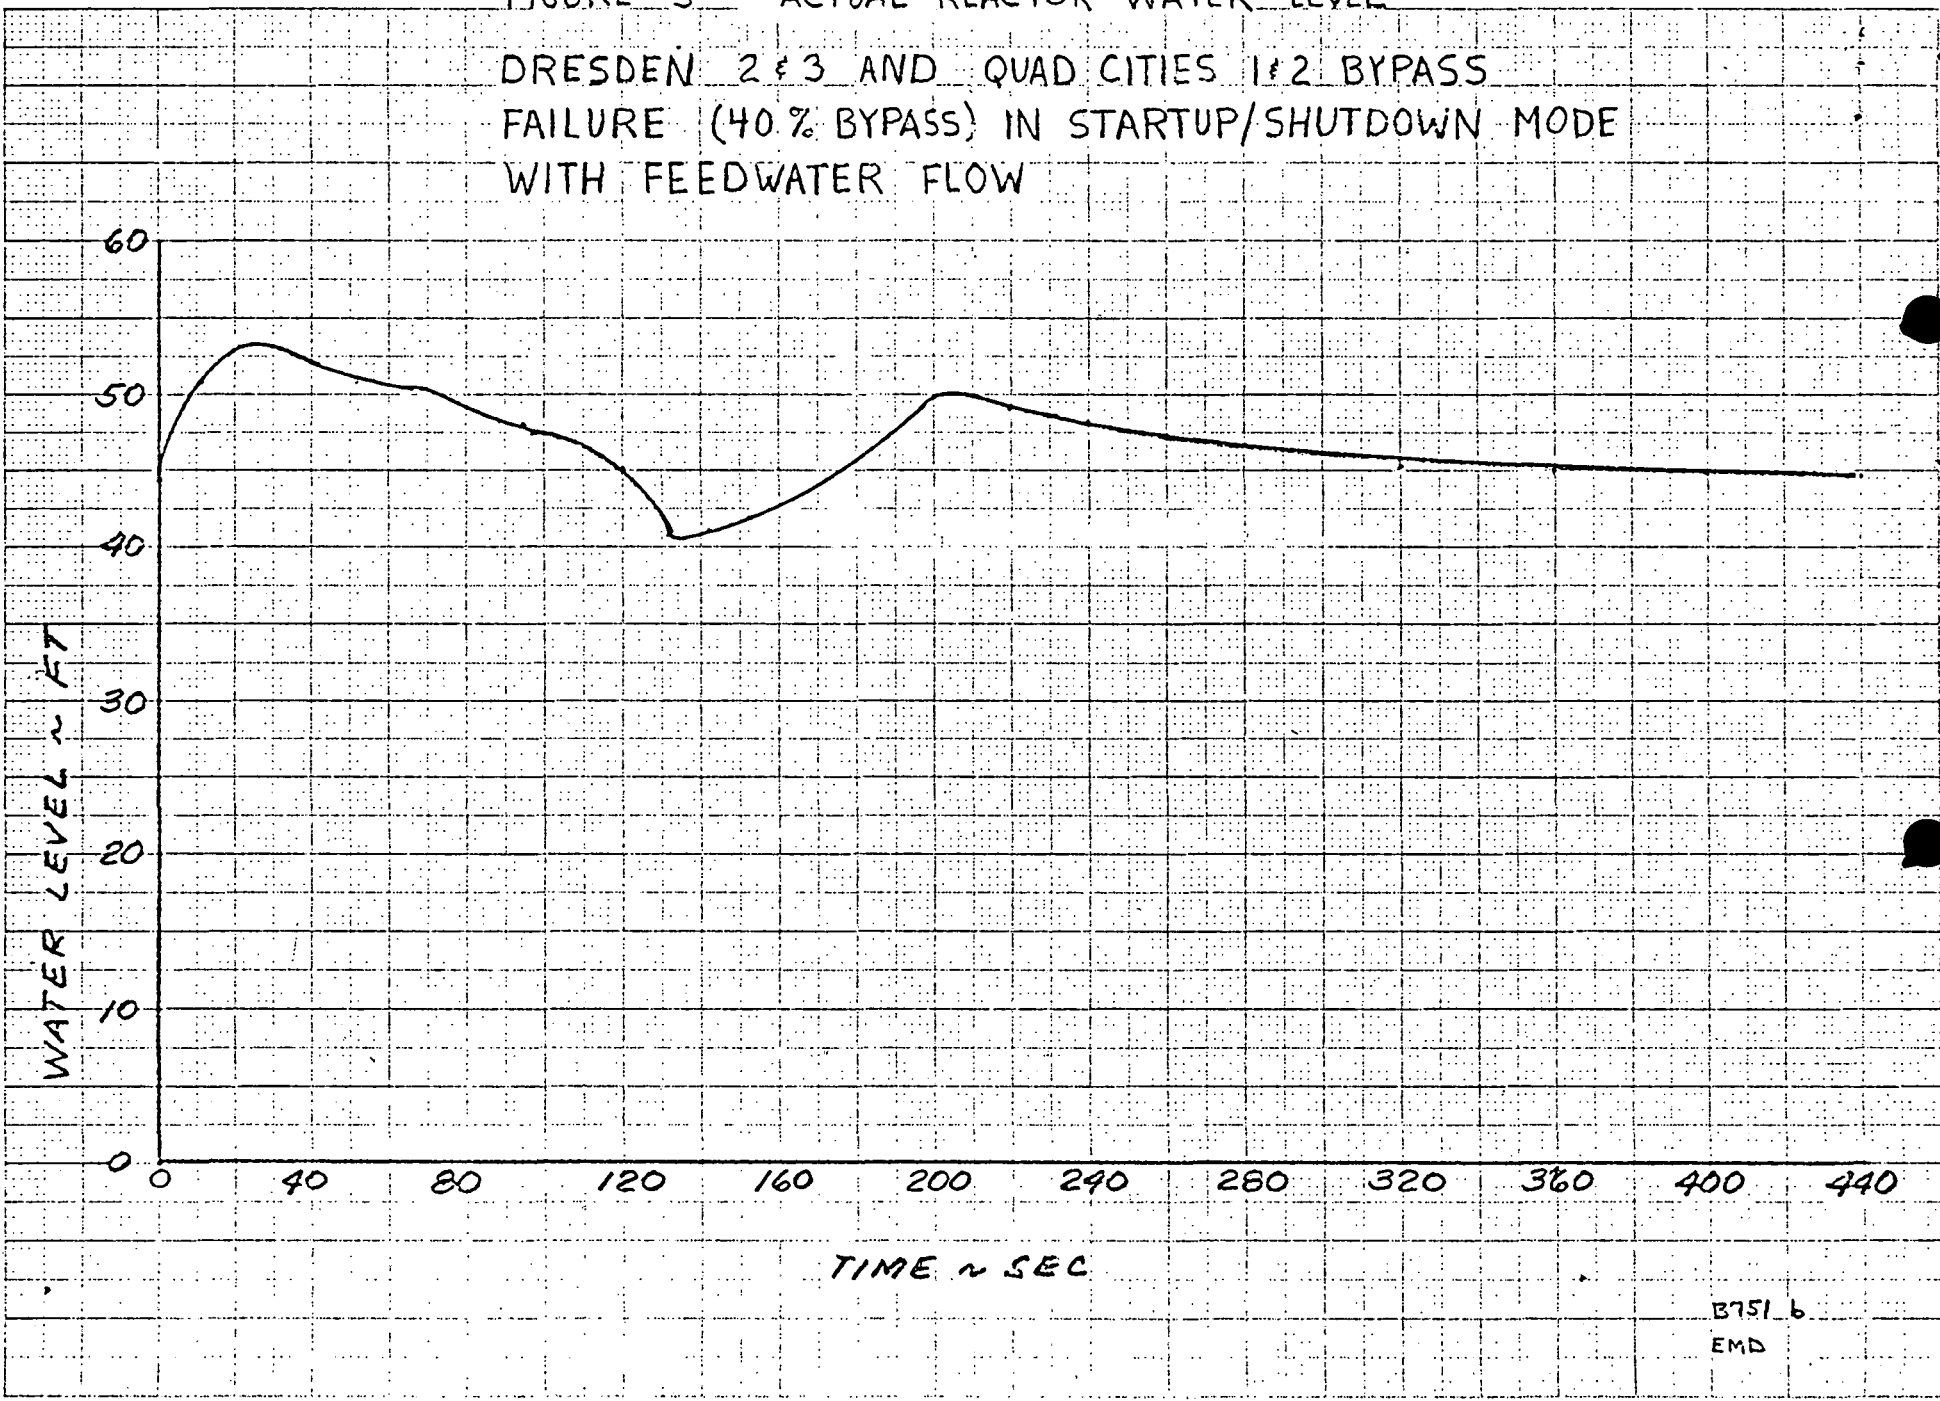
FIGURE 3 ACTUAL REACTOR WATER LEVEL

DRESDEN 2 & 3 AND QUAD CITIES 1 & 2 BYPASS
FAILURE (40% BYPASS) IN STARTUP/SHUTDOWN MODE
WITH FEEDWATER FLOW

The attached curves represent the reactor pressure (Figure 1), temperature (Figure 2), and actual water level (Figure 3) transients that would result from a vessel blowdown through the steam bypass system due to a pressure regulator failure if there were no high level isolation trip. The temperature of the steam and fluid in contact
