Re: St. Lucie Unit 1  
Docket No. 50-335  
Refueling Outage SL1-27  
Steam Generator Tube Inspection Report

### SL1-27 Steam Generator Tube Inspection Report

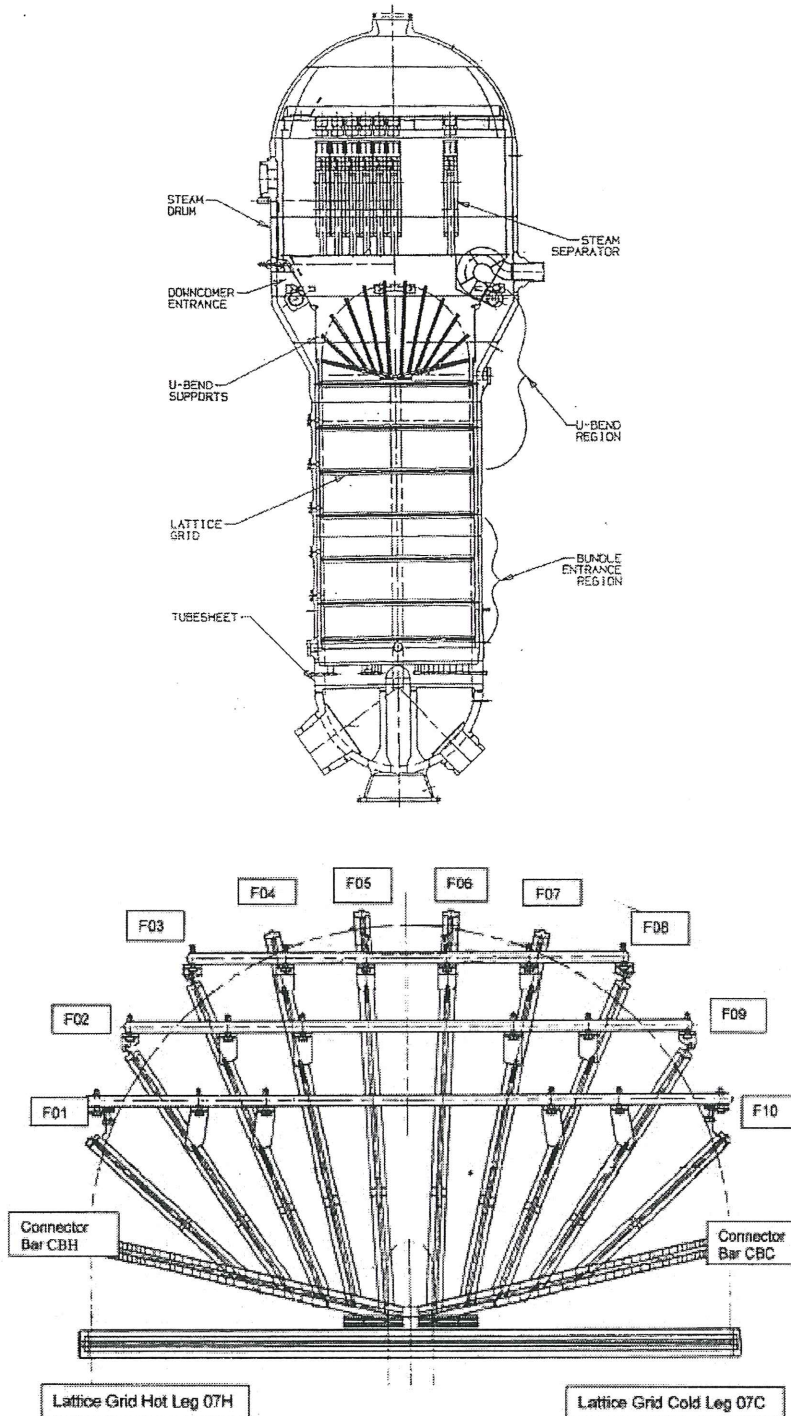
| Tube Support | Horizontal LGS designation | | | | | | |
|---|---|---|---|---|---|---|---|
| Hot Leg | 01H | 02H | 03H | 04H | 05H | 06H | 07H |
| Cold Leg | 01C | 02C | 03C | 04C | 05C | 06C | 07C |
