EVALUATION OF INCIDENTS
OF PRIMARY COOLANT RELEASE
FROM OPERATING BOILING WATER REACTORS

Office of Operations Evaluation
Directorate of Regulatory Operations

October 30, 1972

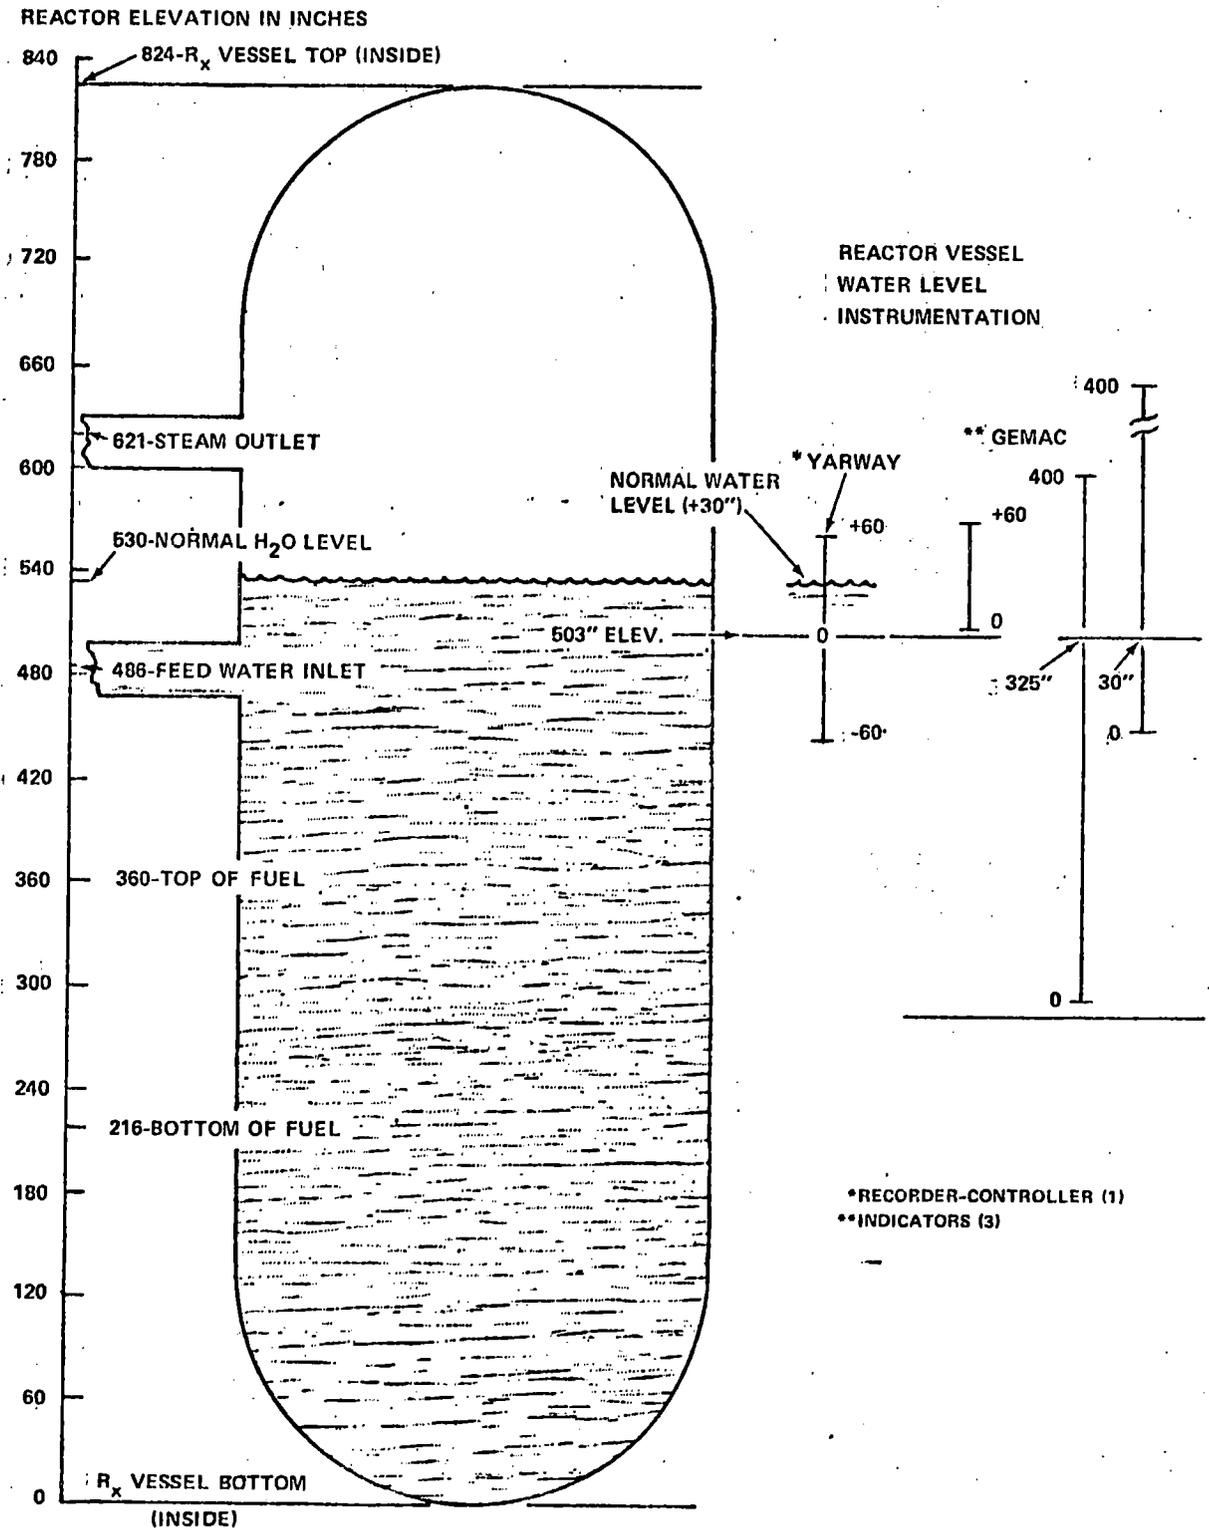
Figure 1 DRESDEN UNITS 2 AND 3 REACTOR VESSEL WATER LEVEL CORRELATION CHART

- a. The feedwater system should maintain the reactor vessel water level within $\pm 5''$ from the normal level (+30'') during steady state operation in the automatic level control mode. Following abnormal occurrences at significant power that result in reactor scram and turbine trip, the Feedwater Control System was intended to maintain automatically the reactor vessel water level within the range of the 0 - 60'' level recorder. Figure 1 indicates schematically the correlation between the reactor vessel water level and the instrument readings. The control functions performed by the water level instrumentation are as follows:
