**RISK-BASED INSPECTION GUIDE FOR THE
SUSQUEHANNA STATION HPCI SYSTEM**

**HIGH PRESSURE COOLANT INJECTION SYSTEM
RISK-BASED INSPECTION GUIDE FOR
SUSQUEHANNA, UNITS 1 AND 2**

Brookhaven National Laboratory
Department of Nuclear Energy
Engineering Technology Division
Upton, NY 11973

Manuscript Completed: April 1992

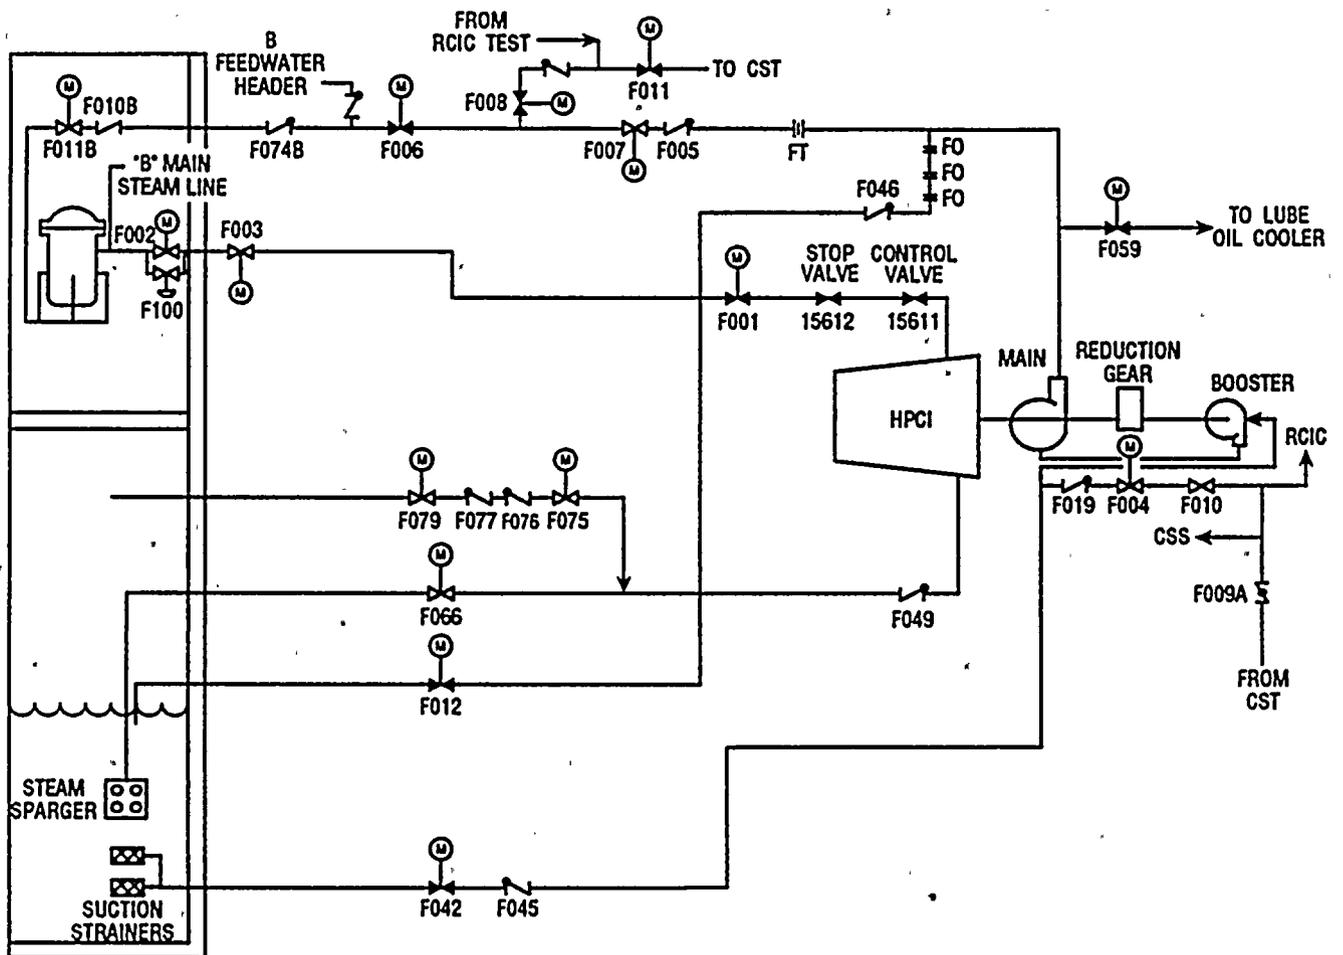
Figure 2-1

The SSES High Pressure Coolant Injection (HPCI) system is a single train system consisting of turbine-driven injection and booster pumps, piping, valves, controls, and instrumentation. A simplified flow diagram is shown in Figure 2-1. The system is designed to pump a maximum of 5000 gpm into the reactor vessel over a range of reactor pressures from 150 to 1150 psig when automatically activated by low reactor water level or high drywell pressure or manually initiated. Two sources of cooling water are available. Initially, the HPCI pump takes suction from the condensate storage tank (CST) through normally open manual valve F010 and motor-operated valve (MOV) F004. The pump suction automatically transfers to the suppression pool on low CST level or high suppression pool level. This transfer is accomplished by a signal that opens the suppression pool suction valve, F042. Once this valve is fully open, valve-position-limit switch contacts automatically close the CST suction valve. The system is designed to take suction from a source that is less than 170°F. Events that raise the suppression pool temperature above 170°F may require a manual suction transfer back to the CST.

Steam is admitted to the HPCI turbine through supply valve F001, turbine stop valve 15612, and turbine control valve 15611, all of which are normally closed and are opened by an HPCI initiation signal. Exhaust steam from the turbine is discharged to the suppression pool, while condensed steam from the steam lines and leakage from the turbine gland seals are routed to a barometric condenser.
