**SUPPLEMENTAL INFORMATION RELATED TO GL 2004-02**

**DOMINION NUCLEAR CONNECTICUT, INC.  
MILLSTONE POWER STATION UNIT 3**

### **Supplemental Information – Predicted strainer submergence levels following a LOCA**

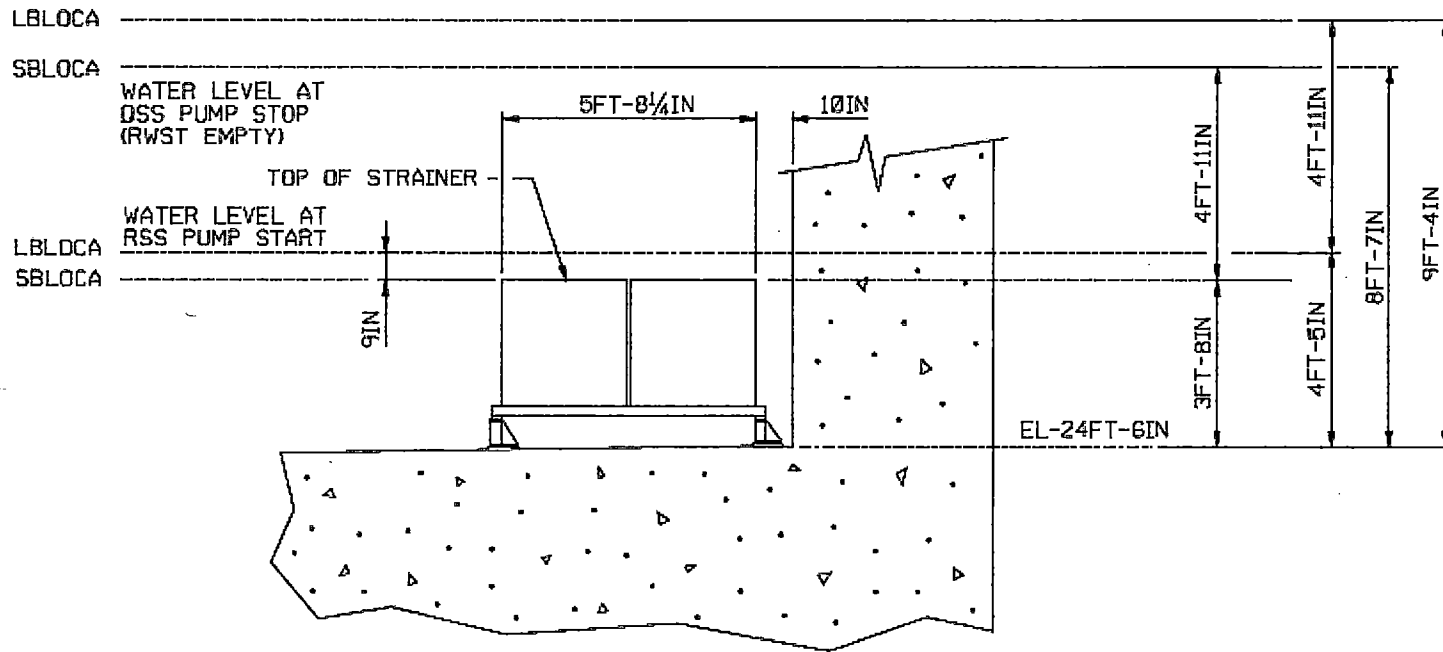
SECTION B-B

scenarios, water level is depicted when the Recirculation Spray System (RSS) pumps start, and when the Refueling Water Storage Tank (RWST) is empty. The water levels are measured from the containment floor.

The water levels shown in the sketch are updated from those provided in the previous DNC letters dated February 29, 2008, March 13, 2009, and September 16, 2010, due to a revised Analysis of Record (AOR) performed in 2014. The revised AOR was a result of implementation of a design change that 1) replaced the RWST level switches with level switches having less uncertainty, 2) increased the RWST maximum temperature, and 3) increased service water intake temperature.
