Commonwealth Edison
1400 Opus Place
Downers Grove, Illinois 60515

Subject: Dresden Nuclear Power Station Unit 3
Submittal of Relief Request (CR-14) for
Inservice Inspection Program
NRC Docket No. 50-249

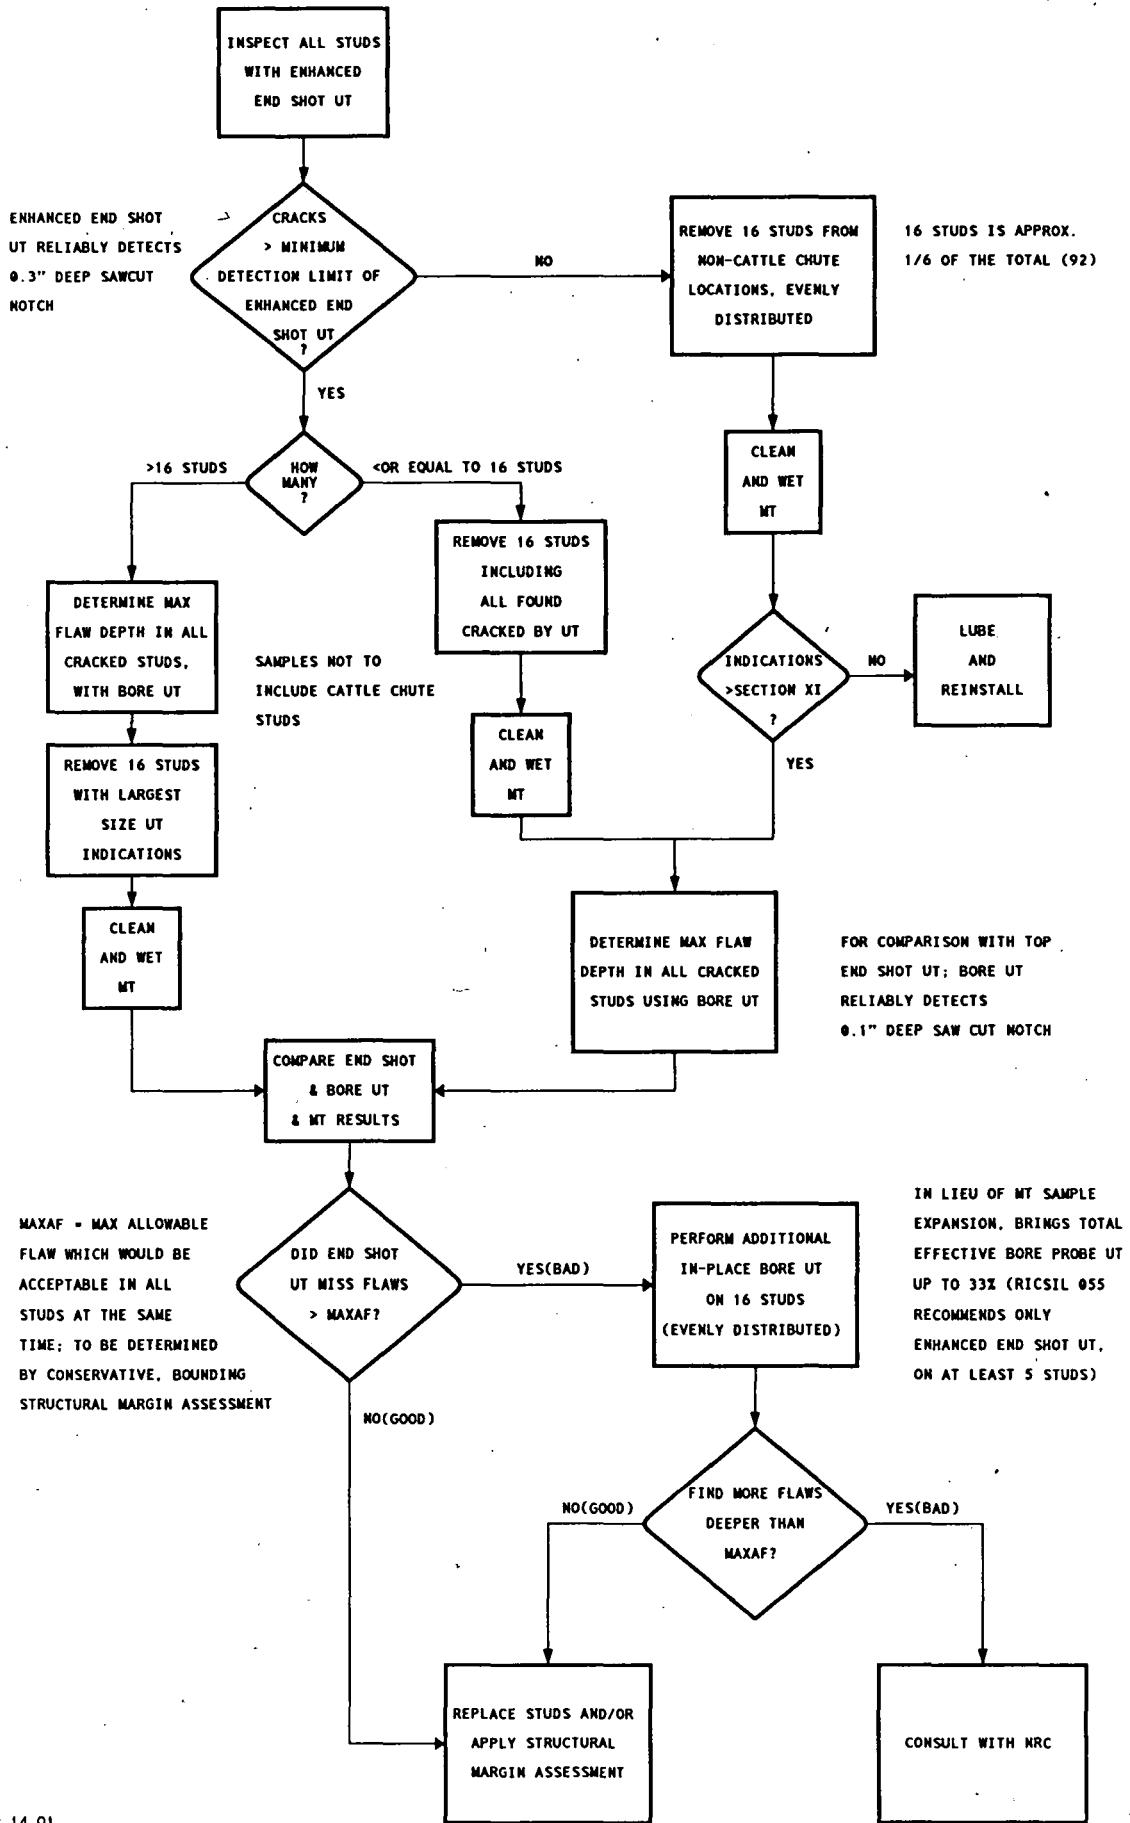
D3R12 RP Stud Examination & Disposit Methodology

Code structural margins will be assured thru the enhanced end shot UT of all studs, and bore probe UT sizing of all cracked studs. Enhanced end shot UT and bore probe UT results will be evaluated in accordance with a conservative, bounding structural margin assessment. The structural margin assessment will be based on fracture mechanics methodology and actual fracture toughness testing of material from one of the low-toughness Dresden Unit 2 studs. If the end shot UT is found to be nonconservative, then an expanded sample with the more sensitive bore probe UT will be performed in accordance with the methodology described in the attached flow chart. This approach will assure that Code structural margins are maintained without expanding the MT sample.

Results of the enhanced end shot UT, bore probe UT, and MT will be compared in order to benchmark the minimum detection limit of the enhanced end shot UT technique. The minimum detection limit of the enhanced end shot UT technique will be judged against a conservative, bounding maximum allowable flaw size which would be acceptable in all 92 studs at the same time (referred to as MAXAF on the attached flow chart). If the minimum flaw detection limit of enhanced end shot UT is found to be greater than the MAXAF, additional bore probe examinations will be performed in lieu of the Section XI-required MT sample expansion.
