Commonwealth Edison
Dresden Nuclear Power Station
6500 North Dresden Road
Morris, Illinois 60450
Telephone 815/942-2920

SUBJECT: LICENSE EVENT REPORT 94-021

License Event Report 94-021, Docket 50/237 is being submitted as required by Technical Specification 6.6, NUREG 1022 and 10 CFR 50.73(a)(2)(v)(D).

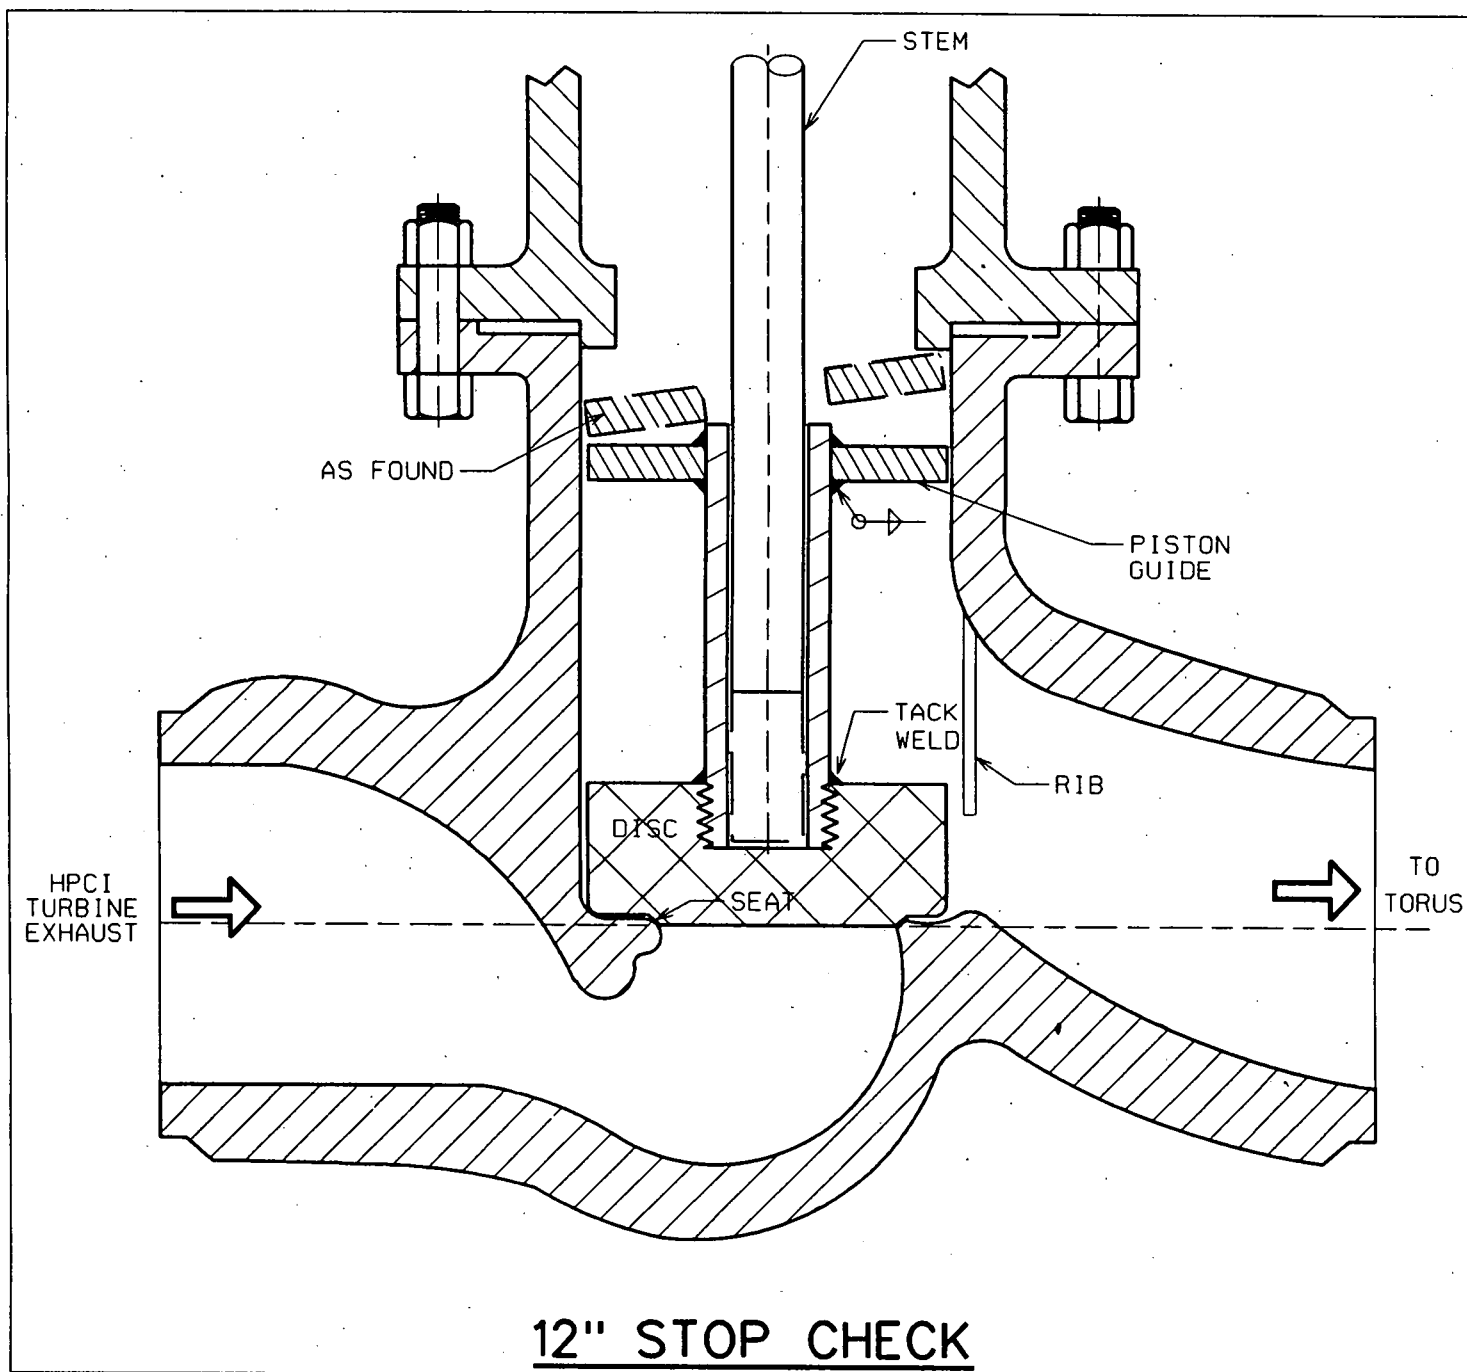
G. COMPONENT FAILURE DATA:

Edwards/Rockwell Stop Check Valve, Model No. 6504Y.

The 2-2301-74, HPCI Turbine Exhaust Check Valve, was disassembled, inspected and repaired under work request D26919. The valve disk was found not attached to the valve guide piston. Further inspection revealed the tack welds, which prevent the assembly from rotating, had broken due to vibration fatigue.
