Commonwealth Edison
Dresden Nuclear Power Station
6500 North Dresden Road
Morris, Illinois 60450
Telephone 815/942-2920

SUBJECT: LICENSE EVENT REPORT 94-021

License Event Report 94-021, Docket 50/237 is being submitted as required by Technical Specification 6.6, NUREG 1022 and 10 CFR 50.73(a)(2)(v)(D).

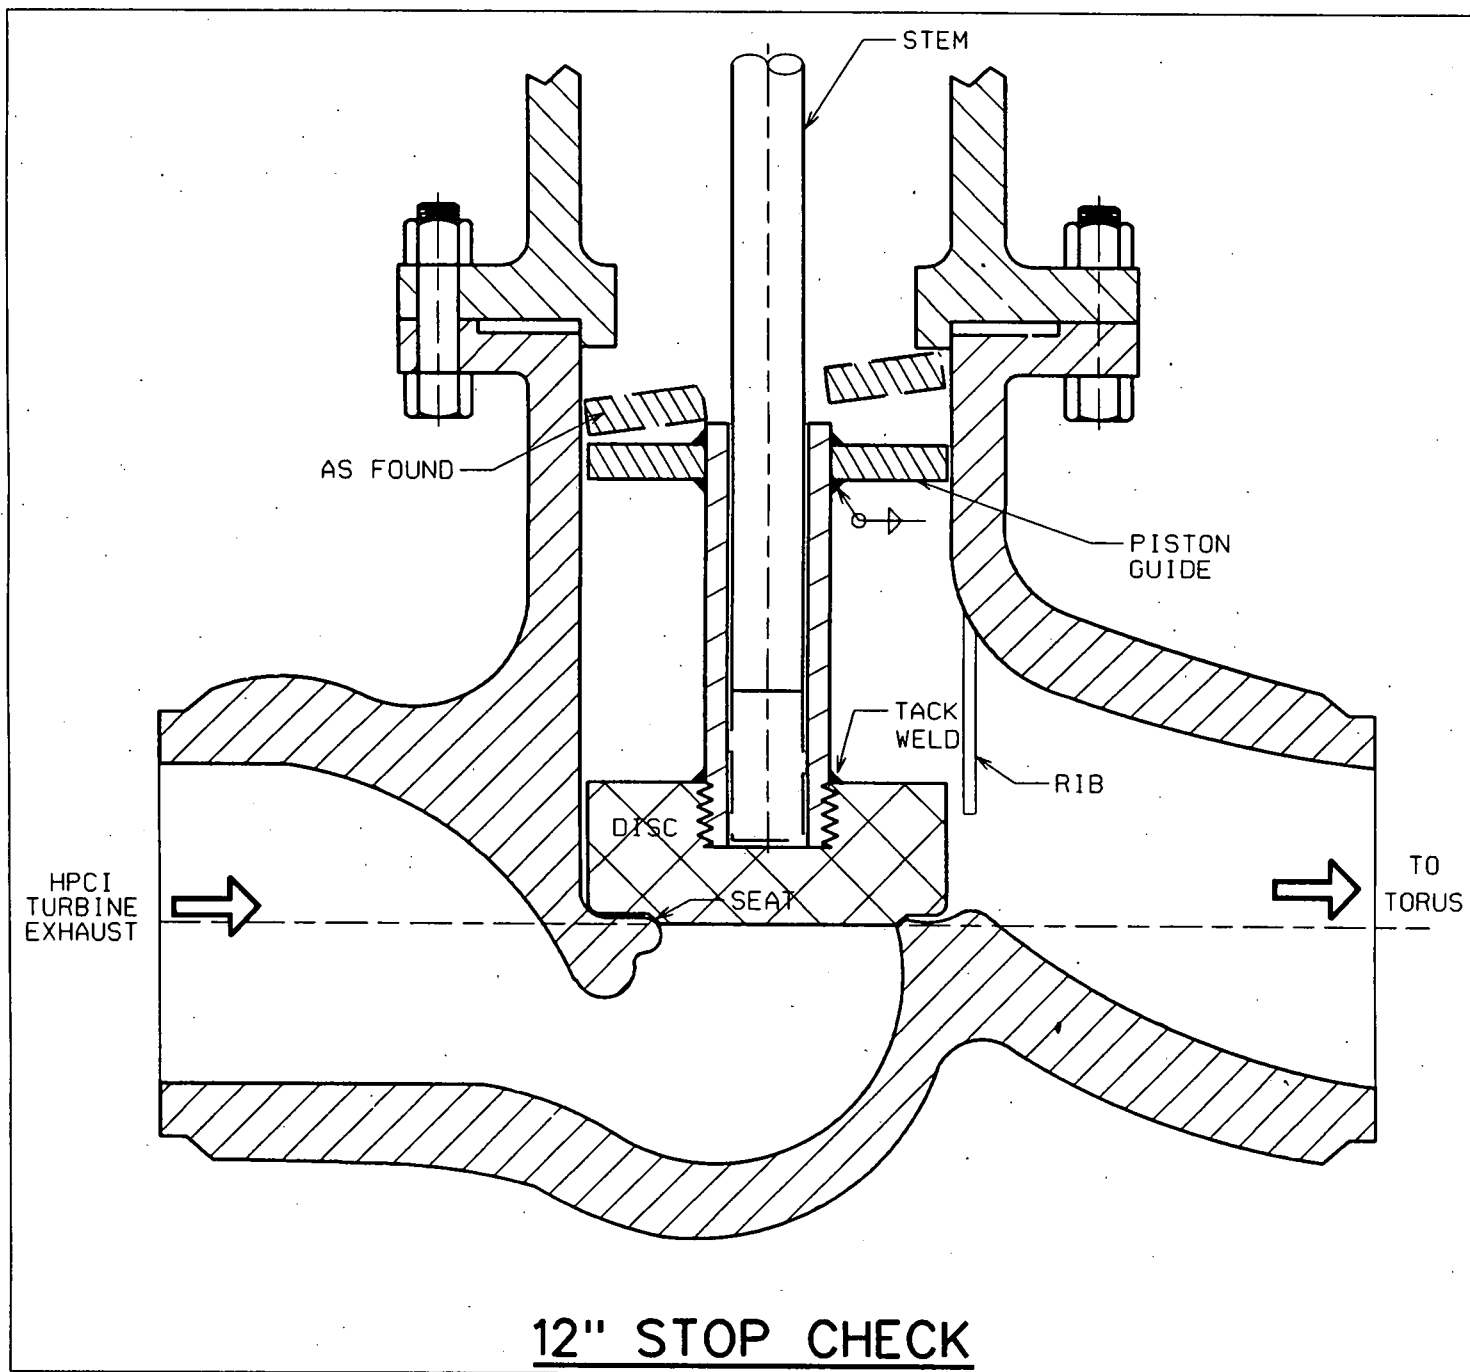
Edwards/Rockwell Stop Check Valve, Model No. 6504Y.

The actual fracture of the tack welds was recent. This conclusion is proven by the condition of the surface of the fractures. The extent of the wear of the fracture surface was enough to remove most of the beaching marks except for the small traces found on two of the four tack welds.

A maintenance history review indicated that the 2(3)-2301-74 valves have never been disassembled. A further review of the station safety related check valves with piston type design indicated that the 2-1402-8A, Core Spray [BM] pump discharge check valve, was a similar style and manufacturer. In addition, it was found that Quad Cities HPCI 2301-74 valve had a similar piston type design as Dresden's 2301-74 valve. The tack welds on the Quad Cities valve were found cracked during routine check valve inspection in April, 1994.

The 2-2301-74, HPCI Turbine Exhaust Check Valve, was disassembled, inspected and repaired under work request D26919. The valve disk was found not attached to the valve guide piston. Further inspection revealed the tack welds, which prevent the assembly from rotating, had broken due to vibration fatigue.
