ST LUCIE PLANT - UNIT NO. 1  
NRC IE BULLETIN 80-11  
FINAL REPORT

PREPARED BY  
EBASCO SERVICES INCORPORATED  
FOR  
FLORIDA POWER & LIGHT COMPANY

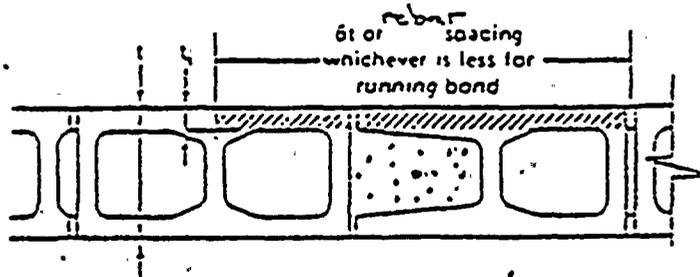
- (1) These values should be multiplied by  $(1 - \frac{h}{40t})^3$  if the wall has a significant vertical load.
- (2) This stress should be evaluated using the effective area shown in figure below except as noted in (6).

Area assumed effective in flexural compression,  
force normal to face

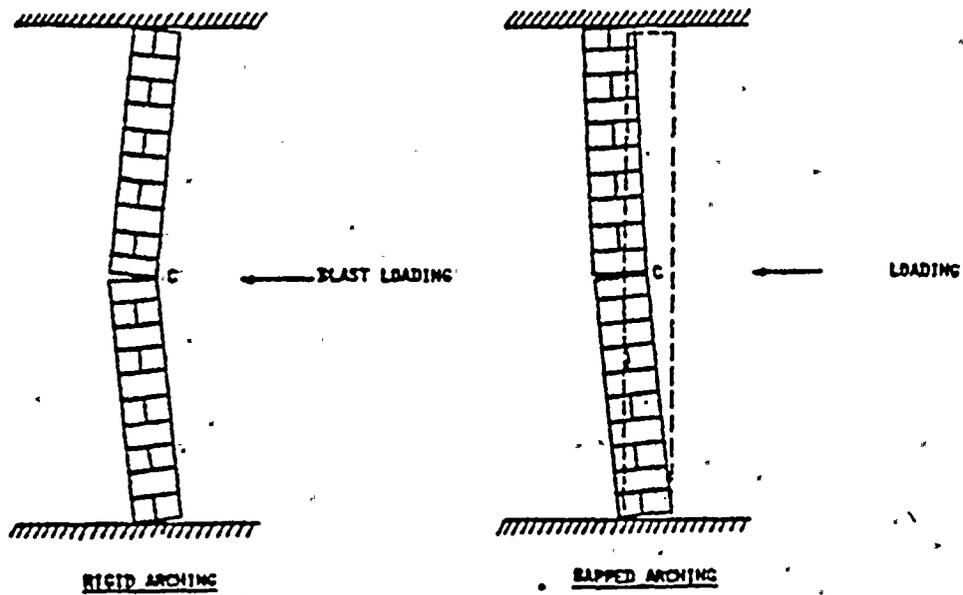
Fig. 1. Sketch illustrating the Differences in Motion Between Rigid and Gapped Arching.

For unreinforced walls, the simply supported condition was assumed for both top and bottom supports. Rigid arching was also assumed when arching analysis was performed, since no gap was detected at the top support during inspection. (See figure 1 and 2)

- 2) Arching Analysis - The behavior of a cracked unreinforced wall may be considered as that of a 3-hinged arch with hinges formed at midspan, top and bottom supports. If a gap exists at the top of the wall, gapped arching action should be assumed; otherwise, rigid arching action is assumed as illustrated in Figure 1. The reactions for the 3-hinged arch can be solved by means of the free-body diagrams shown in Figure 2.

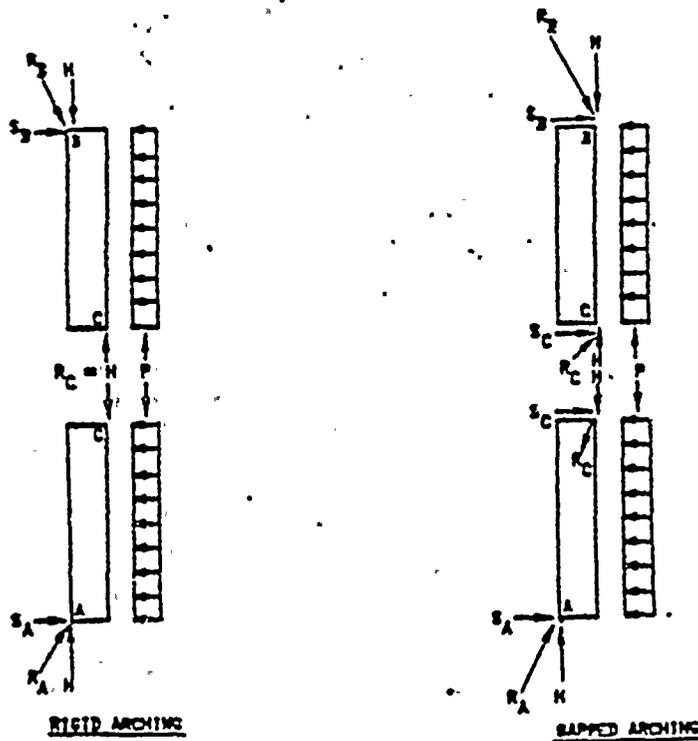
Fig. 2. Free-Body Diagrams Showing Forces in Rigid and Gapped Arching.
