ACCESSION NBR: 8303160228 DOC. DATE: 83/03/11 NOTARIZED: NO
 FACIL: 50-389 St. Lucie Plant, Unit 2, Florida Power & Light Co.
 AUTH. NAME: UHRIG, R. E. AUTHOR AFFILIATION: Florida Power & Light Co.
 RECIP. NAME: EISENHUT, D. G. RECIPIENT AFFILIATION: Division of Licensing

SUBJECT: Submits addl info re human factors under appeal, per NRC mgt 830224-25 site visit. Current configuration of control board 206 will not pose increased risk to health & safety nor involve unreviewed safety question.

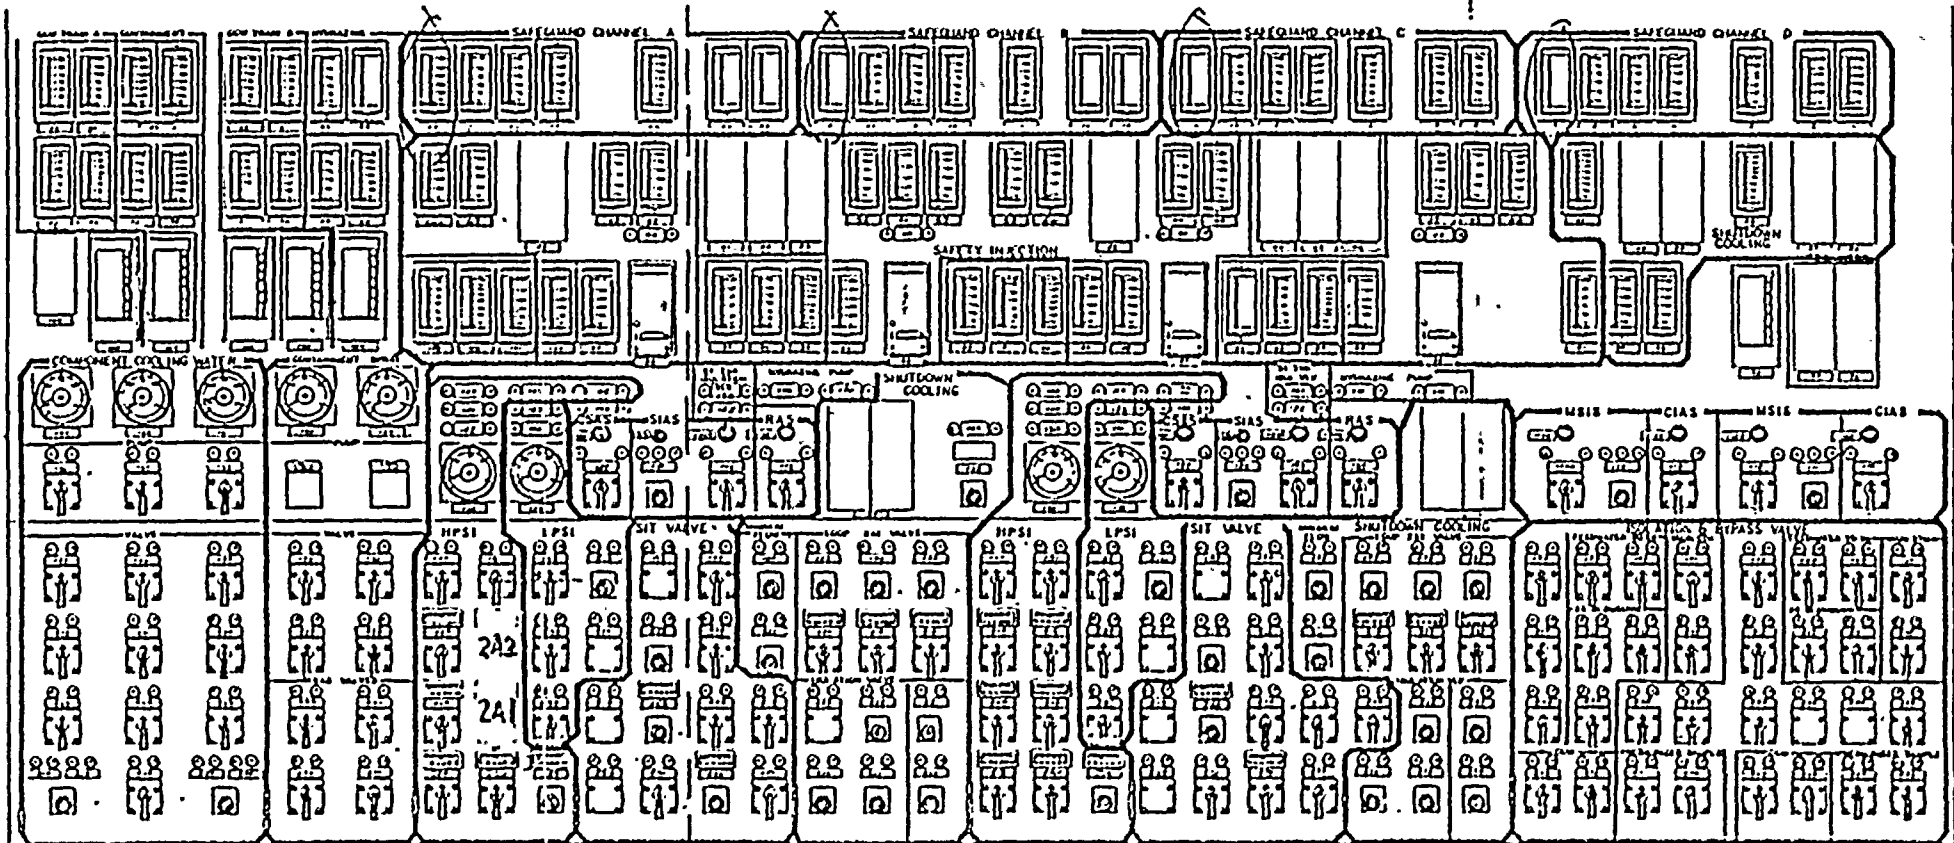
FIGURE 1.

LOOP
2A2

LOOP
2A1

- 1) SAFETY INJECTION TANK
- 2) LOW PRESSURE INJECTION TANK
- 3) HIGH PRESSURE INJECTION TANK

Of the equipment identified to be reworked (Attachment 2), eight displays, two hand controllers, eight hand switches and 12 indicating lights are associated with safety injection tanks 2A1 and 2A2. (See Item 1 on Figure 1).

Of the equipment identified to be reworked (Attachment 2), two displays, two hand switches, and four indicating lights are associated with the low pressure injection supply to cold leg loops 2A1 and 2A2 (See Item 2, Figure 1). Low pressure injection is activated upon receiving an automatic safety injection activation signal. No operator intervention is required unless any of the equipment fails to align properly or a header break is indicated.

Of the remaining equipment to be reworked (Attachment #1), two displays are associated with the high pressure injection supply to Cold leg loops 2A1 and 2A2 (See Item 3, Figure 1). High pressure injection is activated upon receiving an automatic safety injection activation signal. No operator intervention is required unless any of the equipment fails to align properly or a cold leg header break is indicated.
