**FAQ Number** 17-0013 **FAQ Revision** 0 (Draft B)  
**FAQ Title** High Energy Arcing Fault (HEAF) Non-Suppression Probability (NSP)

This FAQ provides an update to the non-suppression probability (NSP) for high energy arcing fault (HEAF) fires based on a review of additional fire event data.

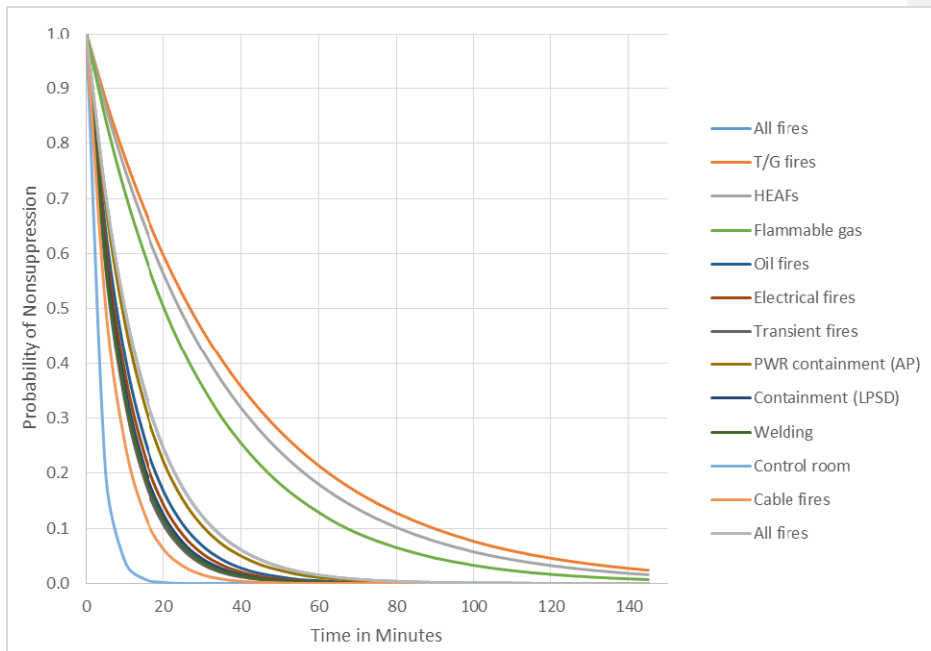
**Figure 5-2**  
Non-suppression curve plots: probability vs. time to suppression
