James A. FitzPatrick Nuclear Power Plant  
Renewed Facility Operating License No. DPR-59  
NRC Docket No. 50-333

Subject: Submittal of Relief Requests Associated with the Fifth Inservice Inspection (ISI) Interval

**Attachment**  
**Relief Requests Associated with the Fifth Ten-Year Interval for the James A. FitzPatrick**  
**Nuclear Power Plant**

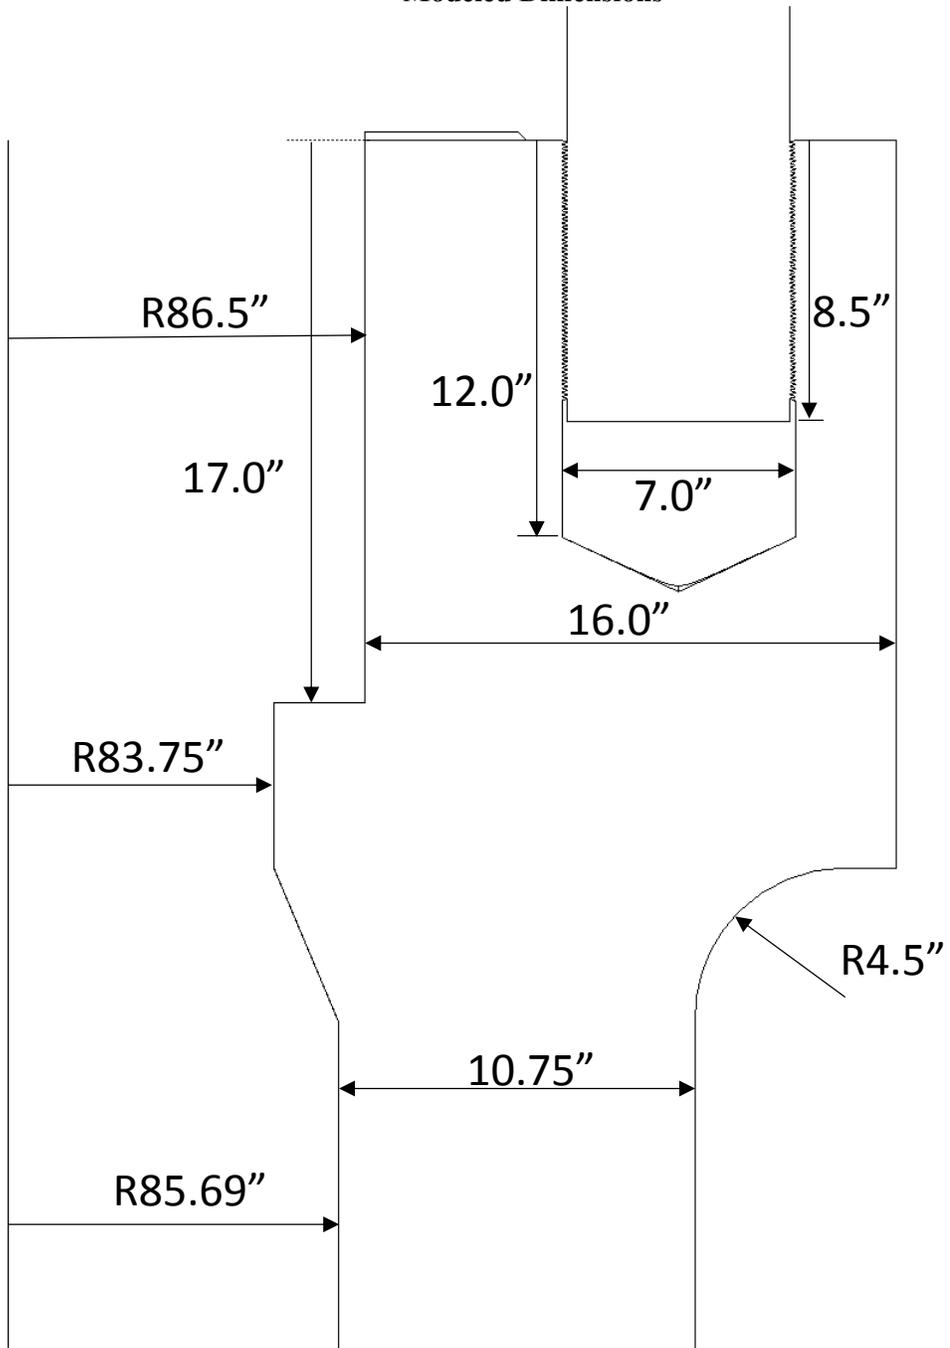
Figure 1  
Modeled Dimensions

A stress analysis was performed in Reference 1 to determine the stresses at critical regions of the thread in flange component as input to a flaw tolerance evaluation. Sixteen nuclear plant units (ten PWRs and six Boiling Water Reactors (BWRs)) were considered in the analysis. The evaluation was performed using a geometric configuration that bounds the sixteen units considered in this effort. The details of the RPV parameters for the JAFNPP as compared to the bounding values used in the evaluation are shown in Table 1. The geometry of the threads at JAFNPP as compared to that used in the analysis in Reference 1 is shown in Table 2. Dimensions of the analyzed geometry are shown in Figure 1.

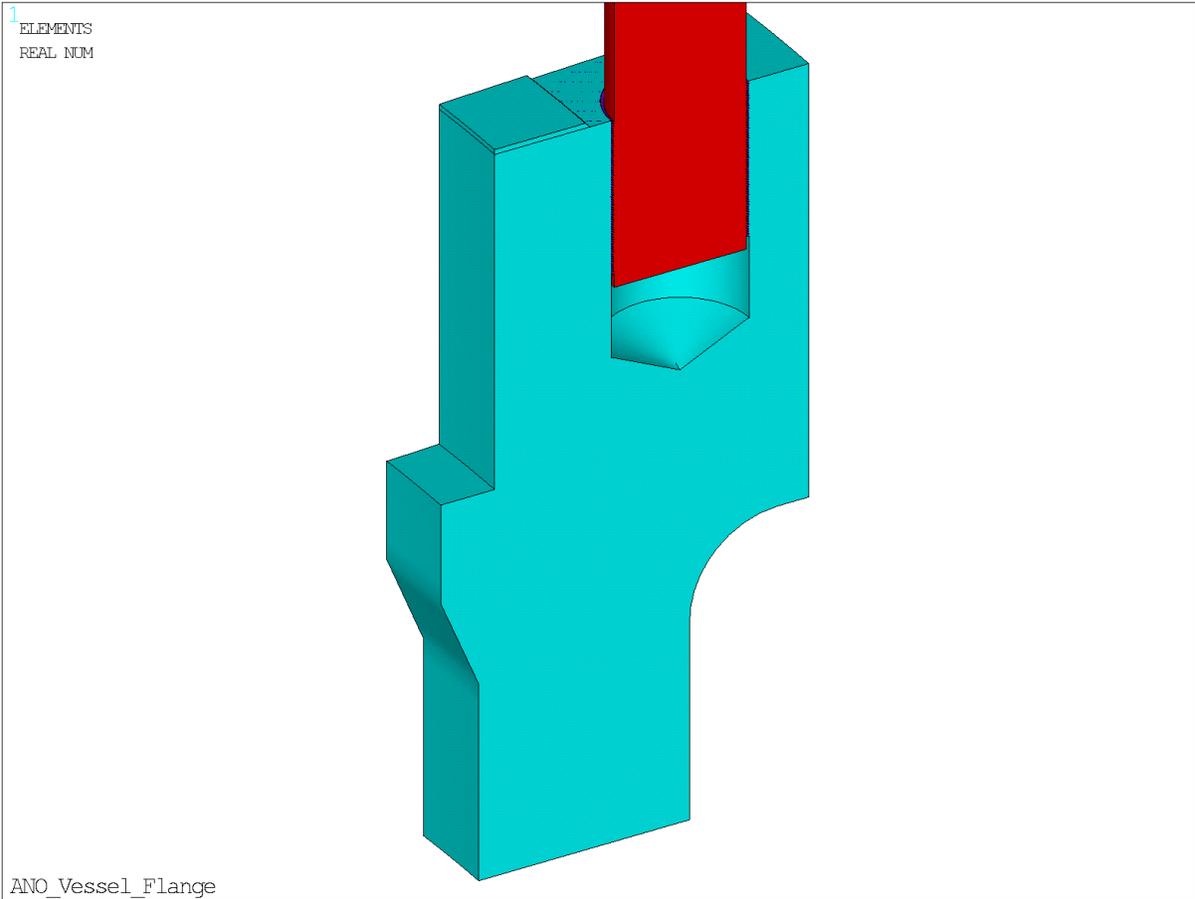
Figure 2  
Finite Element Model Showing Bolt and Flange Connection

The analytical model is shown in Figures 2 and 3. The loads considered in the analysis consisted of:

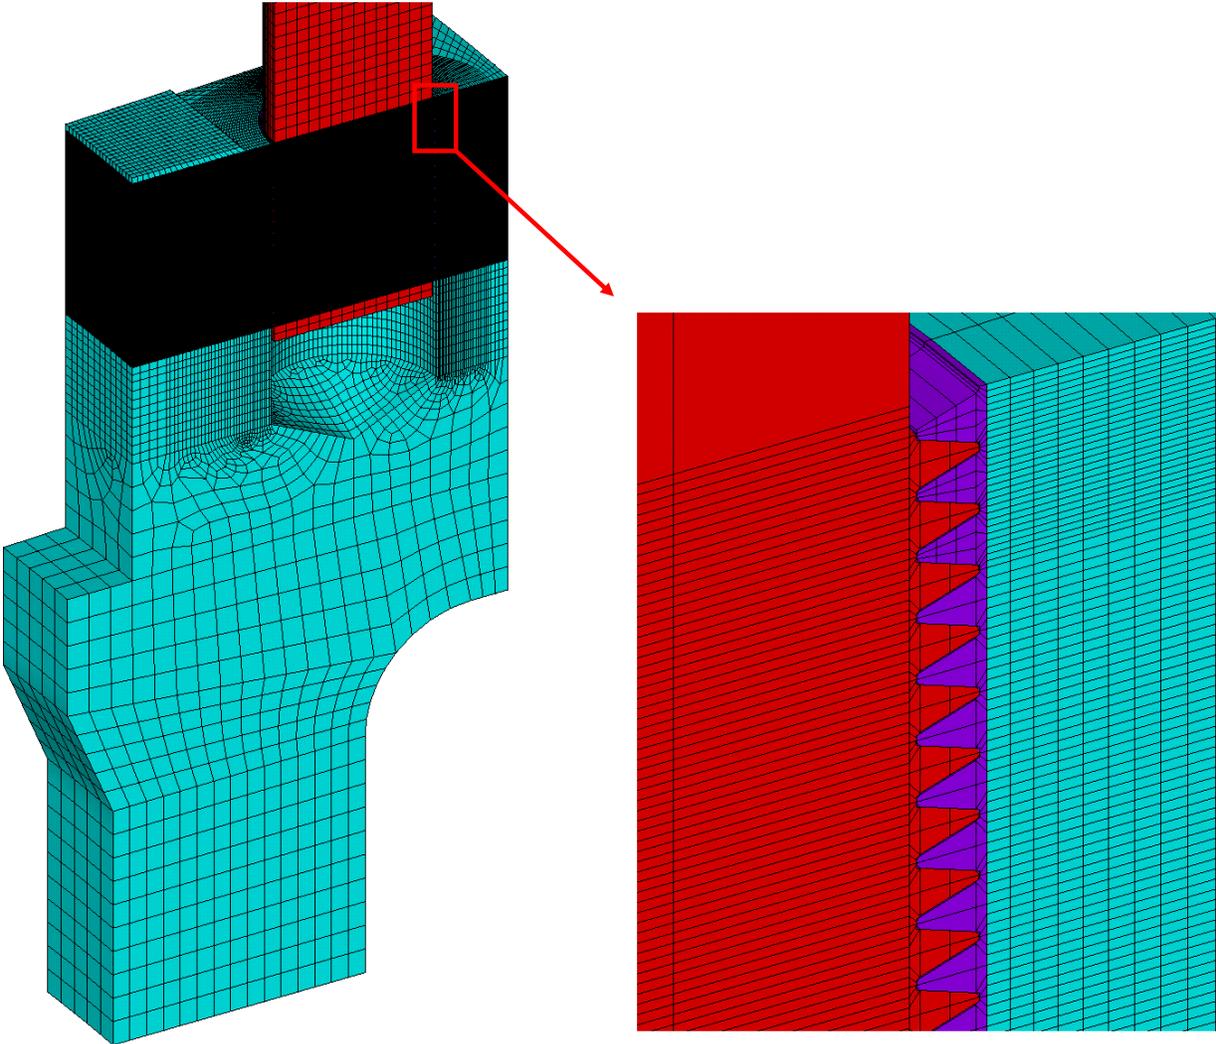
**Figure 3**  
**Finite Element Model Mesh with Detail at Thread Location**

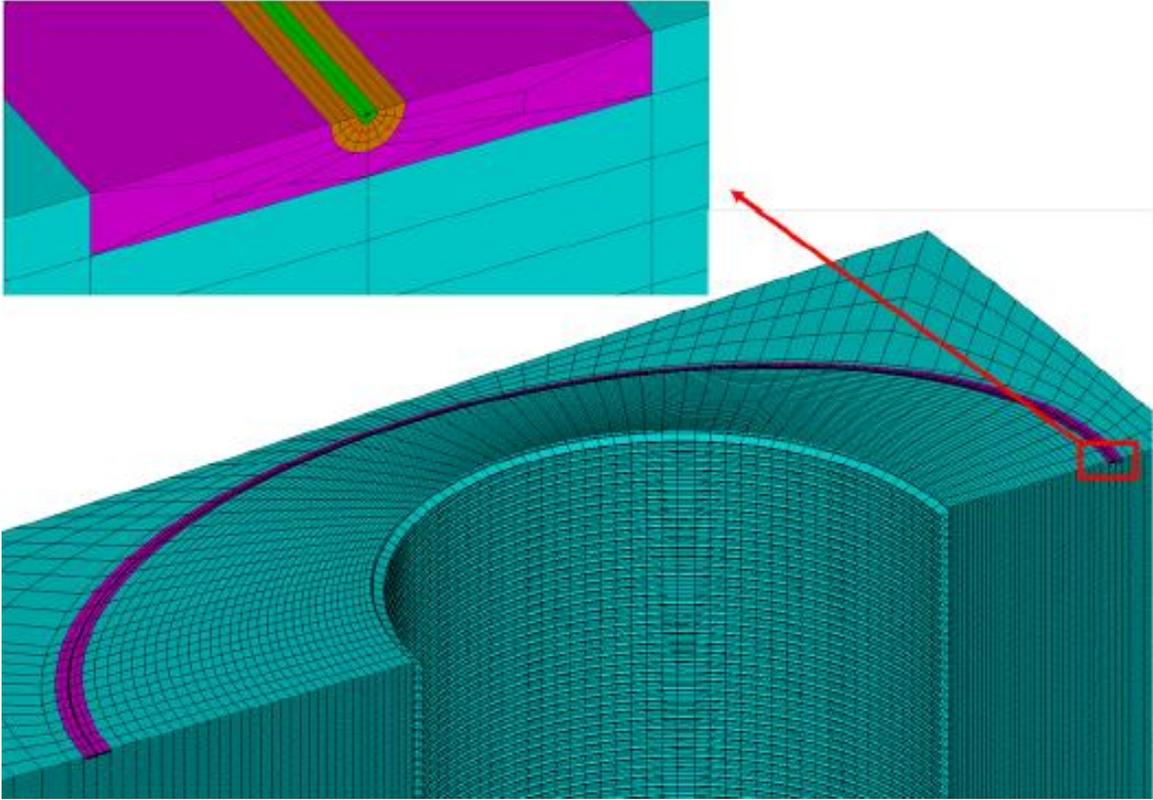
**Figure 4**  
**Cross Section of Circumferential Flaw with Crack Tip Elements Inserted After 10th**  
**Thread from Top of Flange**

hole. This creates an ellipsoidal flaw shape around the circumference of the flange, as shown in Figure 4 for the flaw model with  $a/t = 0.77$   $a/t$  crack model. The crack tip mesh for the other flaw depths follows the same pattern. When preload is not being applied, the stud, stud threads, and flange threads are not modeled. The model is otherwise unchanged between load cases.
