U.S. NUCLEAR REGULATORY COMMISSION
OFFICE OF NUCLEAR REACTOR REGULATION
Division of Reactor Inspection and Safeguards

NRC Inspection Report: 50-335/91-201
50-389/91-201

Facility Name: St. Lucie Plant, Units 1 & 2

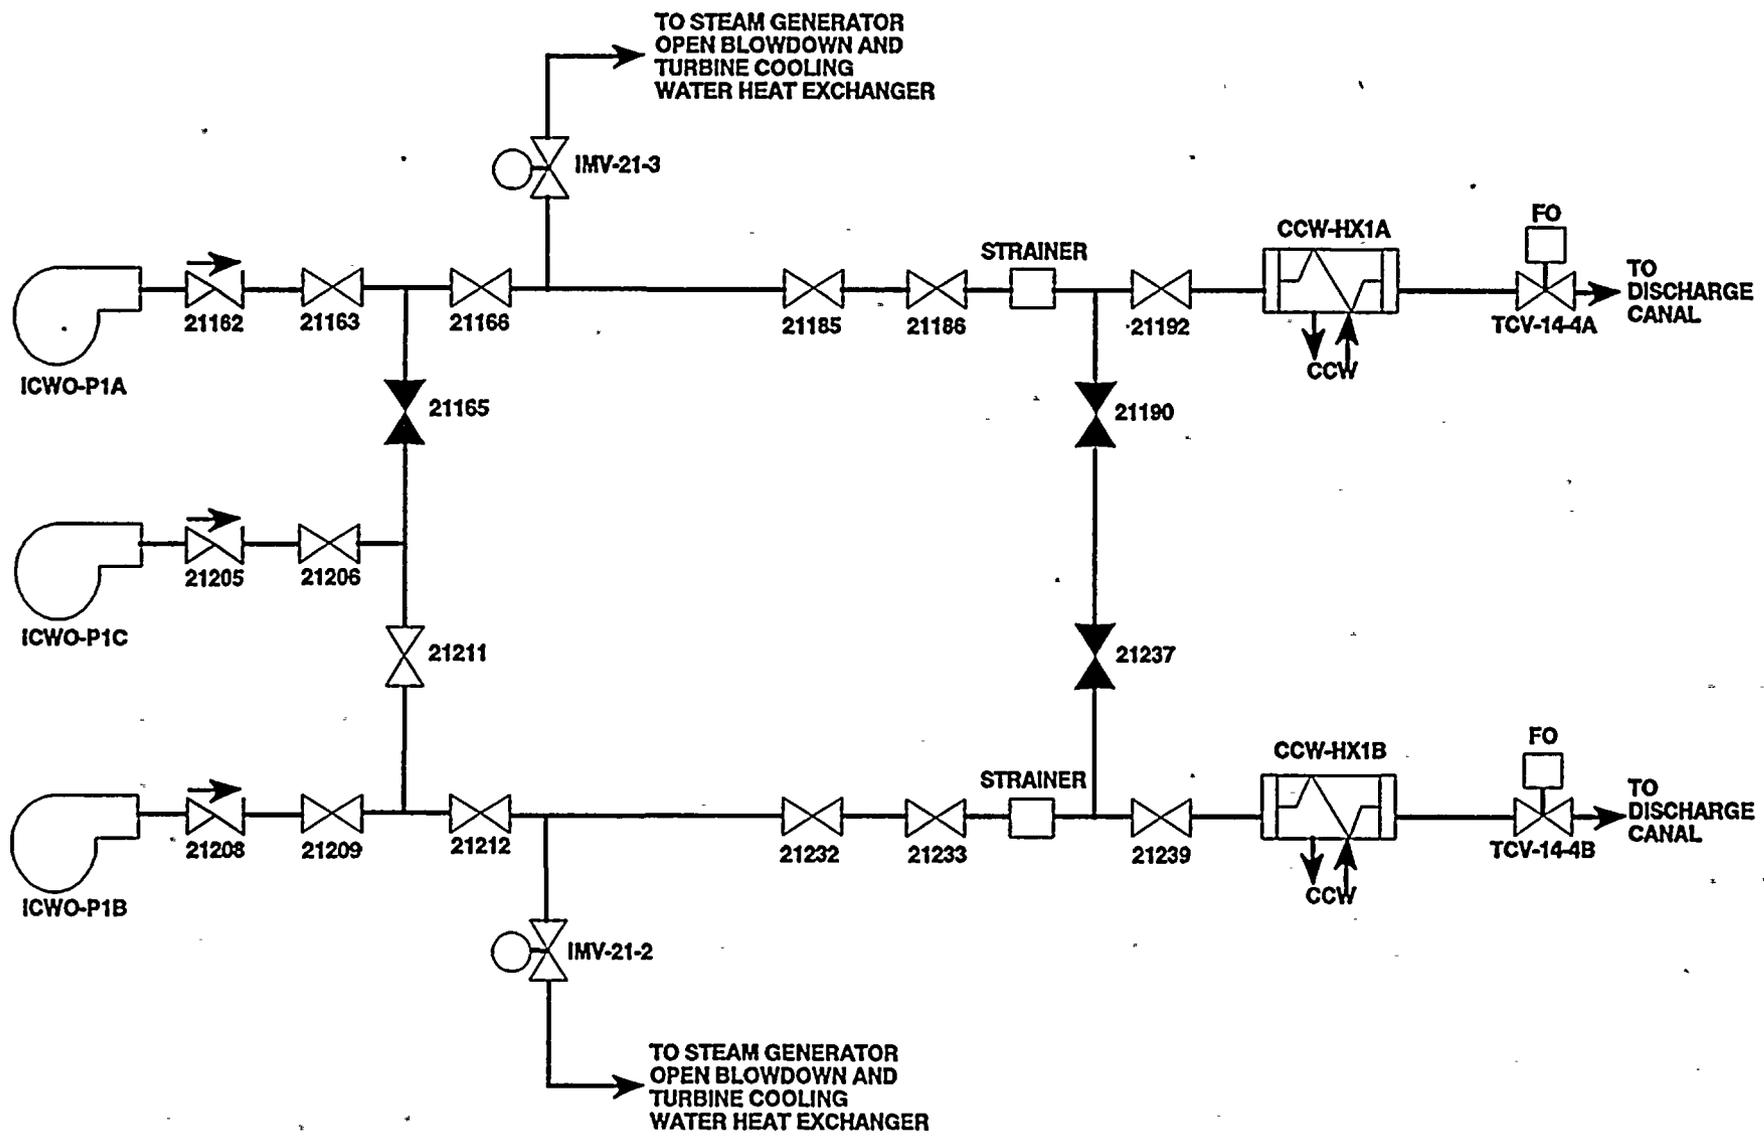
Figure 1 St. Lucie 1 Intake Cooling Water System

Figure 1 depicts the Unit 1 ICW system. The main difference between Units 1 and 2 is that the Unit 2 pump cross-tie valves 21165 and 21211 are normally open and closed, respectively. Each safety-related train includes a submerged pump; a basket strainer; a single-pass, shell-and-tube CCWHX; a flow meter; an air-operated temperature control valve (TCV); a restriction orifice; concrete-lined, carbon-steel piping; and various butterfly isolation valves and pressure and temperature indicators.

The nonessential portion of the ICW system draws sea water directly from the A and B safety-related headers. Upon receipt of a safety injection actuation signal (SIAS), valves MV-21-2 and MV-21-3 close to isolate the nonessential loads and valves FCV-21-3A and FCV-21-3B (Unit 1) and valves MV-21-4A and MV-21-4B (Unit 2) close to isolate the lubricating water flow to the circulating water pumps.

In addition to the A and B pumps, a C pump is also available and can be manually aligned to either of the two ICW trains. On Unit 1 the C pump is normally aligned to the B header; on Unit 2 the C pump is normally aligned to the A header.

FIGURE 1 - ST. LUCIE 1 INTAKE COOLING WATER SYSTEM.	3
---	---
