SUBJECT: Part 21 rept re 2"-1878 globe piston check valves. A/DV plans
 to include philosophy of both enhancement w/smaller piston
 check valves. A/DV evaluated found condition of piston check
 valve, stuck open.

Anchor/Darling

ANCHOR/DARLING VALVE COMPANY			
2"-1878 FULL PORT SOCKET ENDS STAINLESS STEEL PISTON CHECK VALVE NON-COBALT TRIM			
DWN BY: HLD	DATE: 9-23-92	DRAWING TYPE: CCA	REV: 1
CHK BY: BDK	DATE: 10-1-92	W: 9 2 2 3 8 7 0	A
APPD BY: RFB	DATE: 10-19-92	1 2 3 4 5 6 7 8 9

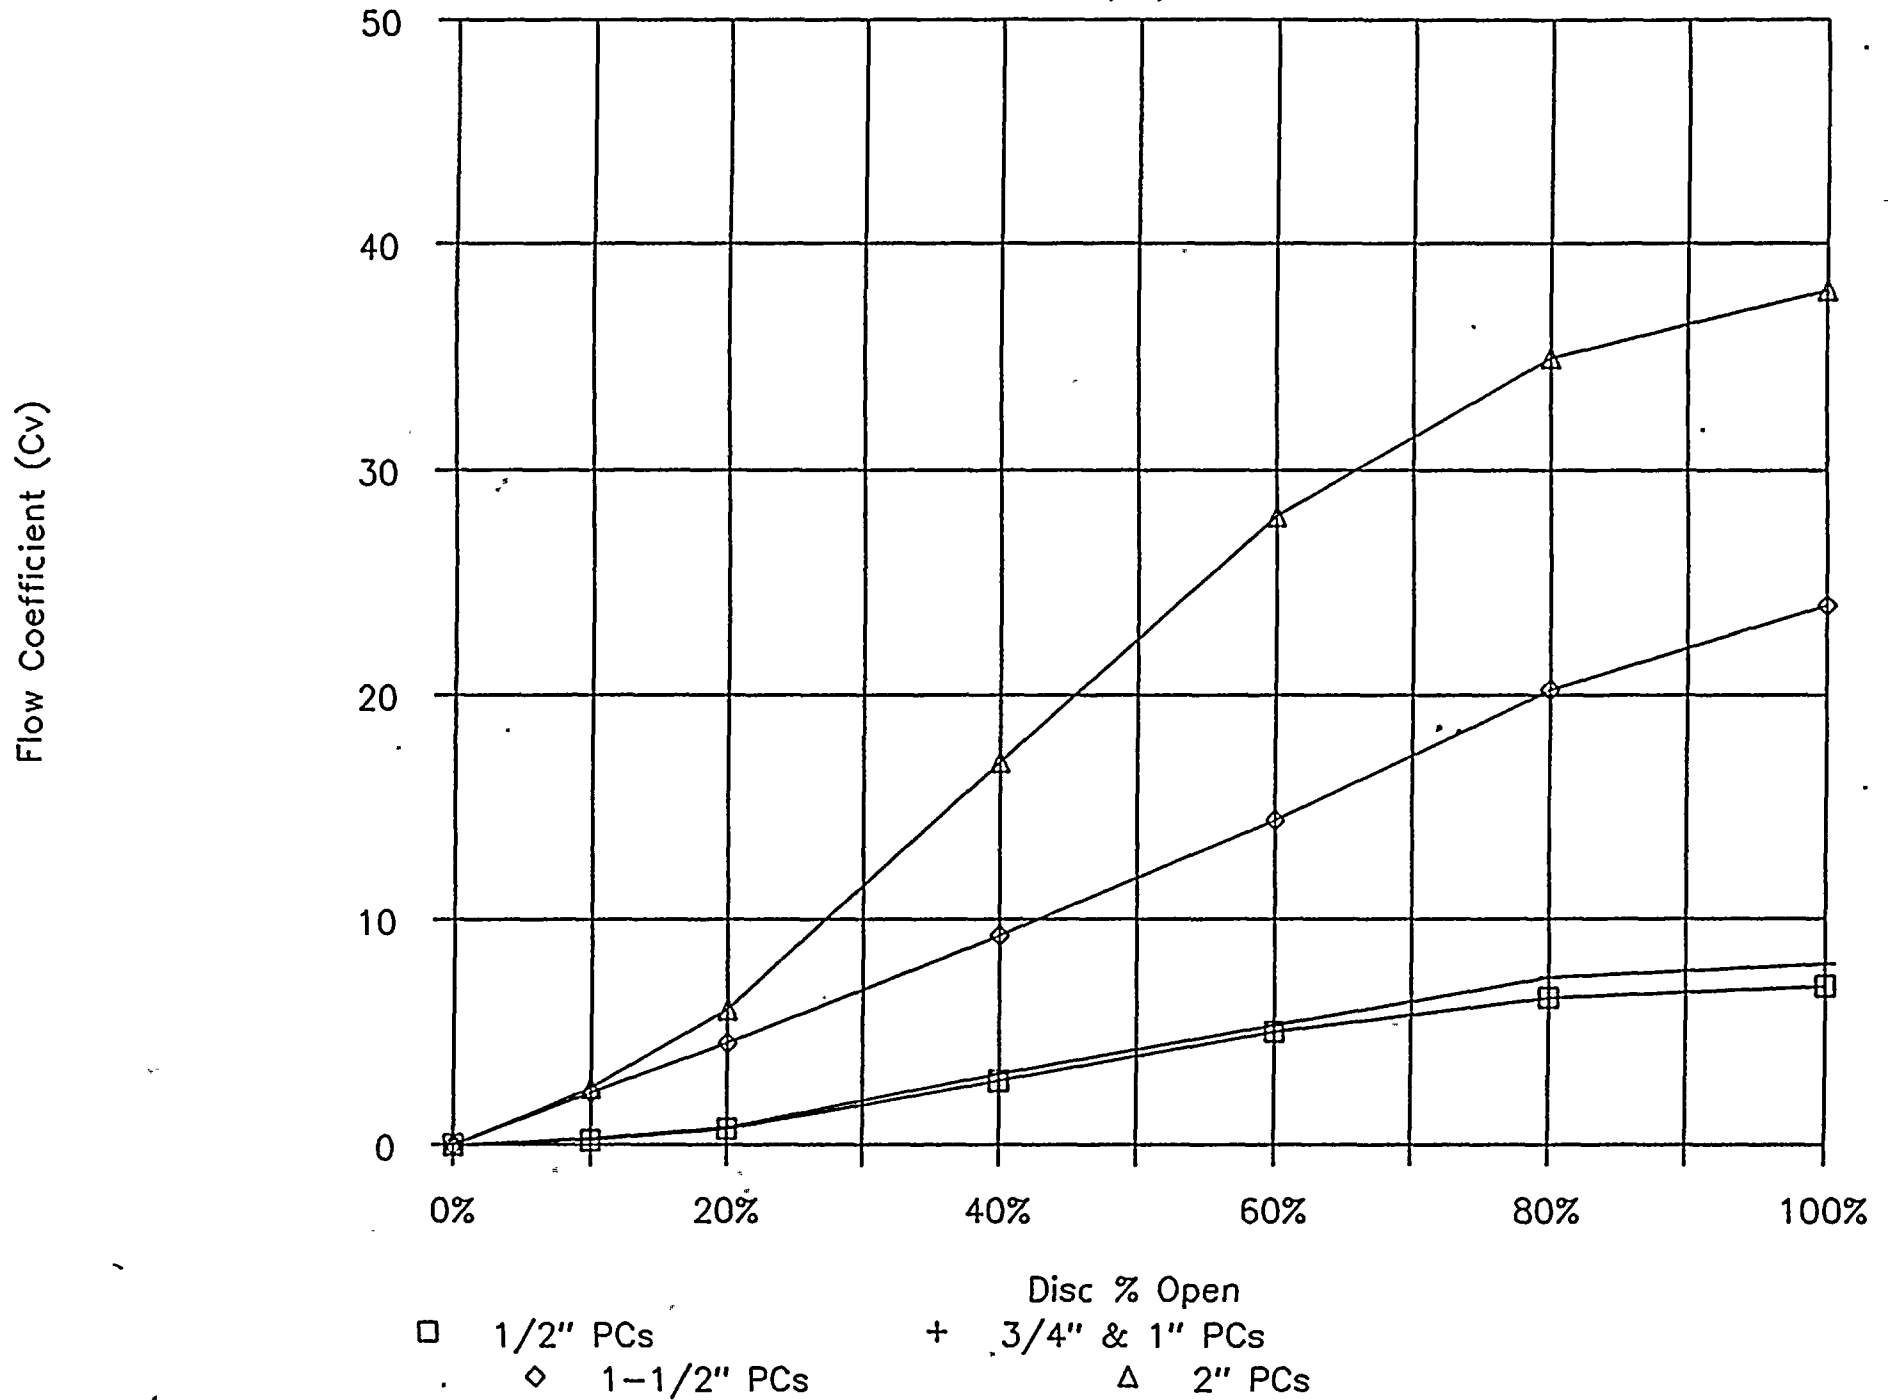
Flow Coefficient (Cv) vs. Disc Position

2" & Smaller T-Piston Check Valves

A/DV evaluated the as found condition of the piston check valve that stuck open. To assist in our root cause analysis, we performed flow tests on two (2) 2"-1878# Piston Check valves (one (1) valve returned from FP&L, S/N ET401-9-6). Reference No. 3 Report, enclosed, documents the task and results. The testing was performed to evaluate valve performance at various forward flow rates. The test conclusion was the valve always closed when forward flow ended.

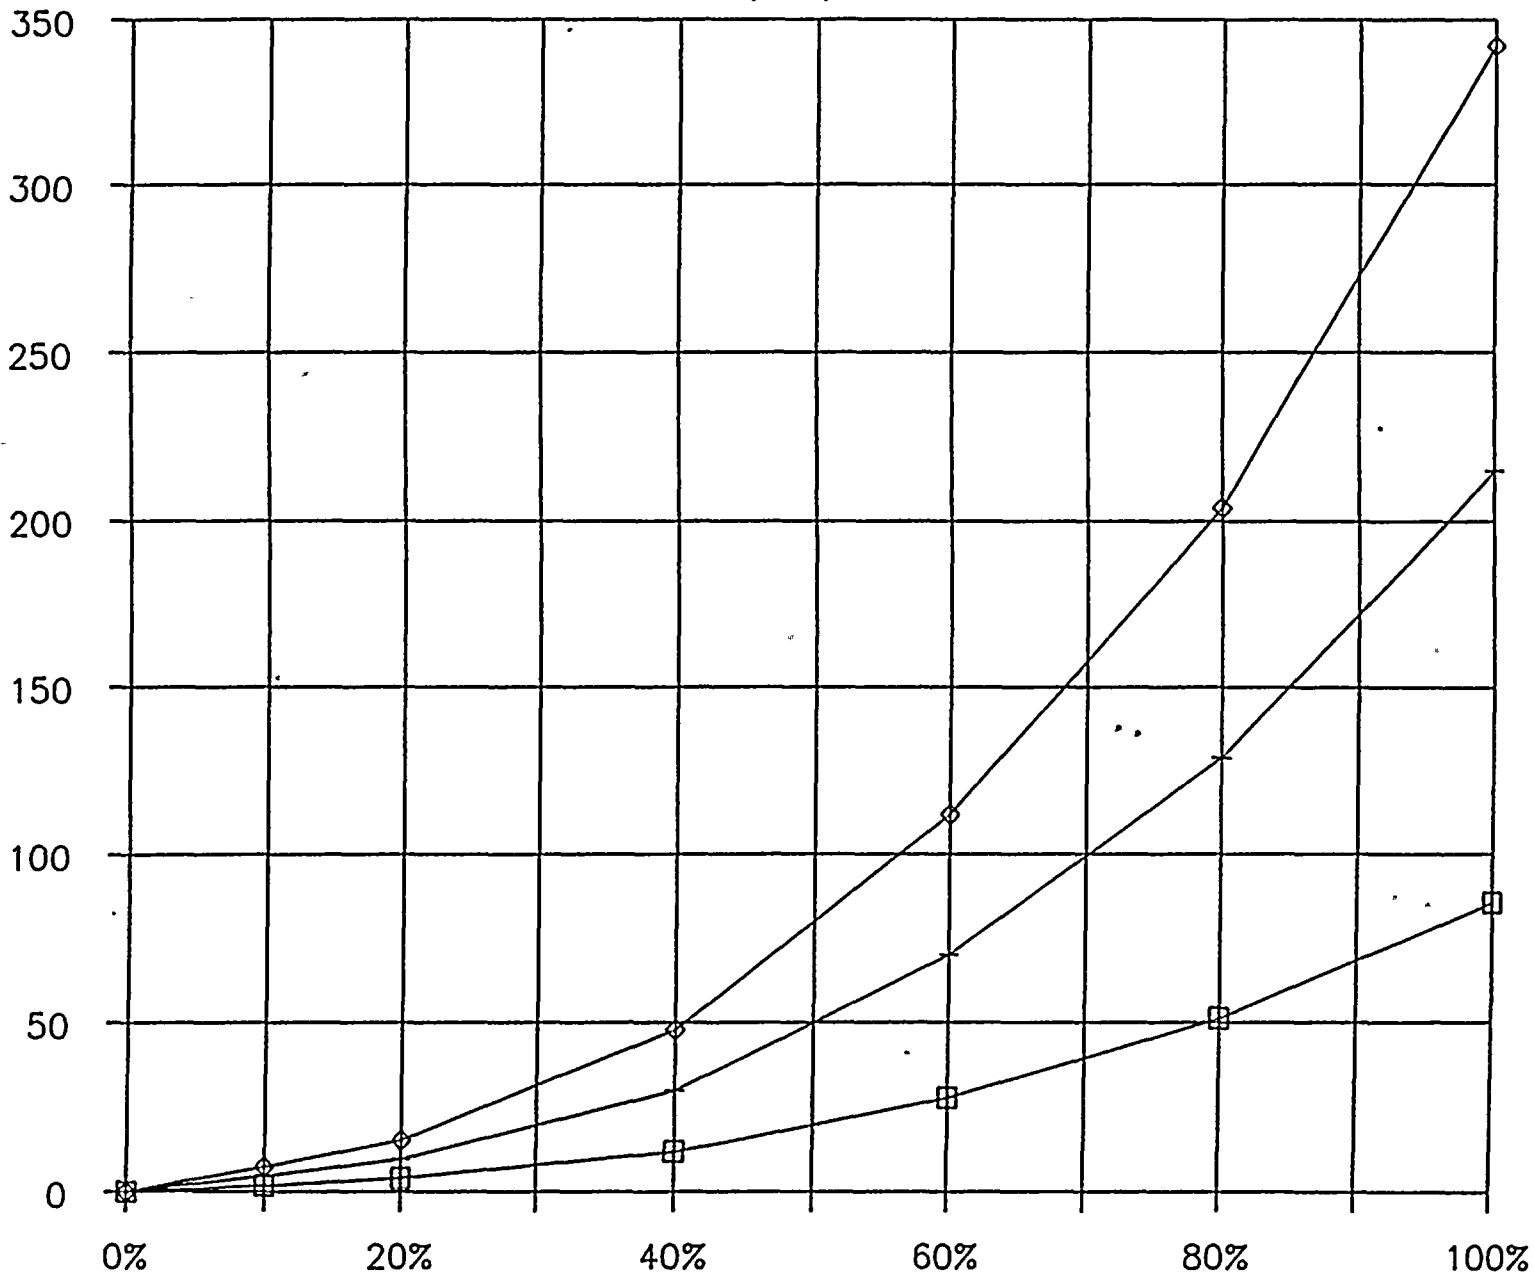
Air Flow Rate (cfm) vs. Disc Position

Air Flow Rate (cfm, 100 psig/115F)

□ 1/2", 3/4" & 1" PCs

+ 1-1/2" PCs

◇ 2" PCs

2" & Smaller T-Piston Check Valves

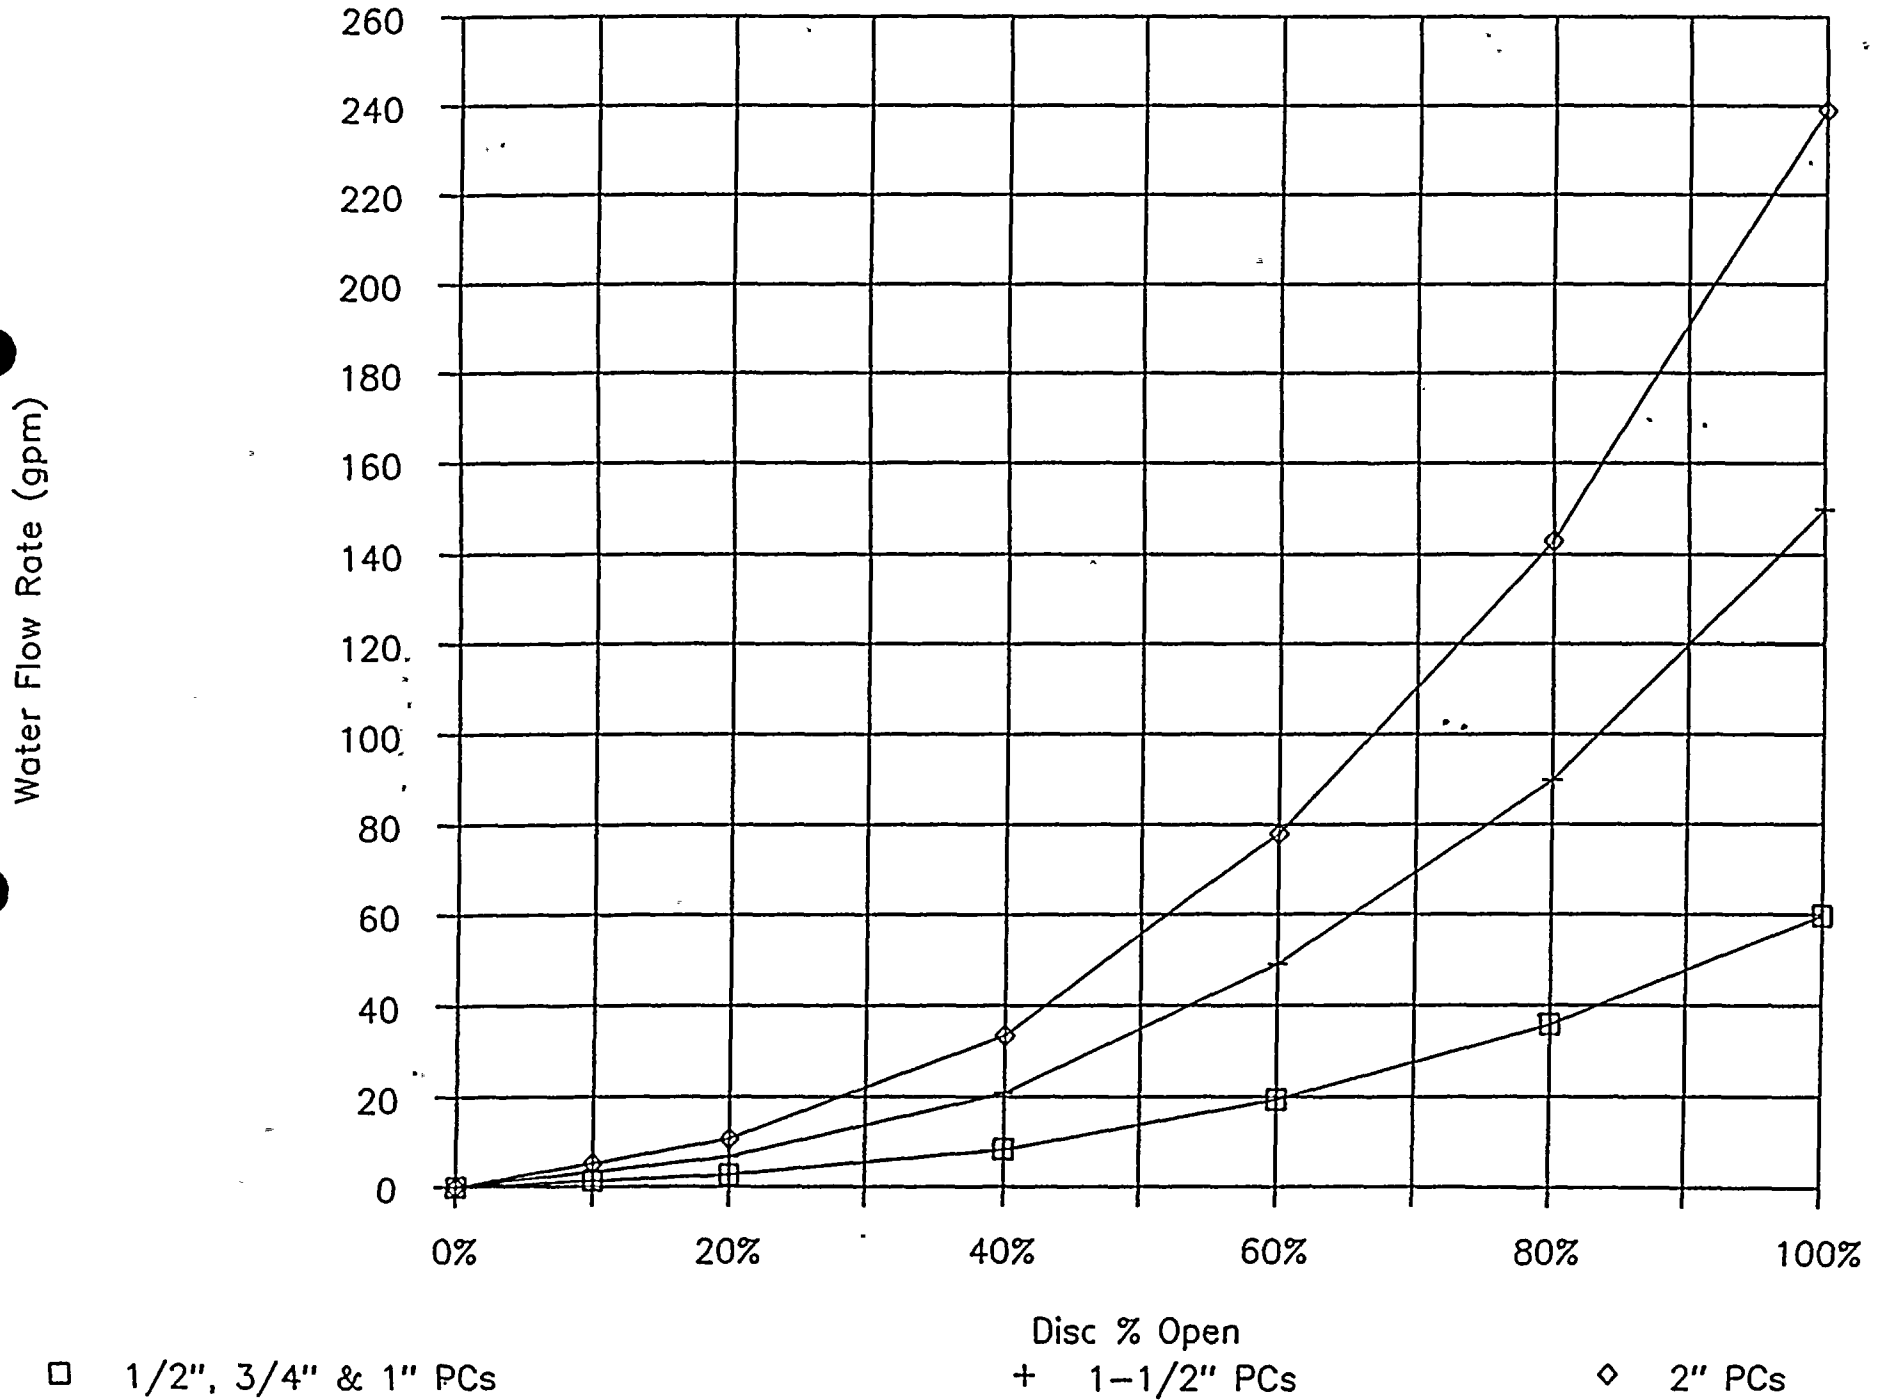
Water Flow Rate (gpm) vs. Disc Position

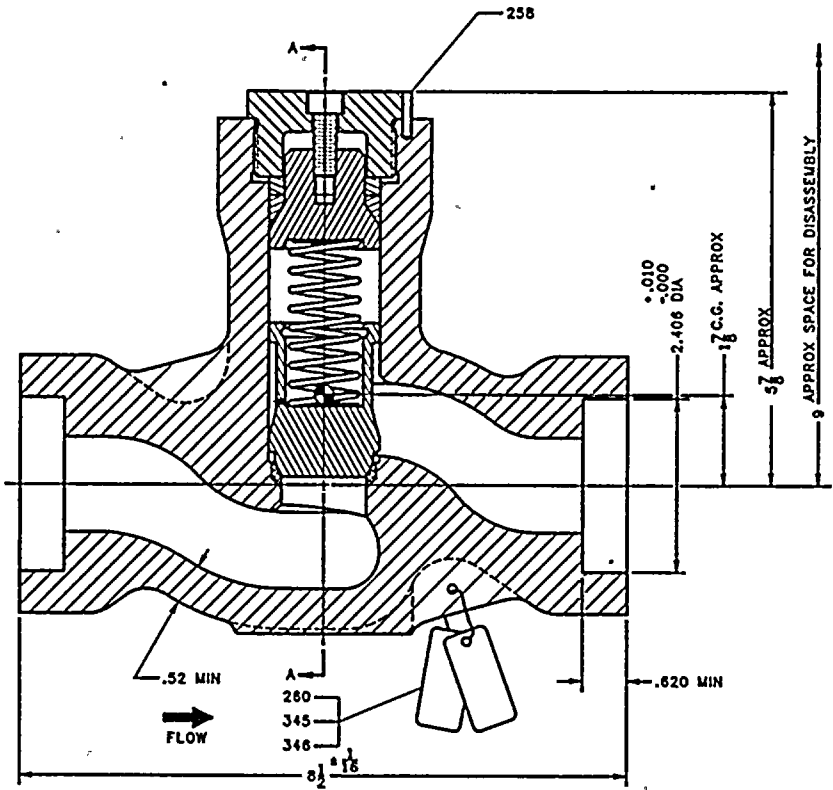
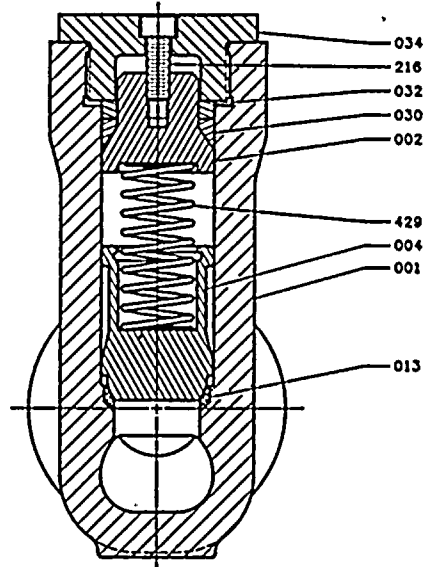
SECTION A-A

1. VALVE IS ASME CLASS 1 PER 1986 ASME SECTION II
2. APPROX VALVE WEIGHT = 24 LBS
3. APPROX $C_v = 38$
4. PISTON CHECK VALVE DESIGNED FOR MOUNTING IN A HORIZONTAL RUN OF PIPE WITH VALVE ENDS HORIZONTAL AND BONNET ON TOP
5. VALVE DESIGN PRESSURE IS 2735 PSI AT 680°F
6. MINIMUM FLOW DIAMETER = 1.500
SEAT RING INSIDE DIAMETER = 1.500

7. Δ - ASME PRESSURE BOUNDARY PART
8. CRACKING PRESSURE = 5 PSI
9. ANSI 1878 STANDARD INTERPOLATED PRESSURE CLASS
10. HYDROSTATIC TEST INFORMATION:
