Colorado Department  
of Public Health  
and Environment

Re: Colorado Radioactive Materials License # 317-02, Completion Review Report for the Durita Site

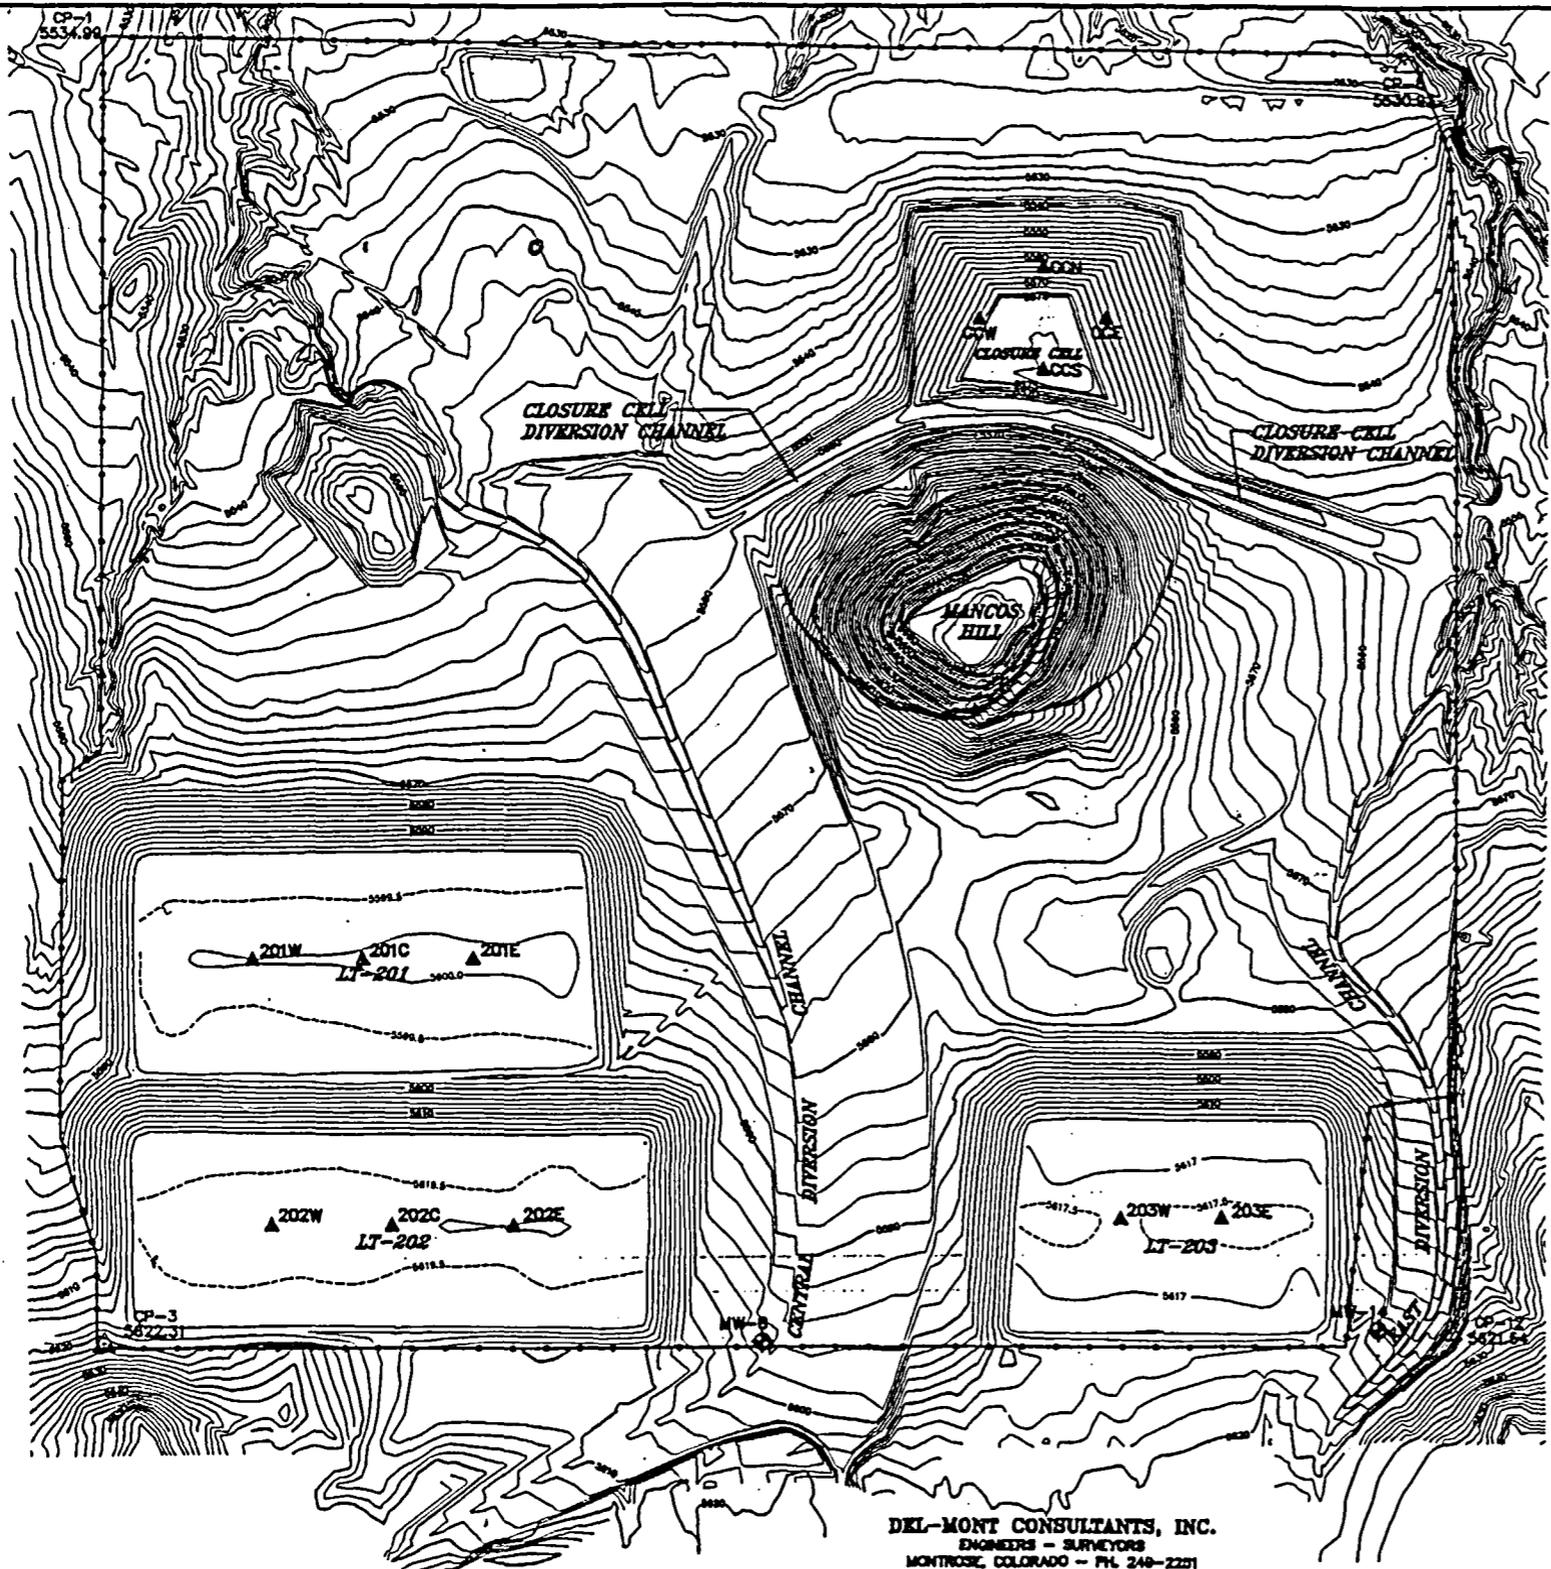
Figure 3 - Durita Site Map after Reclamation

FIGURE 3	
<b>SITE MAP</b>	
1998	
DURITA SITE RECLAMATION	
FOR	
HELCA MINING COMPANY	
DATE: 12/17/98	PLS: 850-34
DRAWN BY: D.L.C.	BY: J.H. 1/2/99

On May 20, 1999, two representatives from HMWMD-CDPHE performed gamma surveys at 10-meter intervals on the tops of leach tanks 201, 202, and 203 and on top of the closure cell (see Figure 3). Gamma readings ranged from 10  $\mu\text{R/hr}$  to 16  $\mu\text{R/hr}$ . It was concluded that the gamma scintillometer readings obtained on top of the three leach tanks and on the out slopes and top of the closure cell were the same as background readings in the area (CDPHE, May 1999).
