Case Study

Remediation of Three Mile Island Unit 2 in Preparation for Decommissioning

John P. Clements
U.S. Nuclear Regulatory Commission

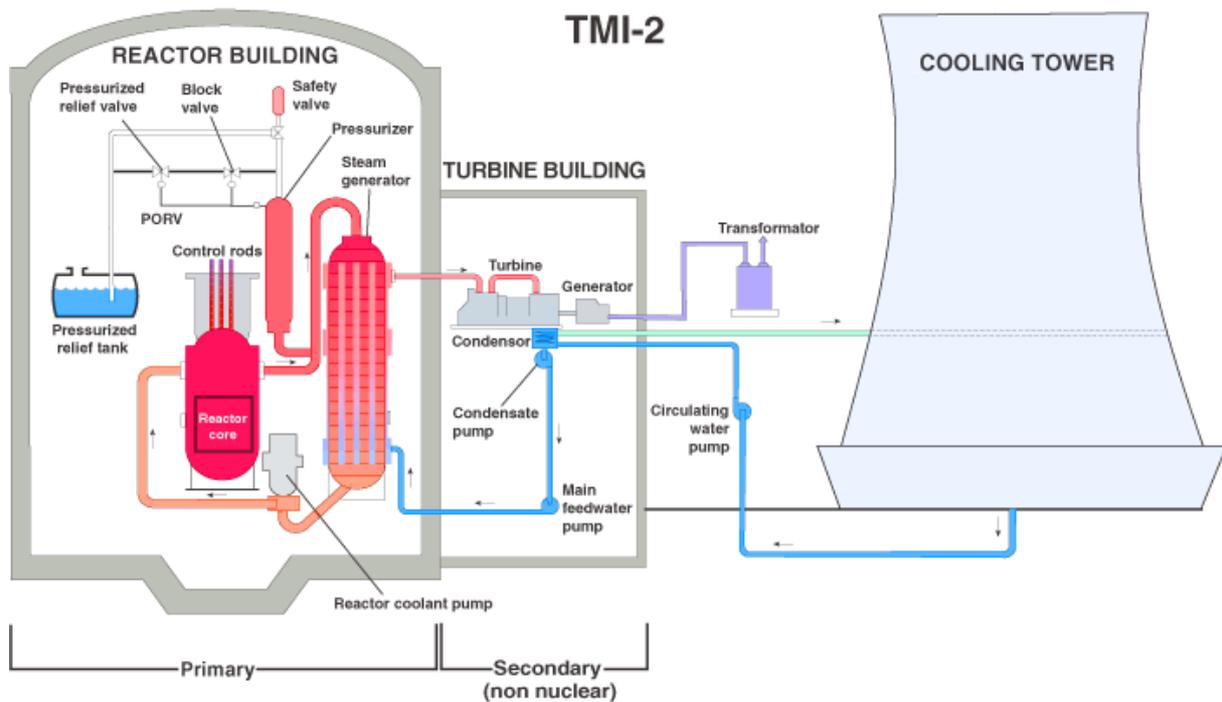
Figure 2 – General Plant Diagram for TMI-2

The reactor vessel and components that were exposed to radioactivity were located within the reactor building (also referred to as the containment building). The turbine generator, feedwater system, and electrical generation equipment were housed inside the turbine building. The remaining support systems, e.g. the high-pressure injection pumps and the makeup and let-down systems, were located in the auxiliary building adjacent to the reactor building. A general plant diagram for TMI-2 is shown in Figure 2. [2]

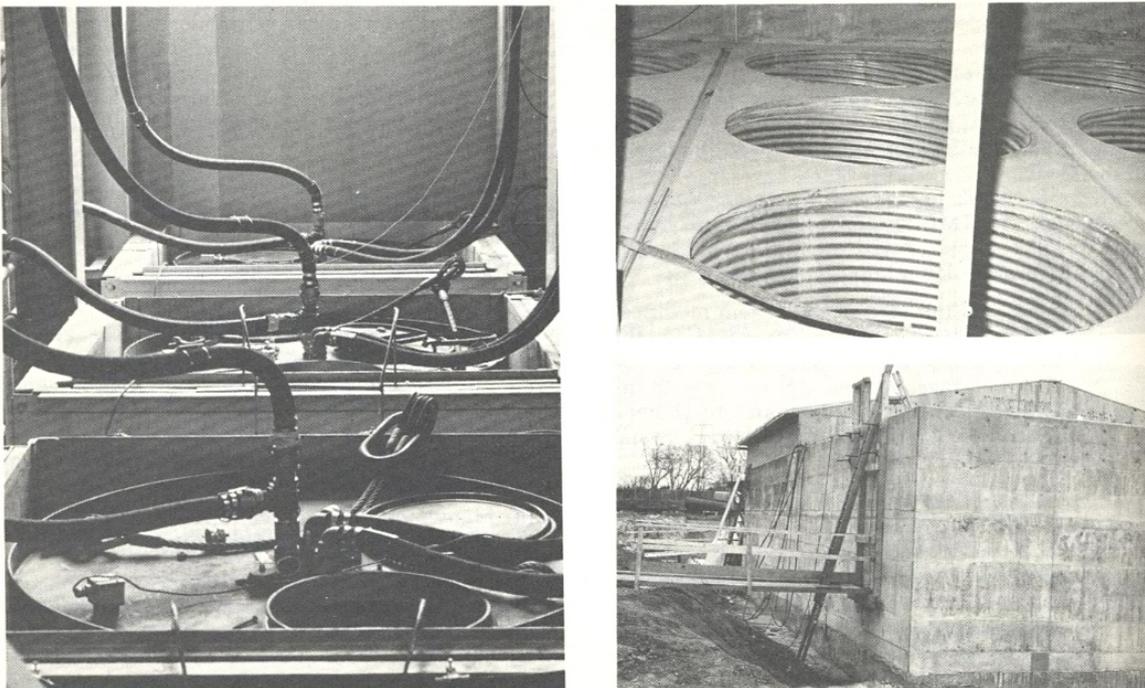
Figure 3 - EPICOR II System, Process Vessels and Storage Overview

It was necessary to decontaminate intermediate level contaminated water (defined as less than 3.7 MBq/mL) in the auxiliary building, and this was accomplished using the EPICOR II filtration system. The EPICOR II system, that was used to decontaminate around 1,438,456 liters [380,000 gallons] of intermediate-level radioactive water held in auxiliary building tanks, is shown in Figure 3. It consists of three process vessels (steel liners) shielded by 10.16 cm [4 inch] lead enclosures located in the chemical cleaning building. Each vessel contains ion-exchange resin. The vessel at the top of the photo at the left is the system prefilter/demineralizer, the center vessel is a cation ion-exchanger, and the third vessel is a mixed-bed polishing ion-exchanger. Each is fitted with three quick-disconnect hoses: a liquid waste influent line, a processed waste effluent line, and a vent line with attached overflow hose. Vented air from each vessel passes through a special filter and charcoal absorber. "Spent" ion-exchange resin liners containing radioactive material removed from the water are transferred by crane to cells (shown at top right) which are housed in modular concrete storage structures (shown at bottom right). The cells are concrete-shielded, galvanized corrugated steel cylinders 2.13 meters [7 feet] in diameter and 3.96 meters [13 feet] high. The storage module shown under construction has 1.22 meter [4 foot] thick walls and is 17.37 meters [57 feet] wide and 27.74 meters [91 feet] long. Each module holds about 60 storage cells. The modular design allowed additional storage modules that could be built on an as-needed basis. [1]

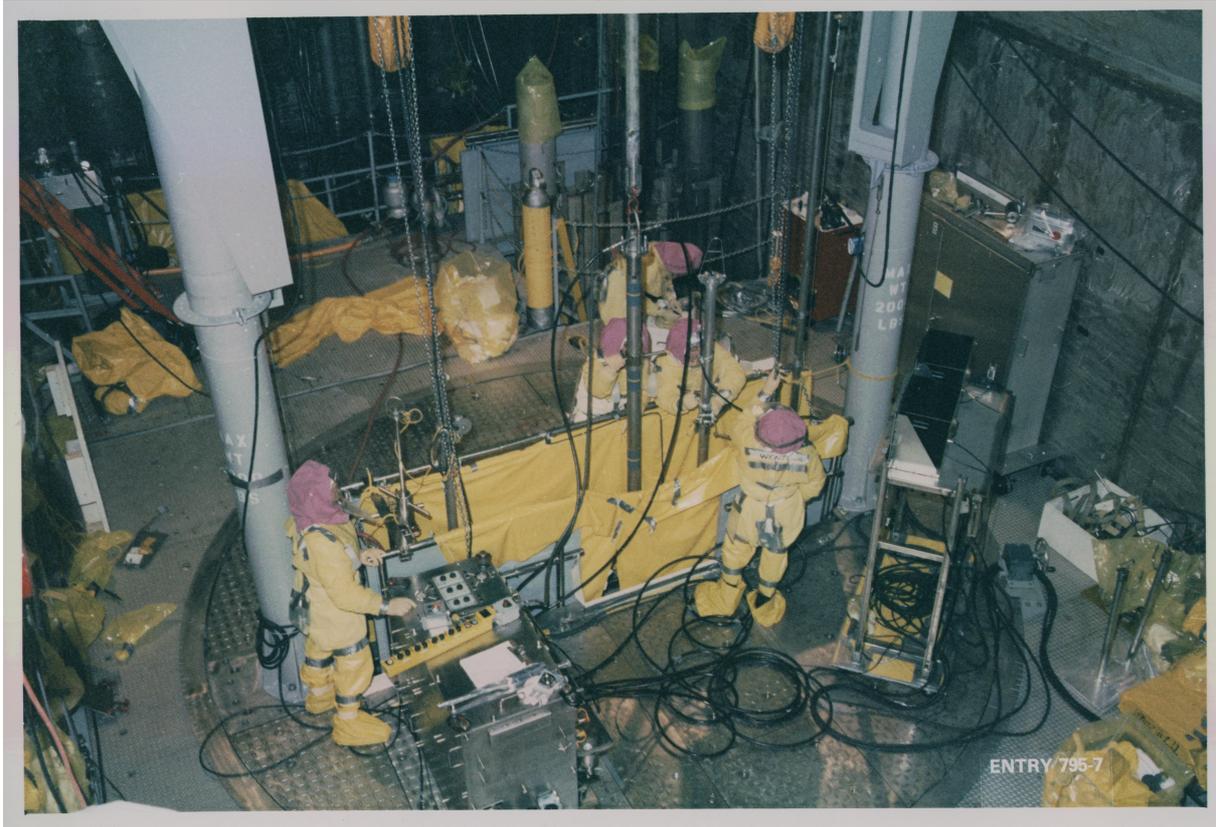
Figure 4 - Shielded Defueling Work Platform (DWP)

In October 1985, operators began to remove damaged fuel and structural debris from the reactor vessel by "pick and place" defueling of the loose TMI-2 core debris. Workers performed defueling operations from a shielded defueling work platform (DWP), which was located 2.74 meters [9 feet] above the reactor vessel flange (See Figure 4). The platform had a rotating 5.18 meter [17 foot] diameter surface with 15.24 cm [6 inch] steel shield plates, and was designed to provide access for defueling tools and equipment into the reactor vessel. The DWP supported defueling operators, specially designed long-handled tools, remote viewing equipment, and two

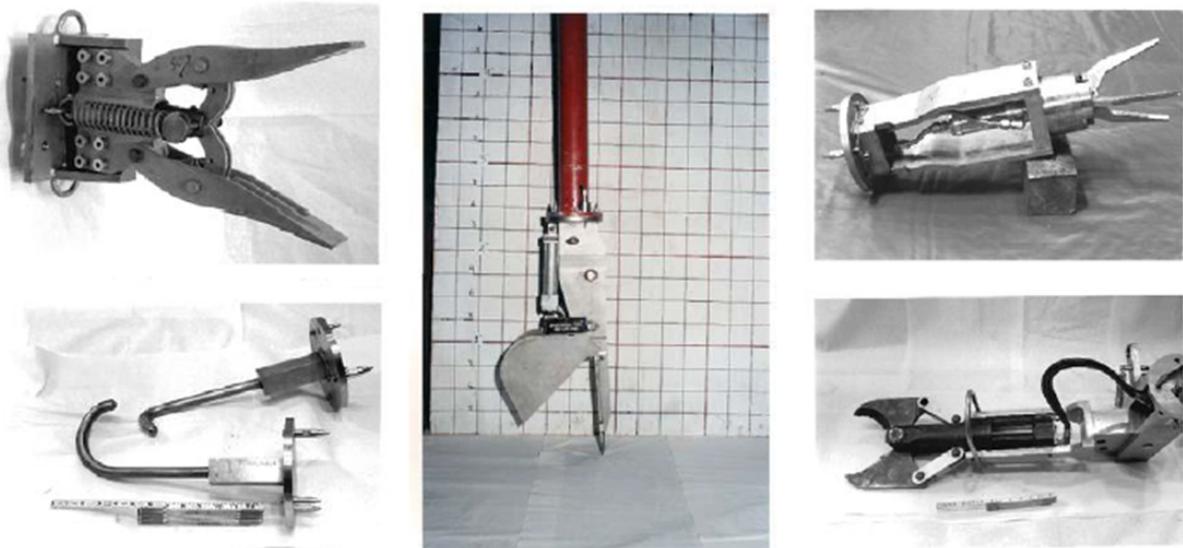
Figure 5 - Manual and Hydraulically Powered Long-Handled Tools Used to Load Debris into Defueling Canisters Positioned Underwater in the Reactor Vessel

jib cranes used to manipulate the tools. Numerous manual and hydraulically powered long-handled tools were used to perform a variety of functions, such as pulling, grappling, cutting, scooping, and breaking up the core debris, several of which are shown in Figure 5. These tools were used to load debris into defueling canisters positioned underwater in the reactor vessel. The canisters were then sealed and transported using shielded canister transfer equipment to submerged storage racks in spent fuel pool “A” of the auxiliary and fuel handling building (AFHB). The canisters were designed and stored to prevent an inadvertent criticality event. Following dewatering to control the buildup of combustible gases, the canisters were loaded into a specially designed shipping cask and transported to a Department of Energy facility in Idaho for interim storage and research.

The heavy-duty long handled tools were only marginally successful, so a drilling rig that was used for boring core samples was reinstalled as the primary tool for breaking up the hard mass of core debris, and drilling commenced in September 1986. Additional details on this drilling rig are provided below in the “Post-Accident Evaluations” discussion.
