SUBJECT: Interim deficiency rept re inadequate concrete strength achieved w/pneumatically placed mortar repairs.Evaluation of all repairs will be completed 801201.Final rept will be submitted by 801215.

INTERIM REPORT  
REPORTABLE DEFICIENCY  
ARIZONA PUBLIC SERVICE COMPANY (APS)  
PVNGS UNITS #1 AND #2

EVALUATION AND DISPOSITION  
OF CONCRETE REPAIRS FOR  
DER 79-12

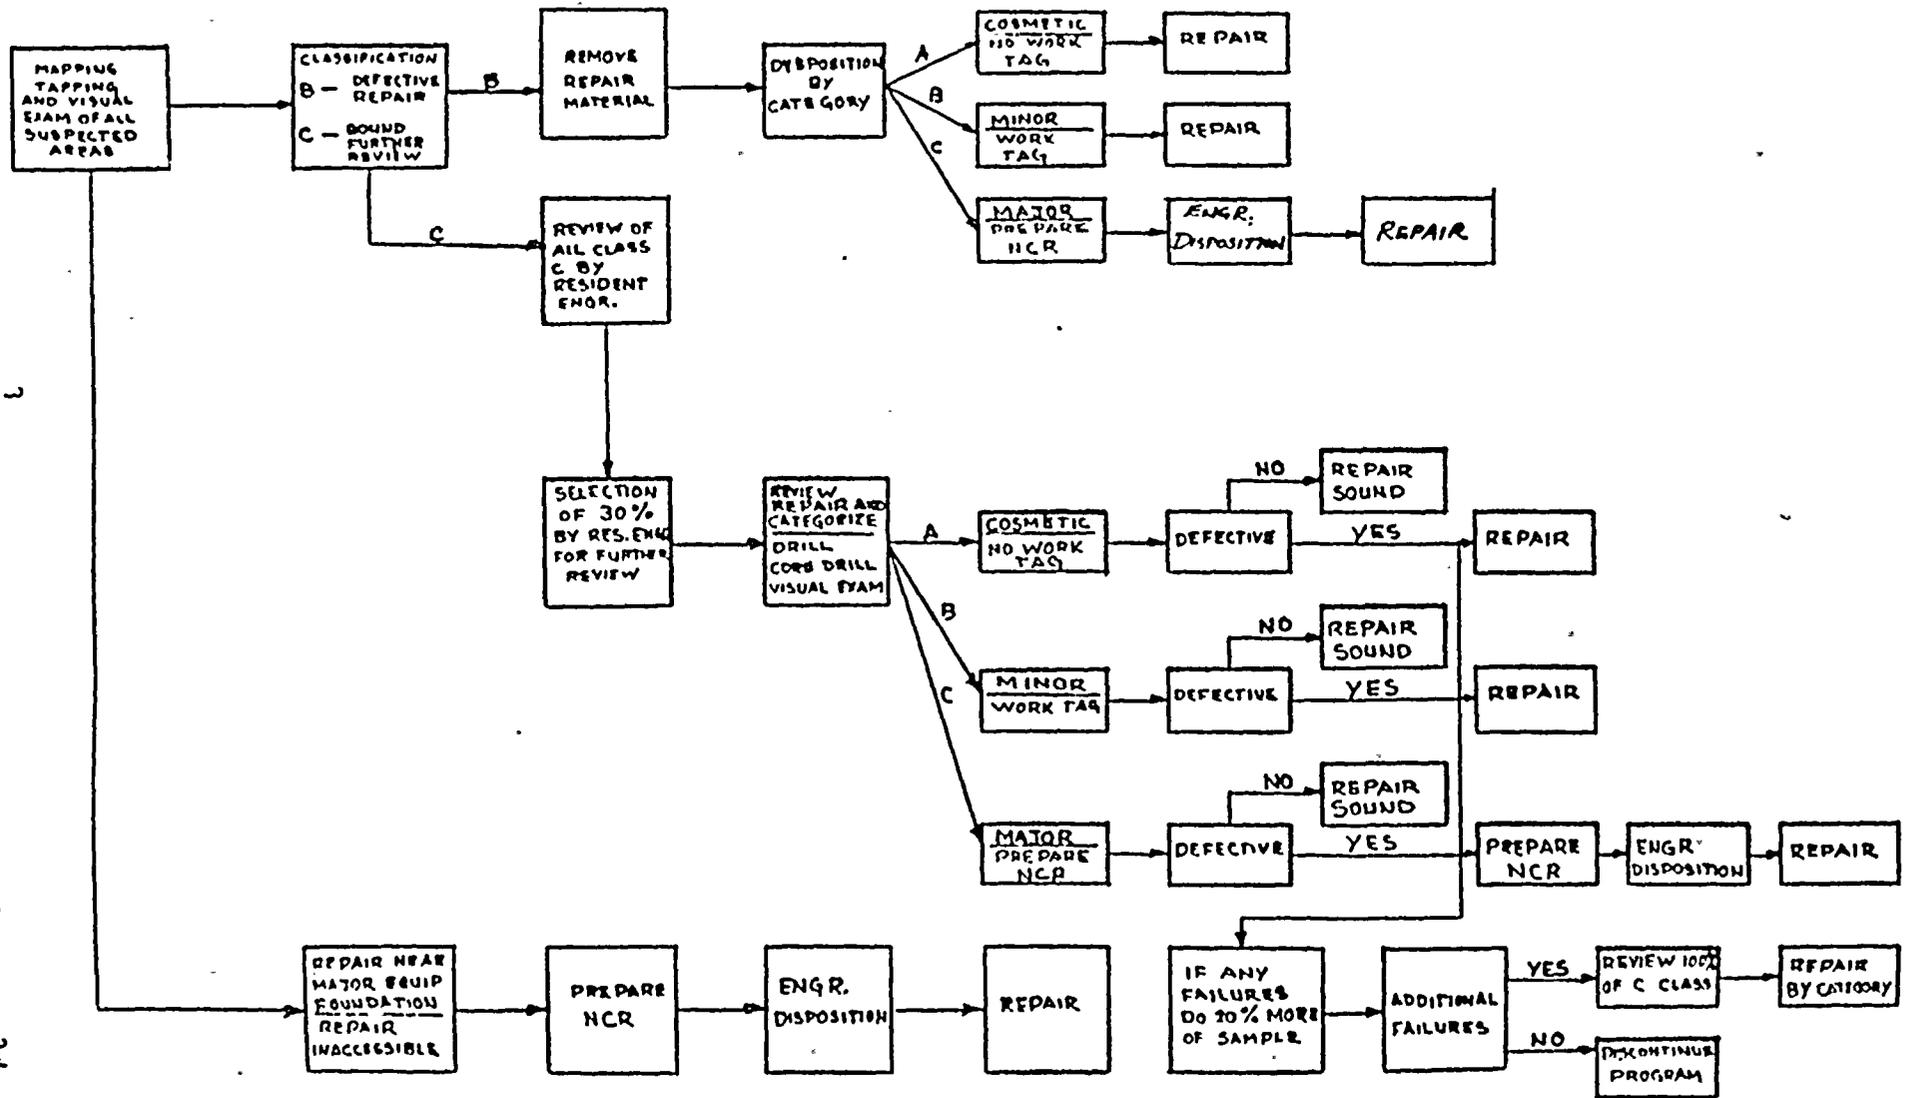
EVALUATION AND DISPOSITION OF  
CONCRETE REPAIRS FOR DER 79-12  
FLOW DIAGRAM

A plan titled "Evaluation and Disposition of Concrete Repairs for DER 79-12" (attached) was developed in April, 1980. This plan provides instructions for the ultimate resolution of this subject by providing a full-scale evaluation, consisting of in-situ testing and a walk-down of all accessible areas of all buildings in Units #1 and #2, to locate all areas of repaired concrete imperfections because the concrete pour records did not indicate the exact location of the surface repairs. Evaluation of each repair consists of visual examination and tapping on repaired areas, and core samples taken of the visually accepted patches to determine the quality of the concrete. During the evaluation, it became apparent that concrete imperfections that had been repaired by pneumatic placement could not be visually distinguished from those repaired by mortar replacement or drypacking. All concrete imperfection areas were, therefore, evaluated and it was determined that not only pneumatically placed repairs were suspect, but all other repair methods were suspect also. NCE's C-X-1897 and C-X-1925 were written so as to include all concrete imperfection repair areas.
