SUBJECT: Forwards Suppl A to "Independent Verification of Design & Const for St Lucie Unit 2 Nuclear Generating Station, Resolution of Discrepancies & Corrective Action Plans."

TABLE OF CONTENTS

FIGURE 1
ENGINEERING VERIFICATION PROGRAM
STEP PROCEDURE FOR RESOLUTION
OF DISCREPANCIES

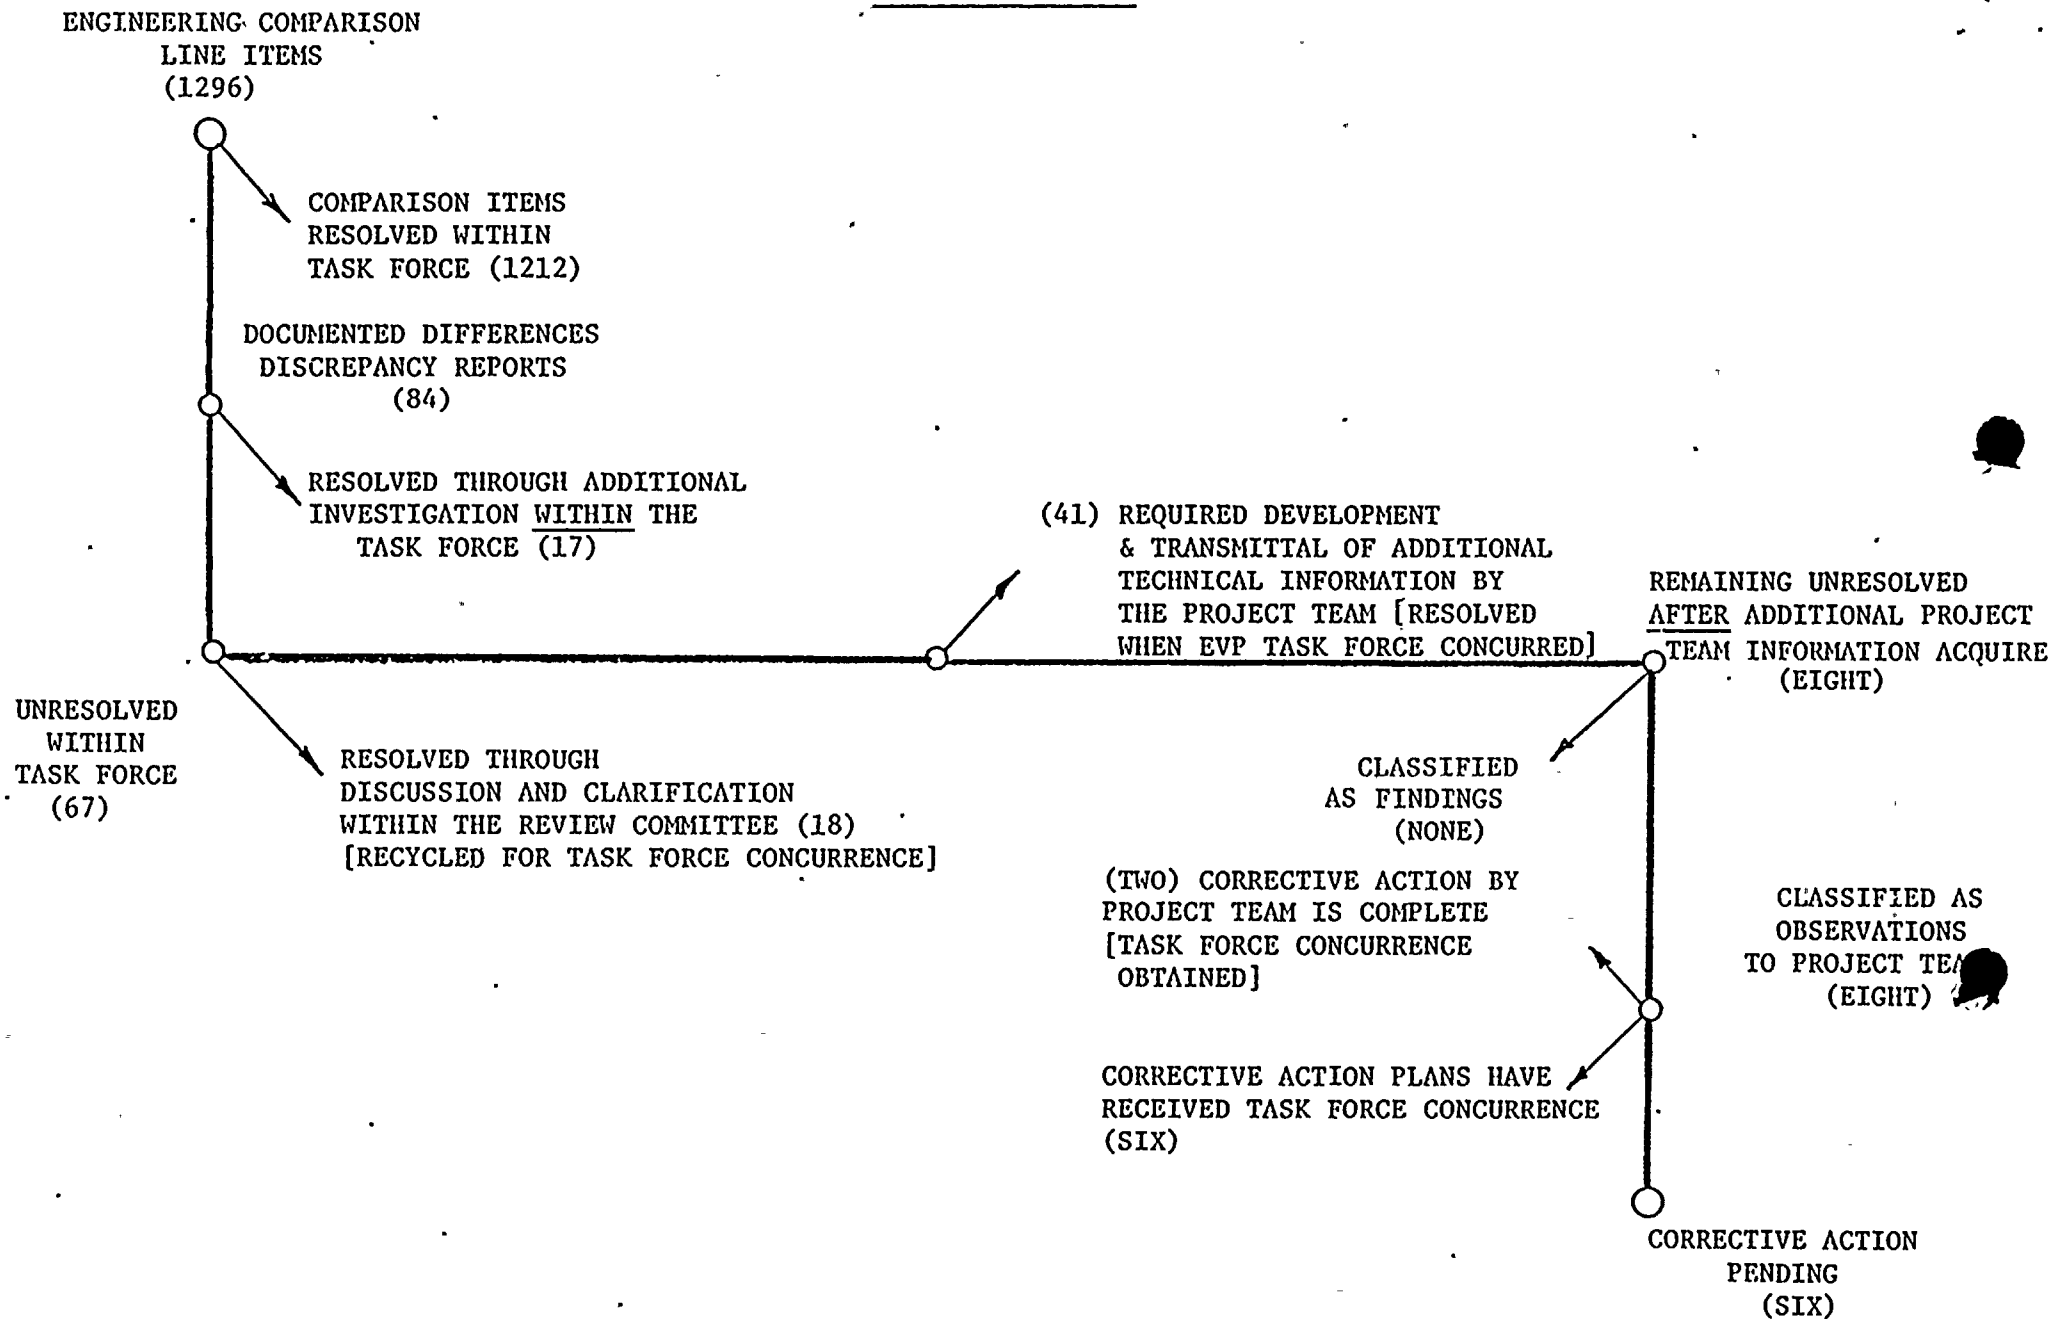
Figure 1 is a step-by-step procedure demonstrating, in flow chart format, the process used for resolution of differences between the independent and existing design along with discrepancies noted in installation and testing of verification items. The six-step process shows how the EVP Task Force, assisted by the Review Committee and the St. Lucie Unit 2 Project Team, carried the program from design comparison through approval of corrective actions now underway.
