FINAL REPORT
ON
PRESSURE-TEMPERATURE LIMITS FOR THE PALO VERDE
NUCLEAR GENERATING STATIONS

1.0 INTRODUCTION

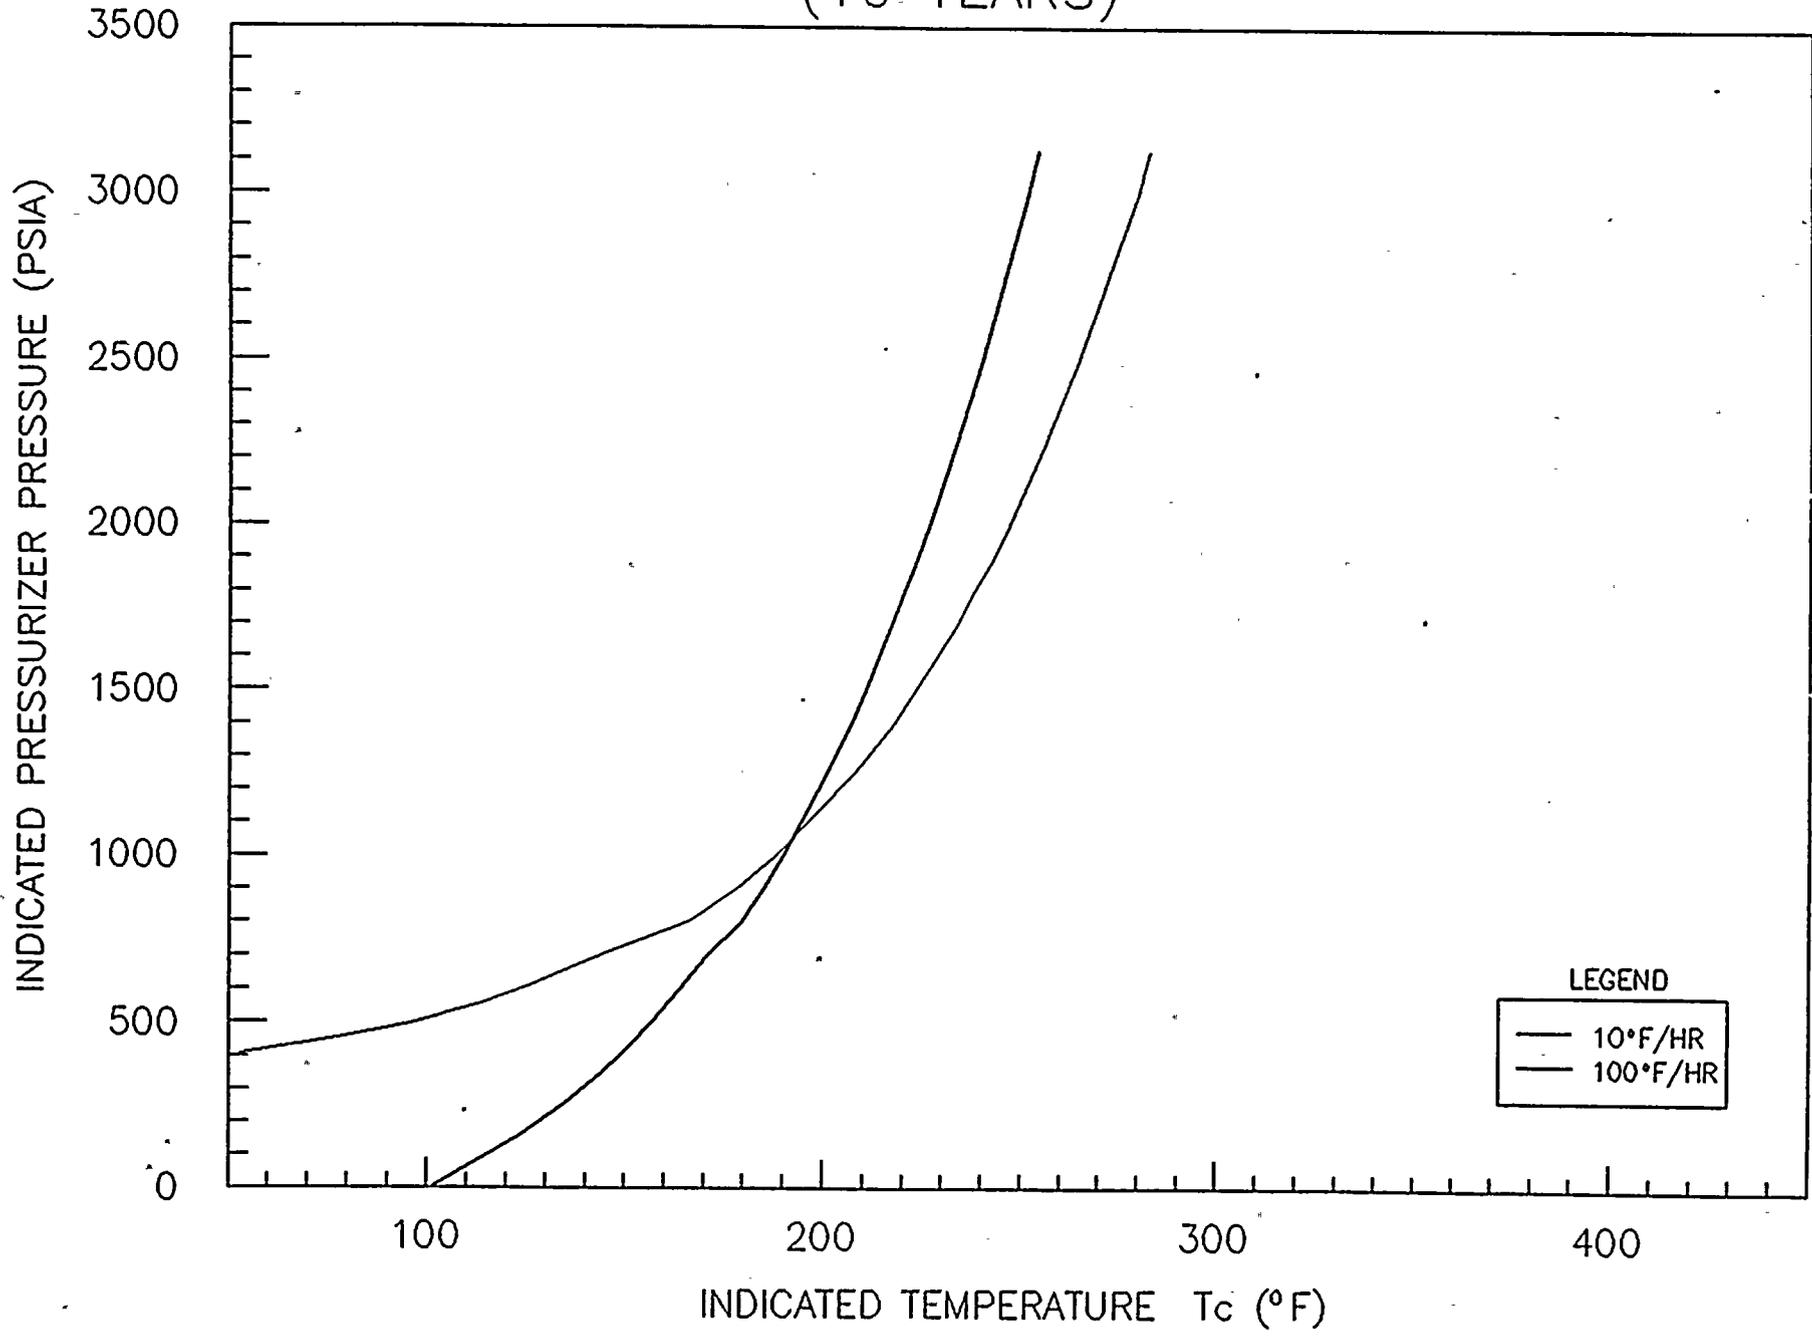
ANPP COOLDOWN P-T LIMITS (10 YEARS)

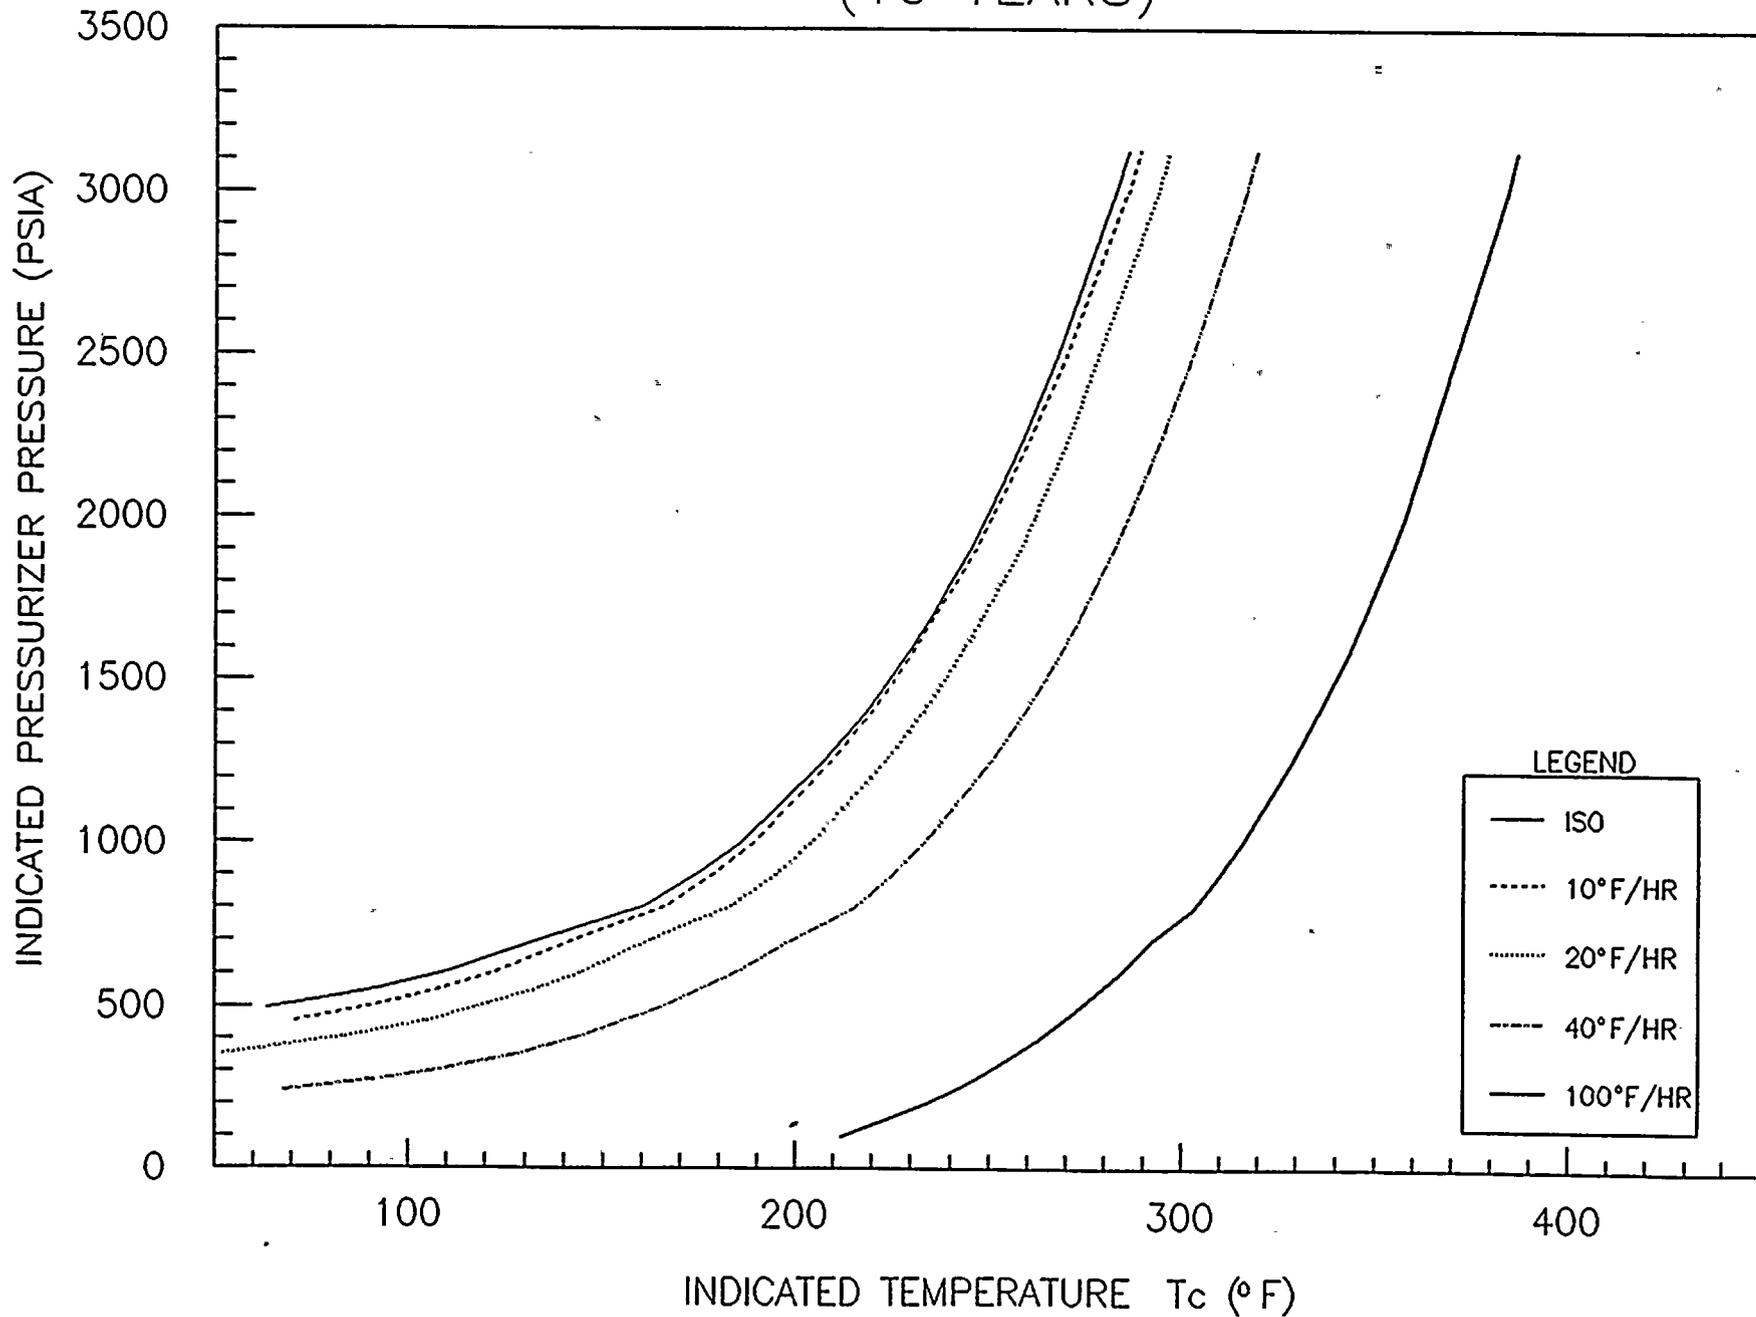
Figure 2

ANPP HEATUP P-T LIMITS (10 YEARS)

Tables 12 through 21 provide the results for the 10°F/hr , 20°F/hr , 40°F/hr , and 100°F/hr heatup pressure-temperature limits. These Tables provide the indicated RCS temperature versus the indicated pressurizer pressure for the various heatup cases. The allowable pressure is in units of psia while temperature is in units of $^\circ\text{F}$. Figures 2 and 4 provide a graphical presentation of the heatup pressure-temperature limit results found in Tables 12 through 21. It is permissible to linearly interpolate between the heatup pressure-temperature limits.

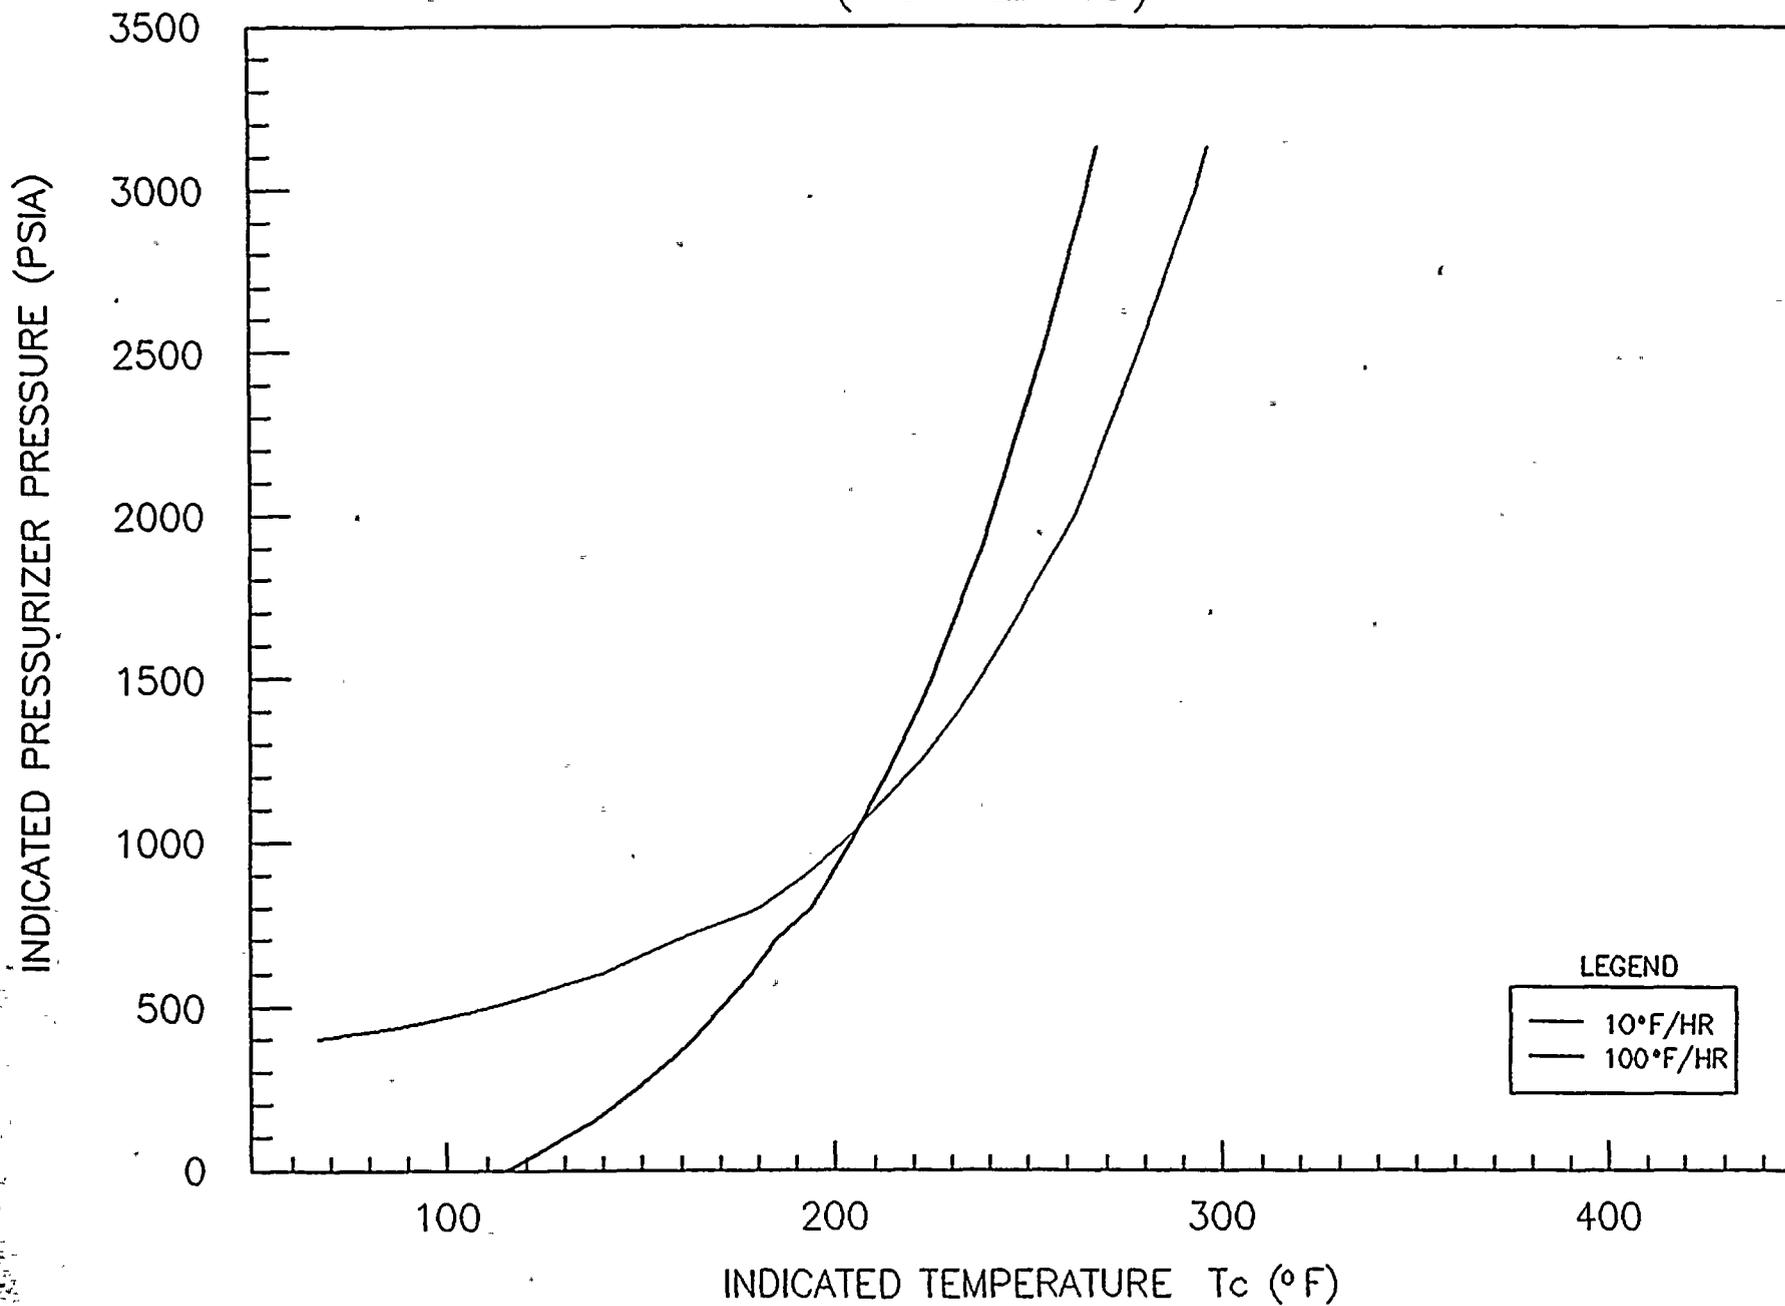
Figure
ANPP COOLDOWN P-T LIMITS
(40 YEARS)

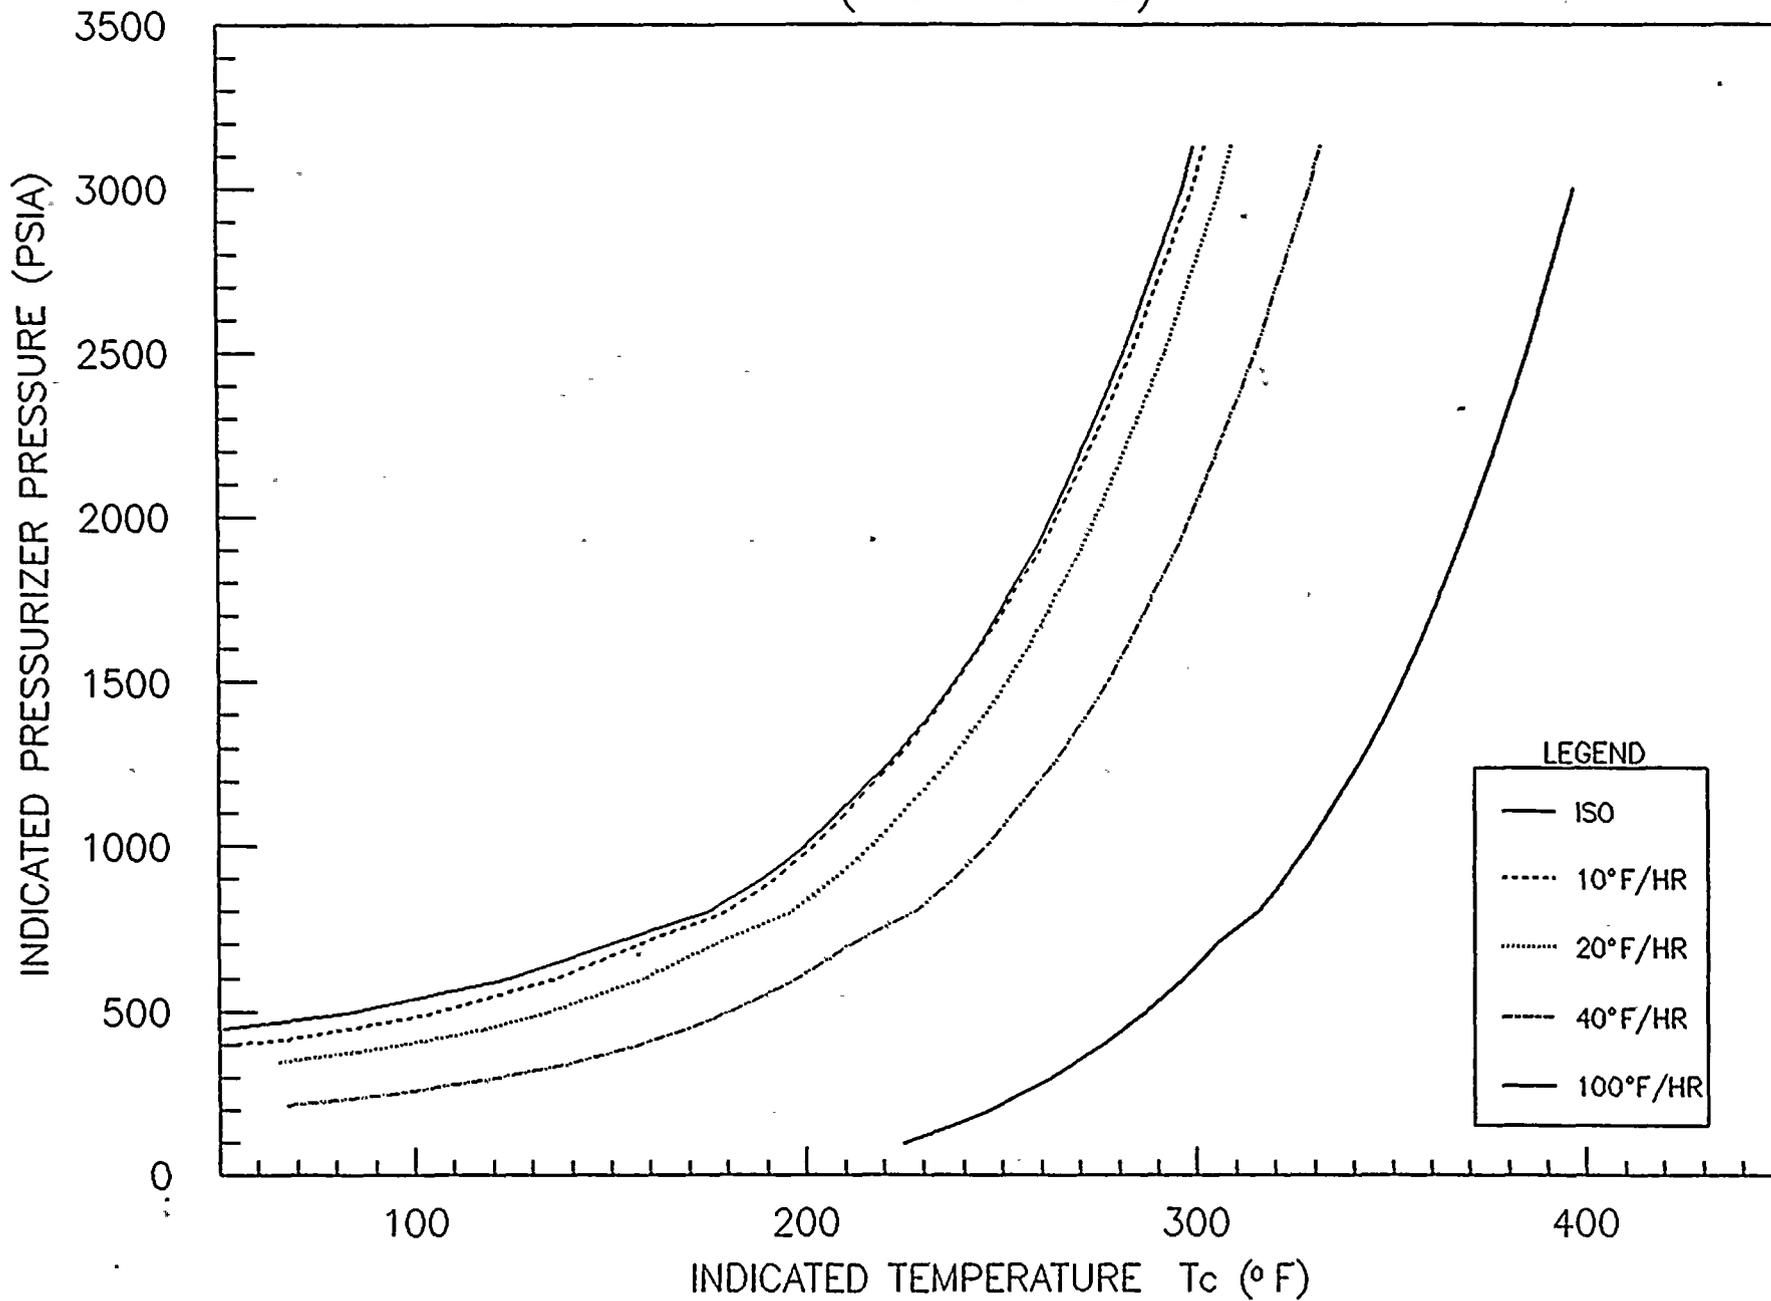
Figure 4

ANPP HEATUP P-T LIMITS (40 YEARS)

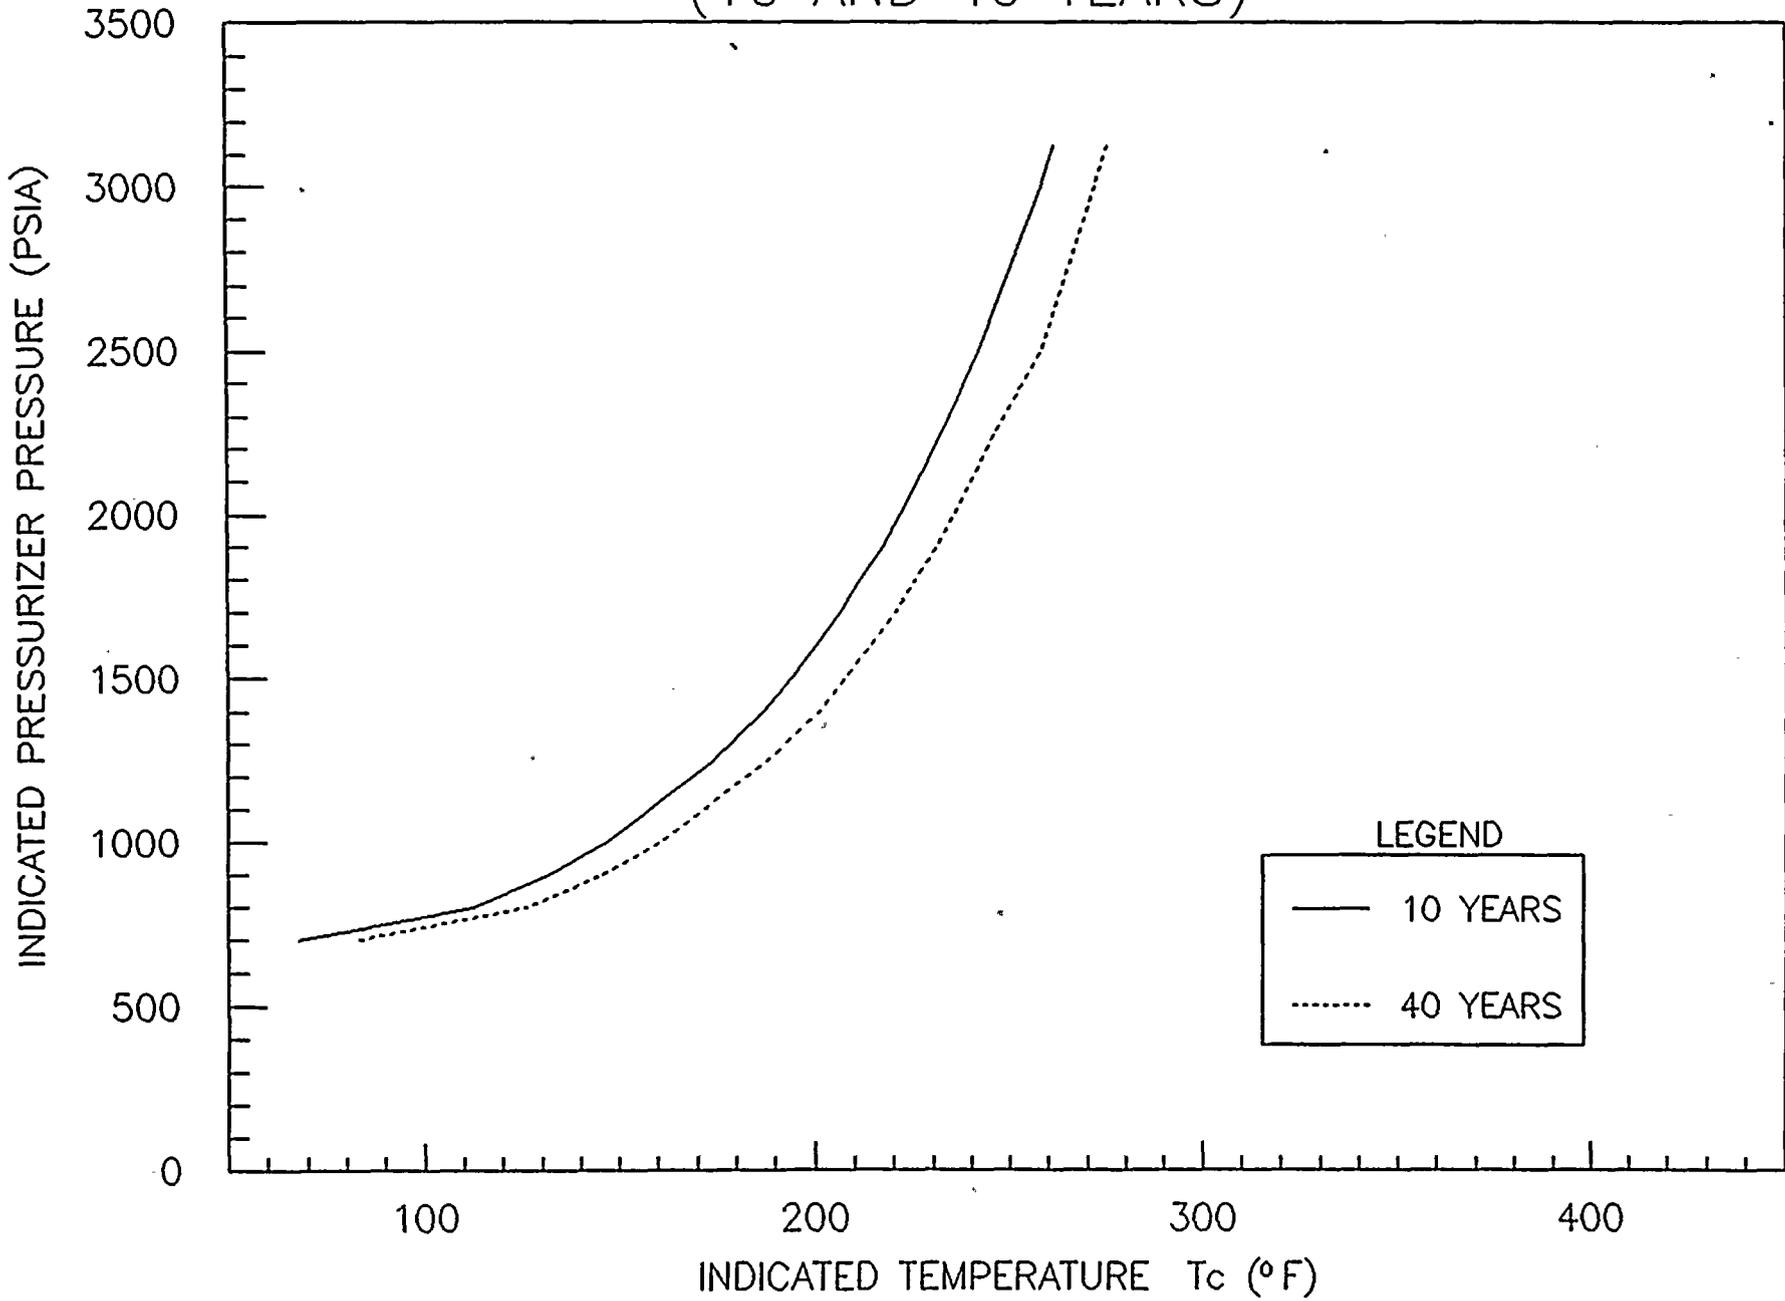
Figure 5

ANPP INSERVICE HYDRO LIMITS (10 AND 40 YEARS)

The inservice hydrostatic limits are provided in Tables 22 and 23 and in Figure 5.

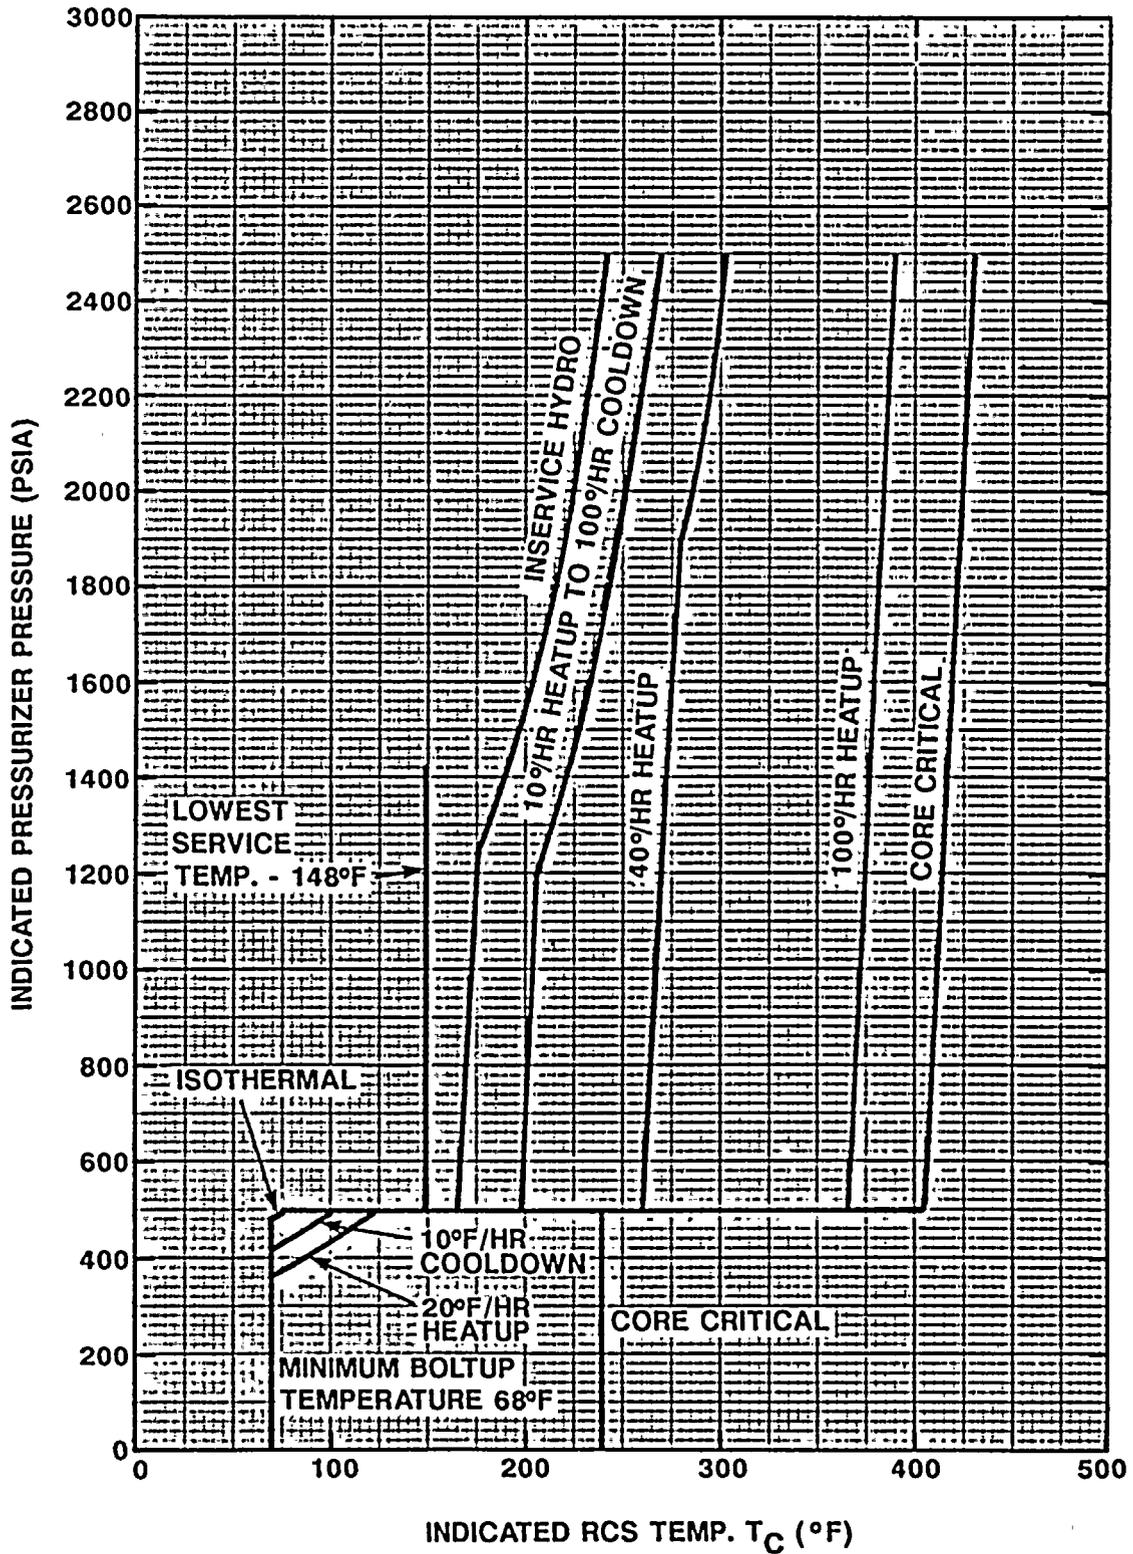
Figure 6

FIGURE 3.4-2a
REACTOR COOLANT SYSTEM PRESSURE/TEMPERATURE LIMITATIONS
FOR 0 TO 10 YEARS OF FULL POWER OPERATION

The composite RCS pressure-temperature limits provided in Figures 6 and 7 are developed based upon the RPV beltline and flange regions. The RPV primary coolant nozzles were found to be non-limiting. Examination of the composite RCS pressure-temperature limits generally illustrates that the flange region is controlling for the 100°F/hr heatup condition, while the flange and beltline regions are controlling for the inservice hydrostatic test, the 10°F/hr heatup to 100°F/hr cooldown limit and the 40°F/hr heatup limit. The isothermal, 10°F/hr cooldown, and the 20°F/hr heatup limits at the lowest temperatures are controlled by the RPV beltline region.

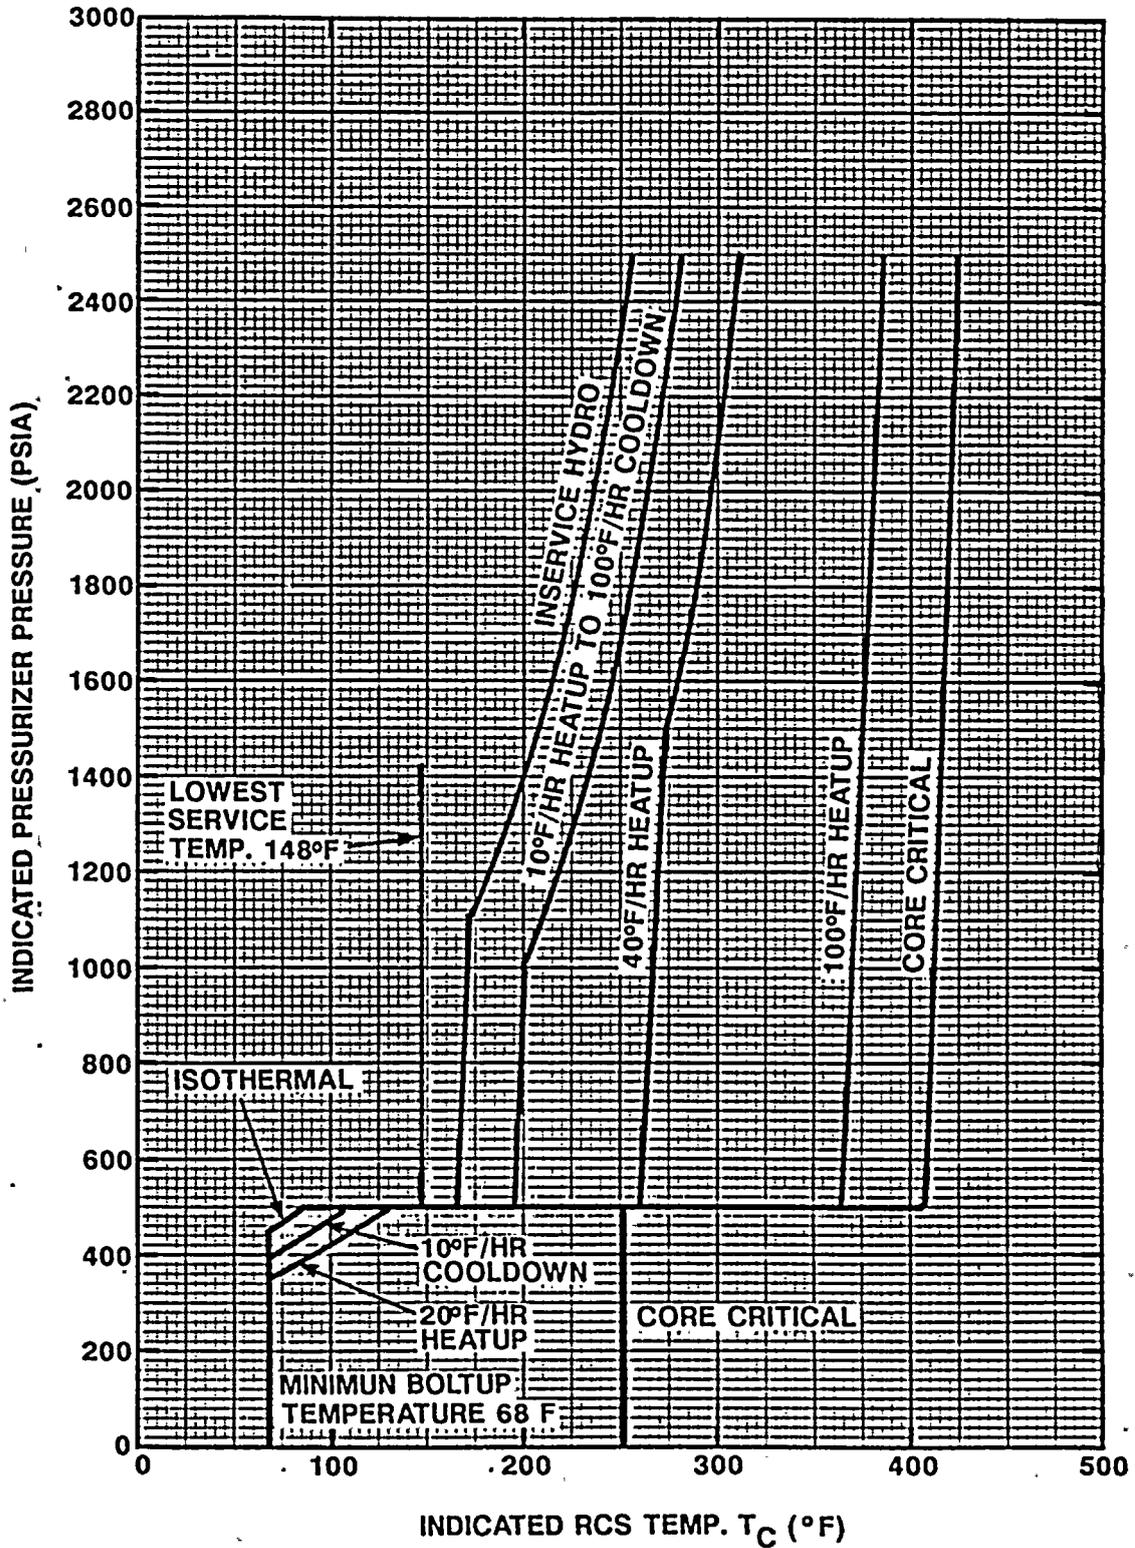
Figure 7

FIGURE 3.4-2b
REACTOR COOLANT SYSTEM PRESSURE/TEMPERATURE LIMITATIONS
FOR 10 TO 40 YEARS OF FULL POWER OPERATION
