AEOD ENGINEERING EVALUATION REPORT

UNIT: Sequoyah 1/2 and D. C. Cook 1/2  
DOCKET NO.: 327/328 and 315/316  
LICENSEE: TVA and Indiana and Michigan Electric  
NSSS/AE: Westinghouse/TVA and  
Westinghouse/AEPSC

SUBJECT: FROZEN ICE CONDENSER INTERMEDIATE DECK DOORS

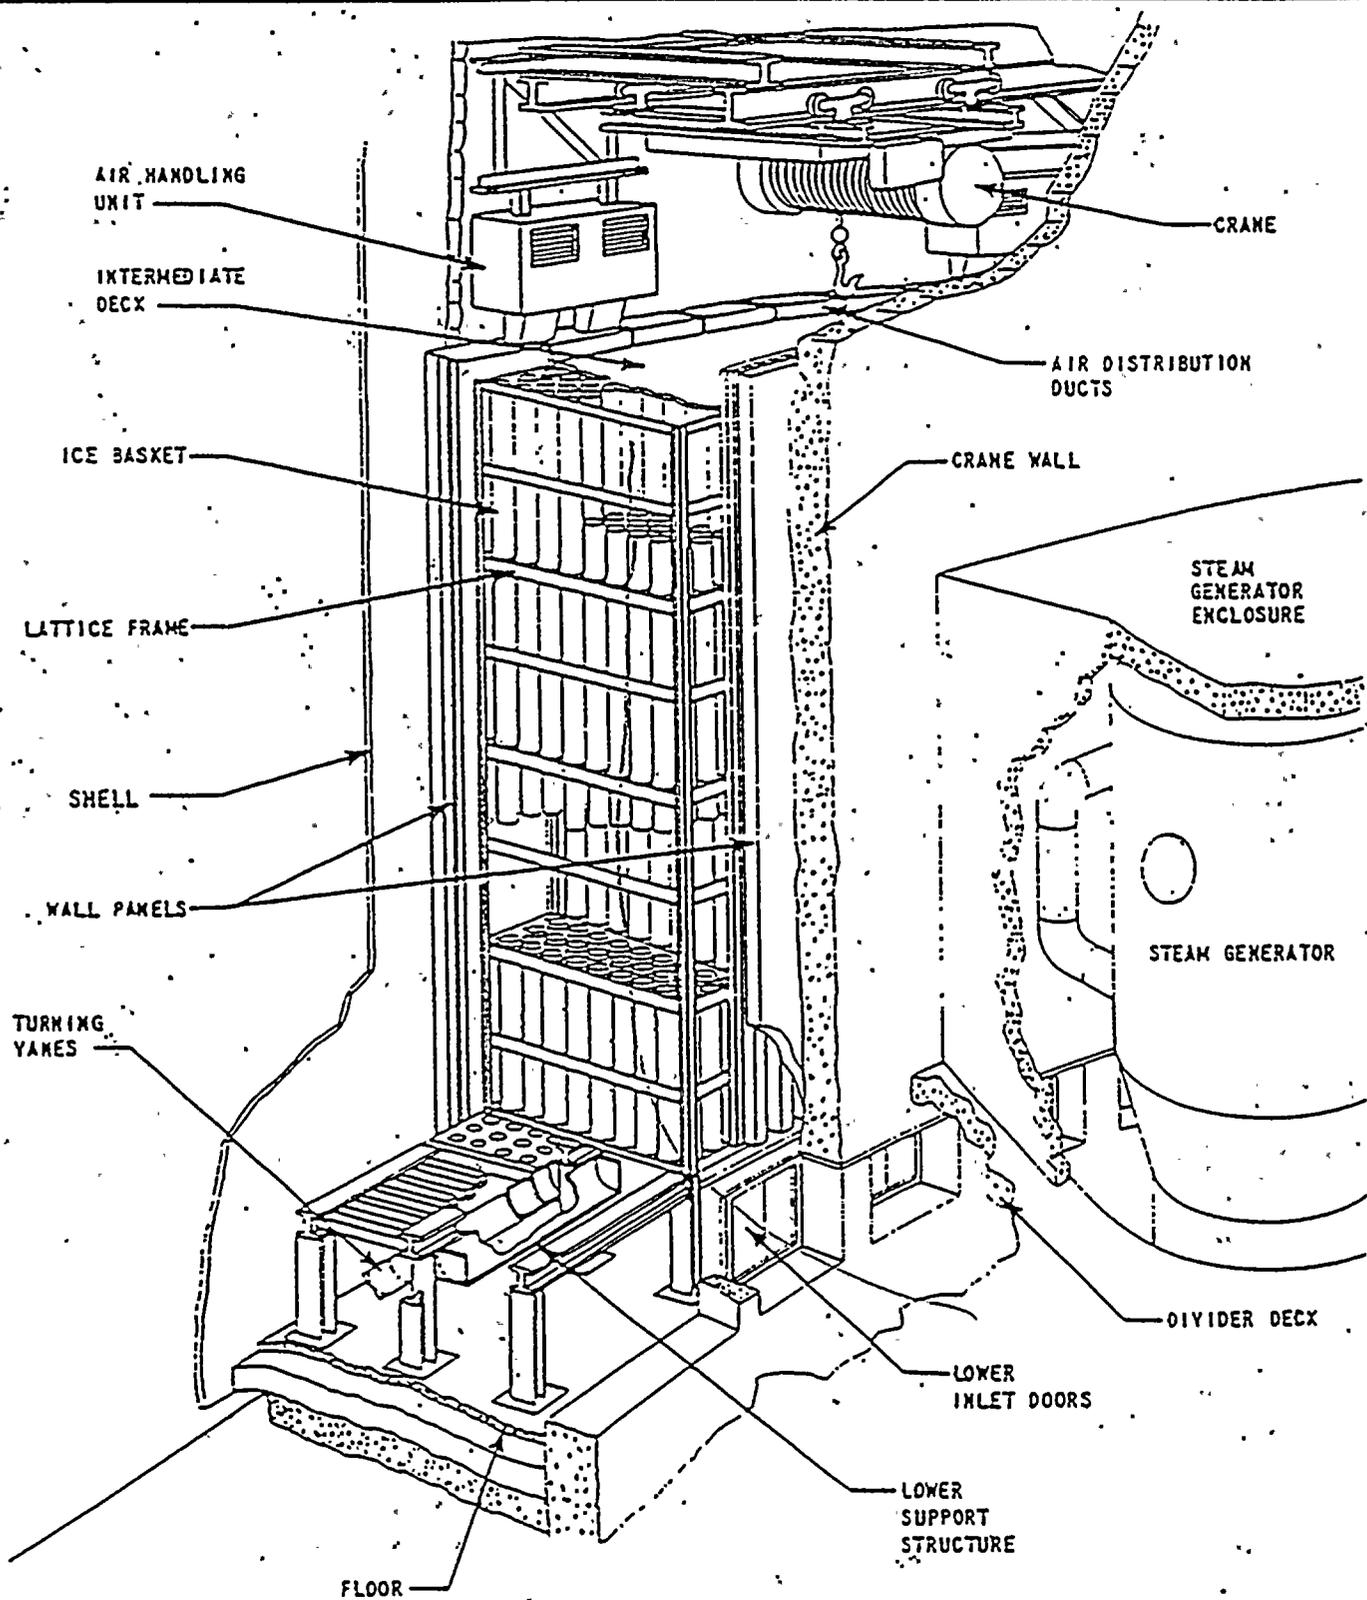
Figure 1 Isometric Of Ice Condenser

# Ice condenser

The Ice Condenser System is designed to be a totally passive system. It provides a means of absorbing the energy released to the containment following a Reactor Coolant System or steam pipe break. The ice condenses the steam thereby reducing the maximum containment pressure. An isometric of the ice condenser system is shown in Figure 1. When the pressure across the lower inlet doors exceeds 1 psfd, these doors open, directing steam up through the ice baskets and out through the intermediate deck doors, the top deck doors, and ultimately into the upper containment. The intermediate deck doors are immediately above the intermediate deck. The top deck doors are not shown on the figure.
