REGULATORY INFORMATION DISTRIBUTION SYSTEM (RIDS)

SUBJECT: Forwards addl info re reactor vessel fracture toughness, per NRC 880531 SER request.

Re: Turkey Point Units 3 and 4
Docket Nos. 50-250 and 50-251
Reactor Vessel Fracture Toughness
NRC Tac Nos. 68249 and 55042

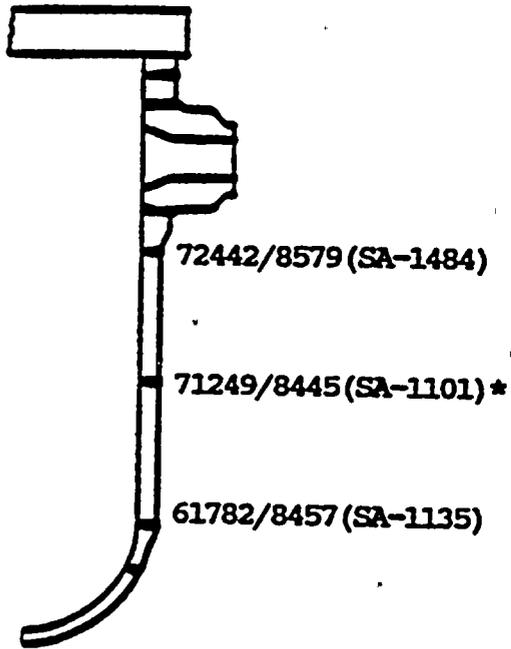
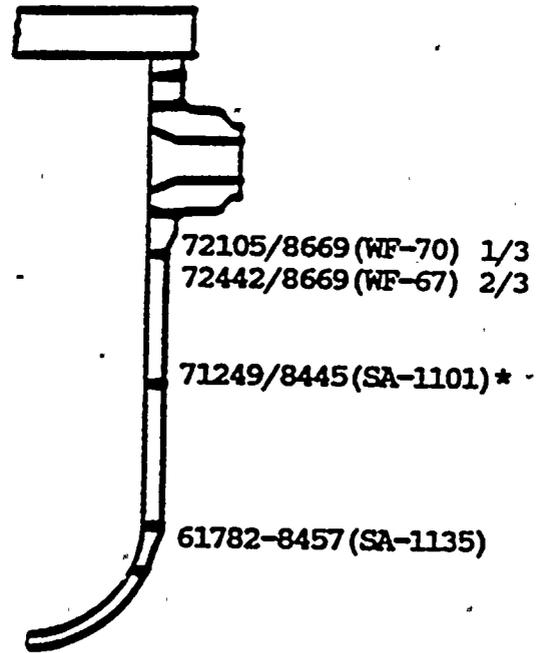
FIGURE 1

Turkey Point-3

Turkey Point-4

1. The analyses assumed a flaw in the weld 2 inches deep by 12 inches long oriented axially and radially. Turkey Point Units 3 and 4 only have circumferential welds. This is shown in Figure 1 which shows a schematic of both Turkey Point Units 3 and 4 reactor vessels with the welds identified. The critical weld in both vessels is the intermediate to lower shell weld No. SA-1101. There are no longitudinal welds since the shell courses are SA 508 Class 2 ring forgings. The most likely orientation for a fabrication induced weld flaw to occur would be in the circumferential direction. Locating the flaw in the axial and radial direction 2 inches deep and 12 inches long would, in reality, locate most of the crack in the forging material which has much better irradiated properties. The assumed crack location and material properties used are equivalent to assuming a longitudinal weld which has twice the applied load due to hoop stresses acting on it. This is a very conservative approach and similar to adding a safety factor of 2.
