SUBJECT: Forwards addl info re NUREG-0737, Item III.D.3.4, "Control Room Habitability Requirements," per 830106 request. Design changes made & justification provided for unsubstantial backfit items, per 830307 ltr.

Re: Turkey Point Units 3 & 4
Docket Nos. 50-250 & 50-251
Post TMI Requirements
Control Room Habitability
NUREG-0737 Item III.D.3.4

Re: Turkey Point Units 3 & 4
Post TMI Requirements
Control Room Habitability
NUREG-0737 Item III.D.3.4

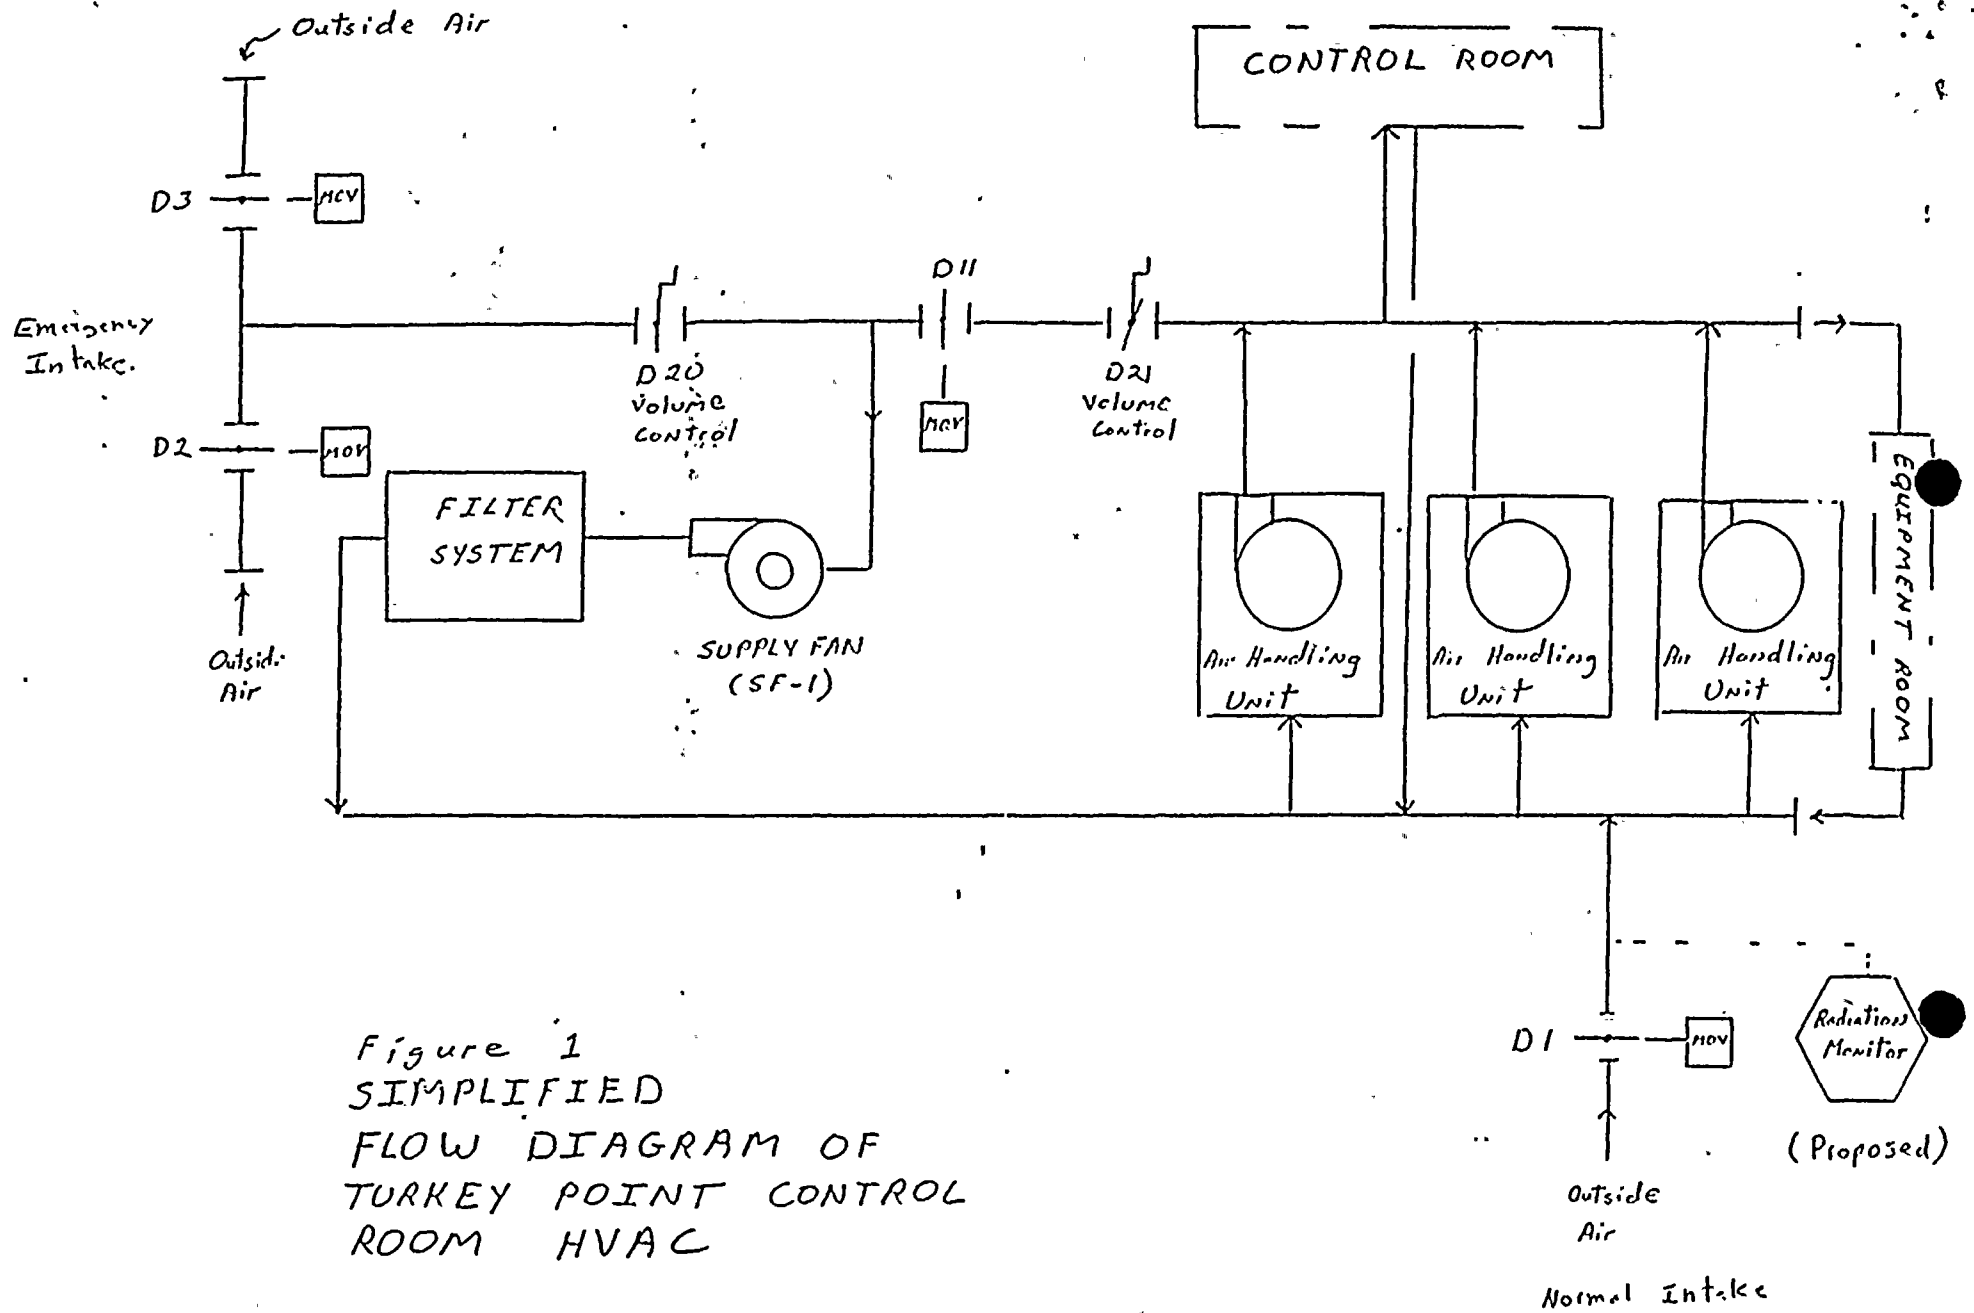
Figure 1
SIMPLIFIED
FLOW DIAGRAM OF
TURKEY POINT CONTROL
ROOM HVAC

Ref: Dwg. 5177-181-M-1 Rev 4

Damper D-20 is a fixed position, volume control damper that performs no active function once it is positioned during initial HVAC balance. In order to maintain operator exposures below the requirements of GDC-19 this damper is adjusted to provide a predetermined filtered emergency air intake following an accident. It does not serve an isolation function since filtered intake is provided to remain within the dose limits of GDC-19. On an isolation signal dampers D-2 and D-3 open to provide emergency intake air and thus D-20 is not needed as a redundant isolation damper. See Figure 1.

This statement implies a misunderstanding of the operation of the control room HVAC system. The following is a description of the operation of this equipment. (See Figure 1 for details).
