SUBJECT: SUMMARY OF PUBLIC WORKSHOPS TO DISCUSS GENERIC LETTER 95-07,
"PRESSURE LOCKING AND THERMAL BINDING OF SAFETY-RELATED
POWER-OPERATED GATE VALVES"

**NRR MANAGEMENT PERSPECTIVE ON
PRESSURE LOCKING AND THERMAL BINDING**

RECENT
PRESSURE LOCKING AND THERMAL BINDING
EXPERIENCE AND ANALYSES

**PRESSURE LOCKING AND THERMAL BINDING
PROGRAM AT WNP-2**

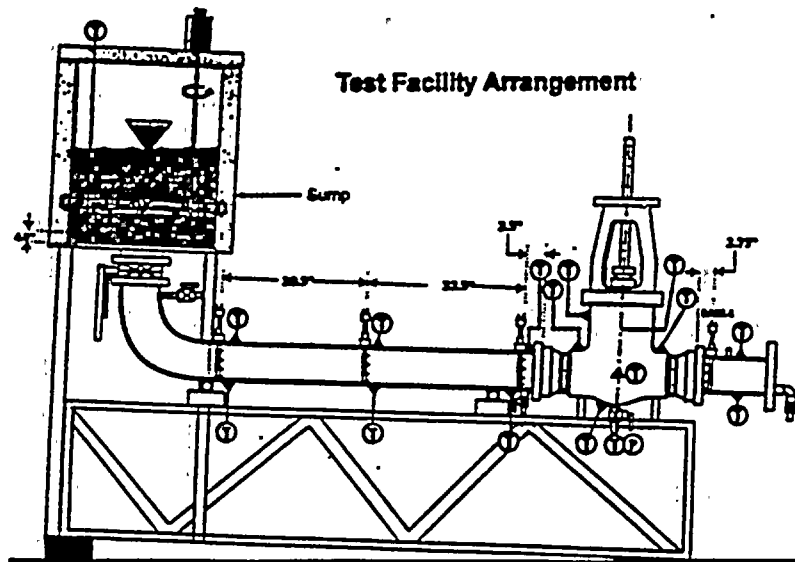
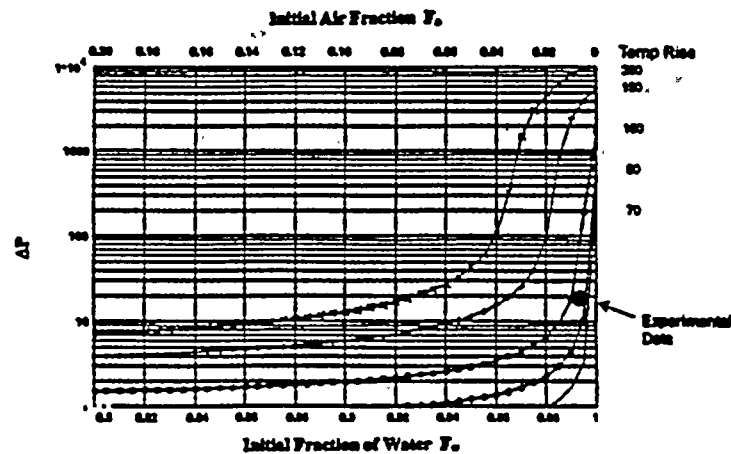
Fig. 1: Millstone 2
1/4 Scale Tests at Creare

- Creare Inc. testing of MP2 Sump Recirculation Valves (see Fig. 1)
- Small Quantities of Air Mitigates PL
- Figure 1 shows Situational Nature

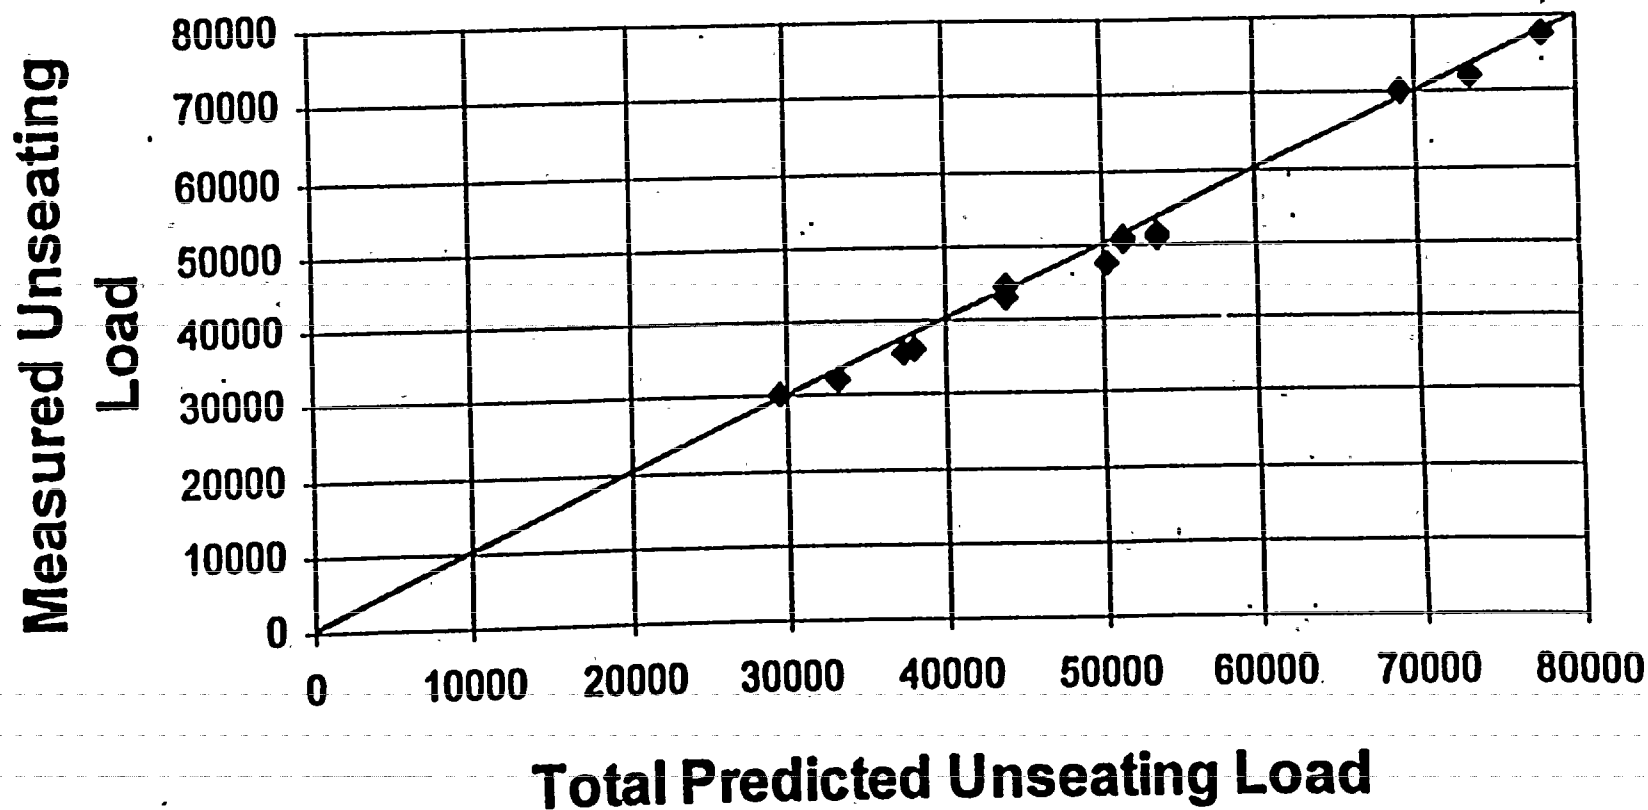
Predicted Unseating Thrust Versus Measured Pressure Locking Unseating Force for Crane Valve

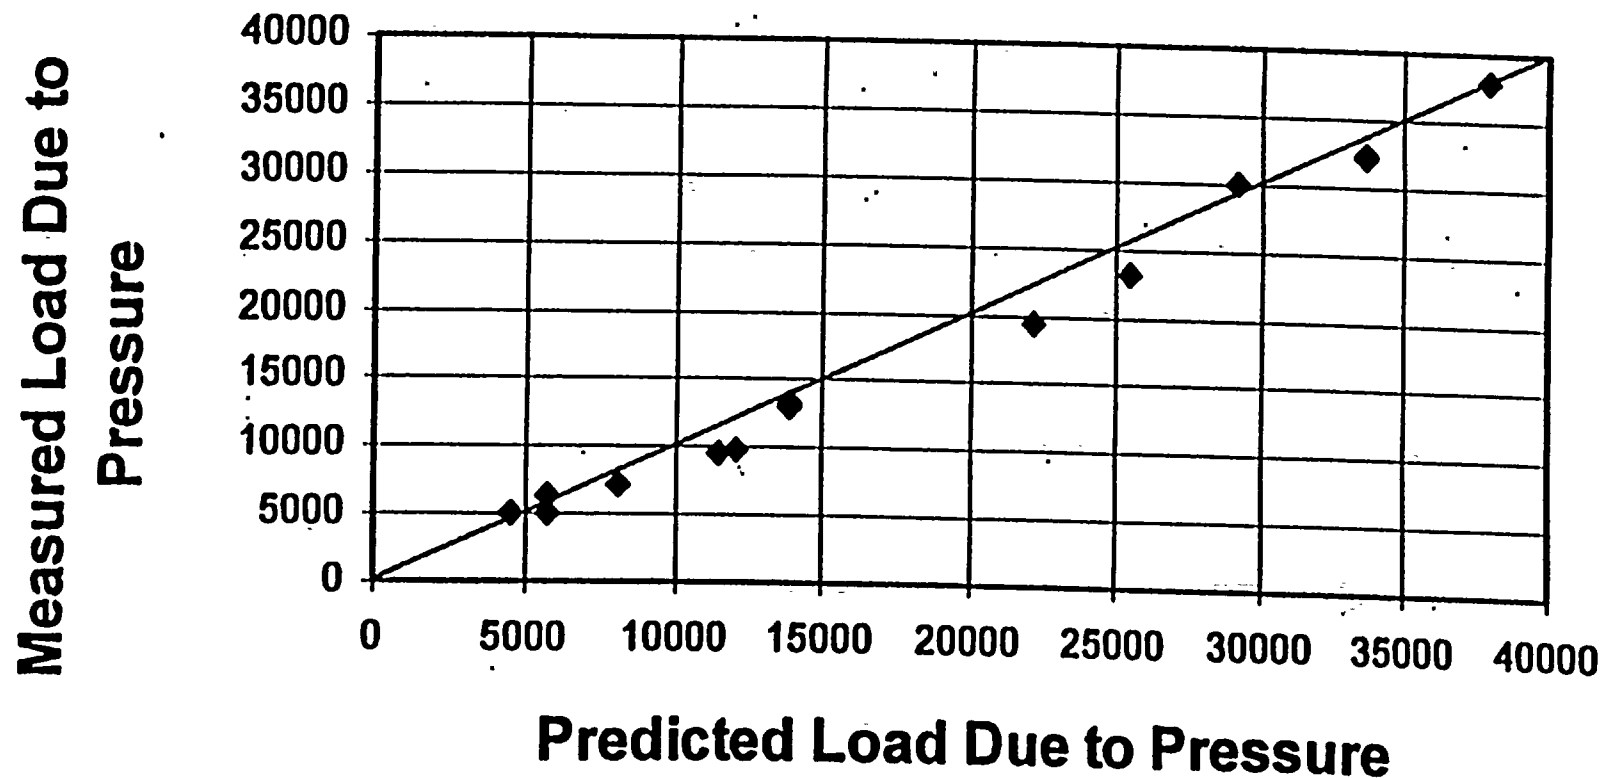
Predicted Versus Measured Portion of Pressure Thrust Due to Pressure Forces for Crane Valve

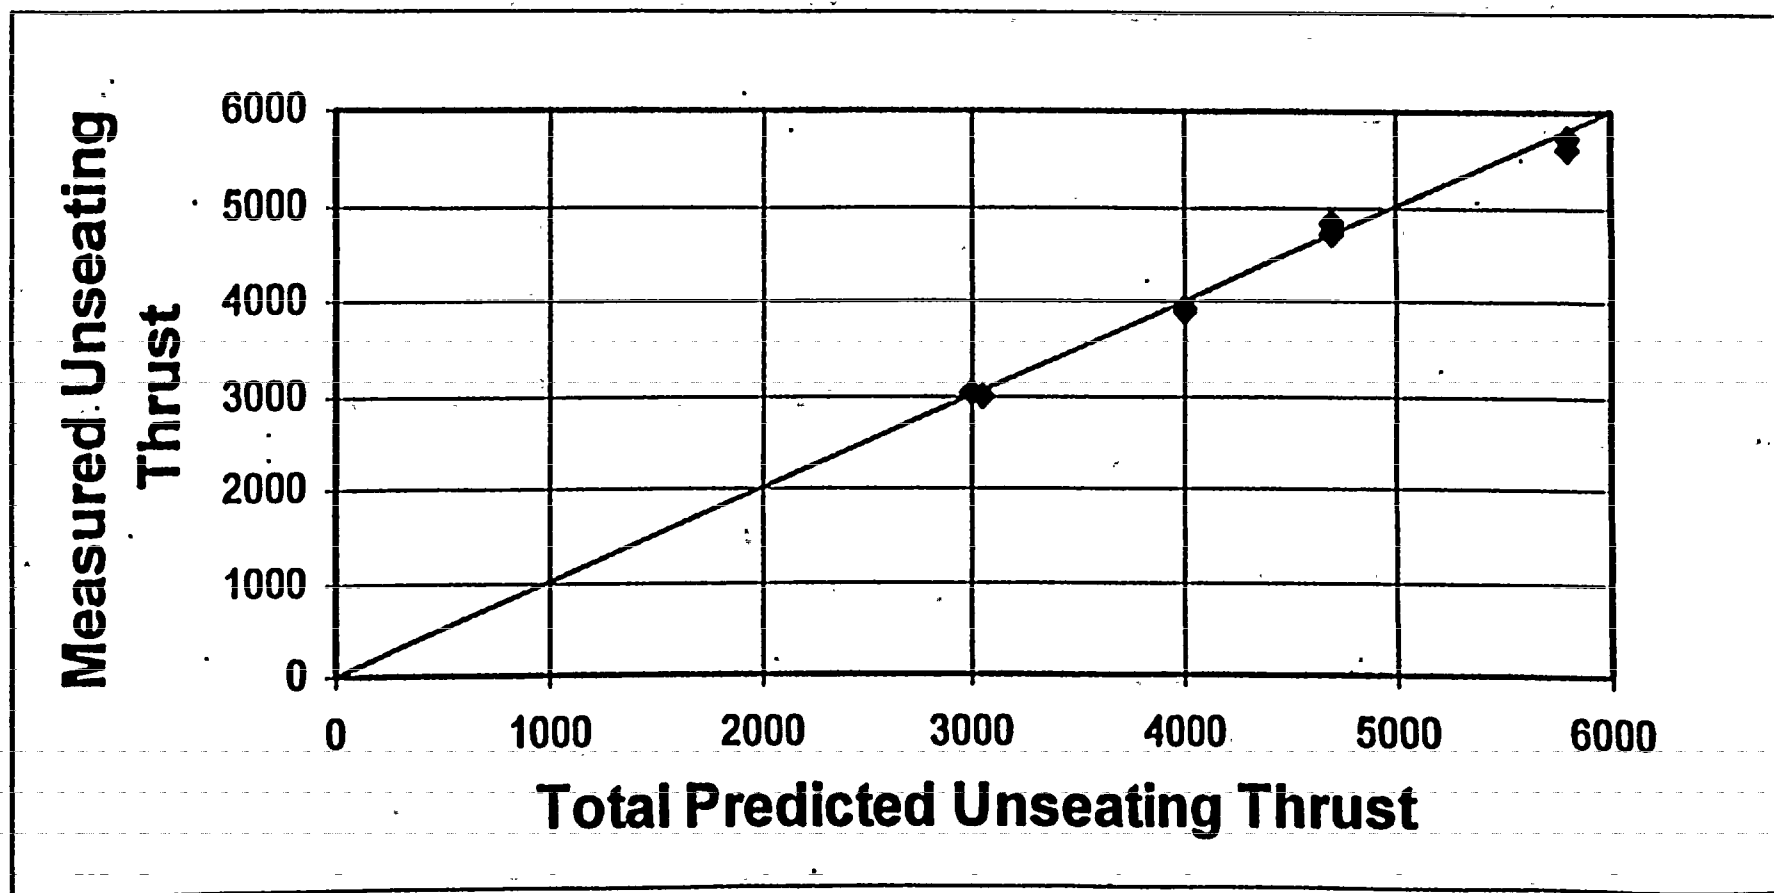
Predicted Unseating Thrust Versus Measured Pressure Locking Unseating Thrust for Westinghouse Valve

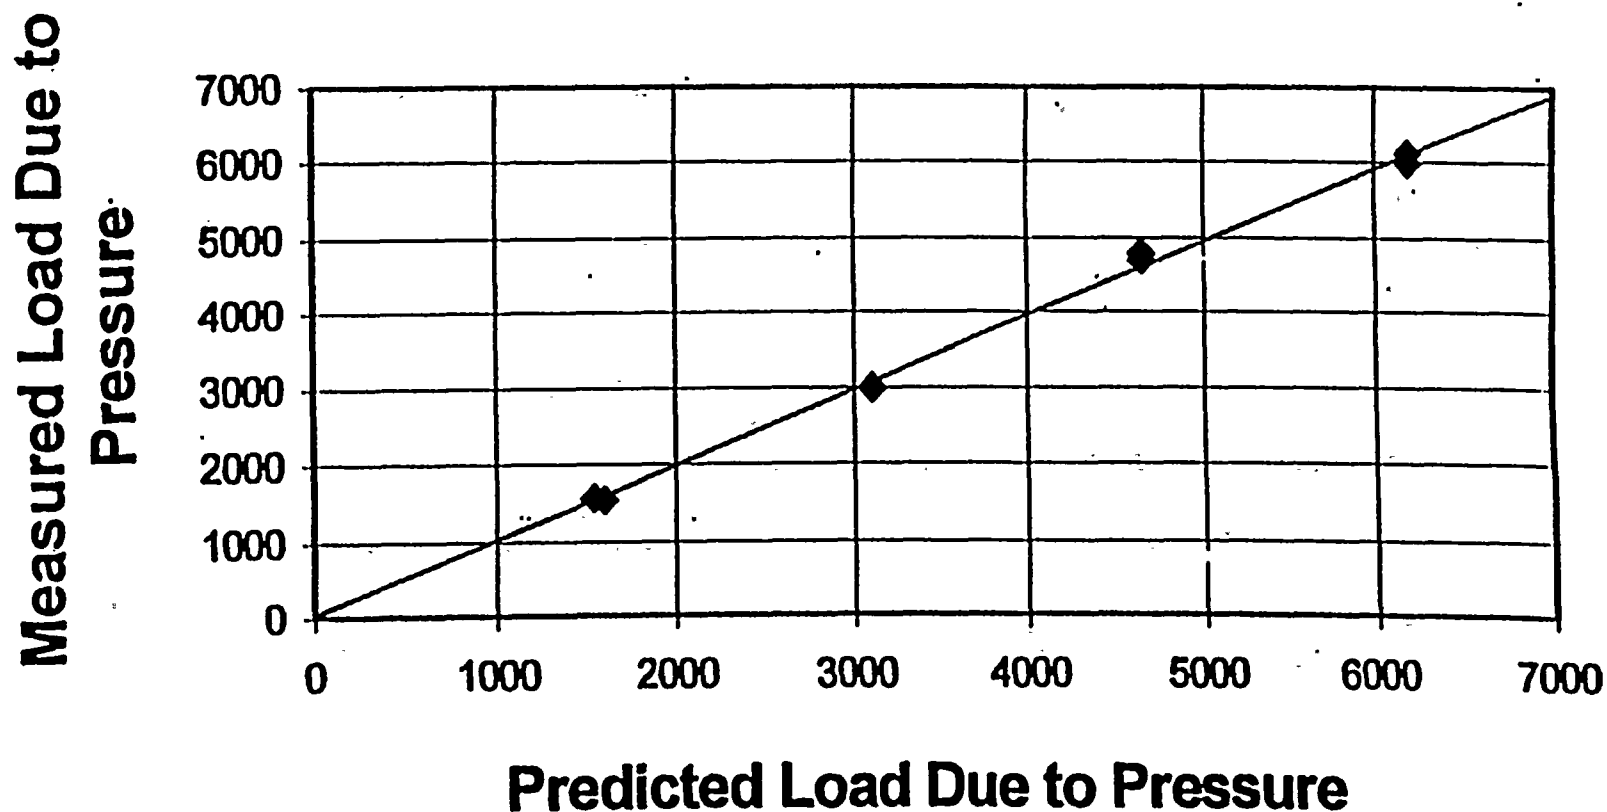
Predicted Versus Measured Portion of Unseating Thrust Due to Pressure Forces for Westinghouse Valve

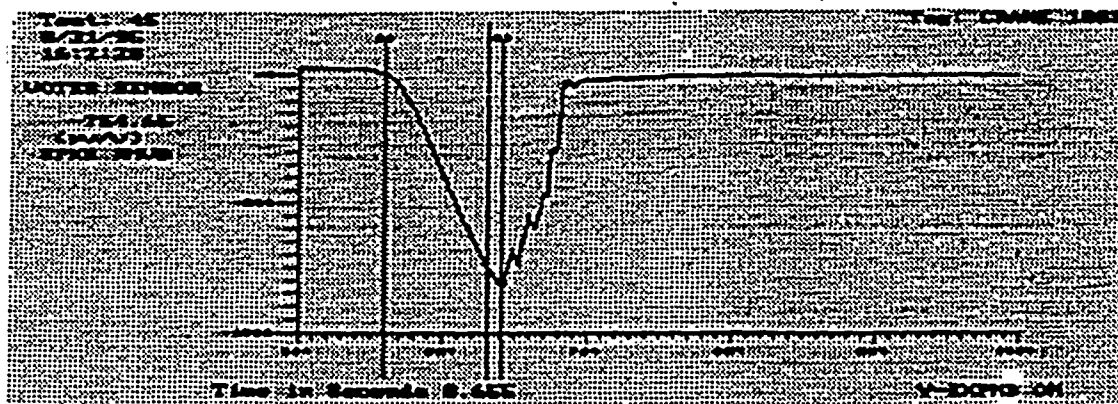
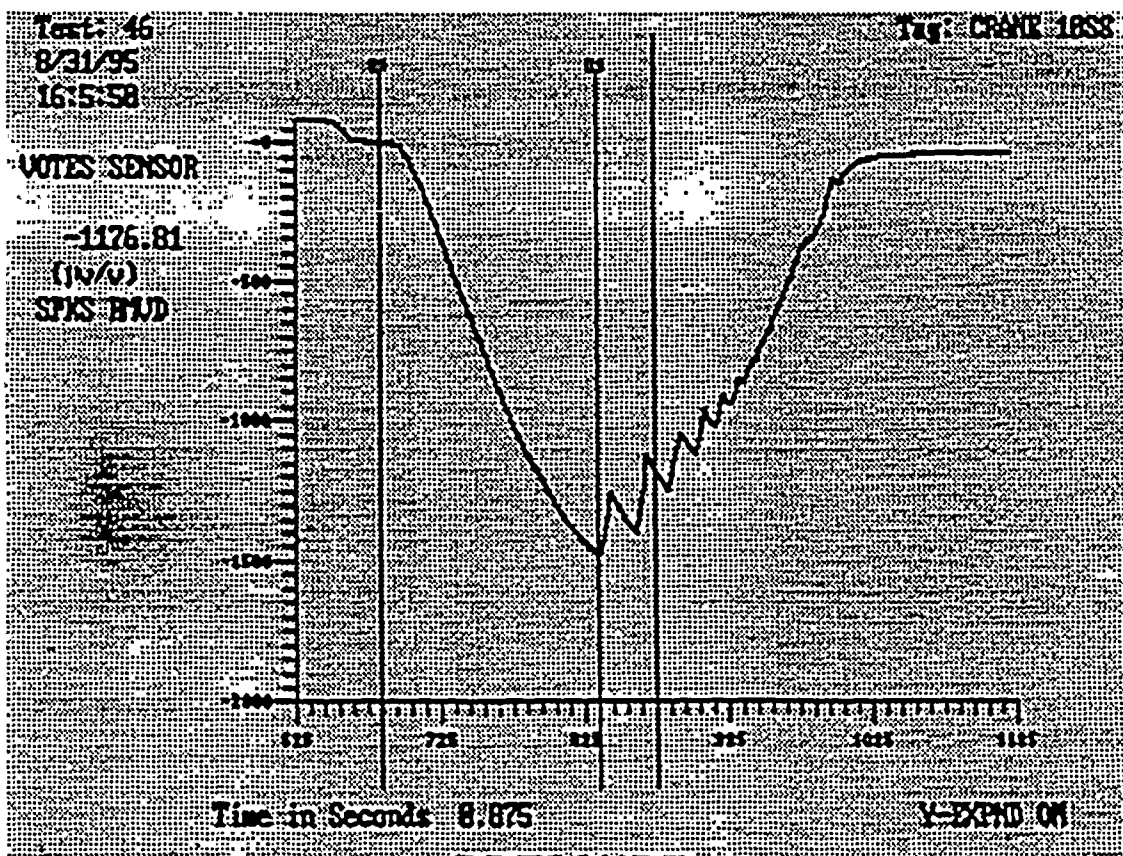
Comparison of Static Unseating to Pressure Locking Unseating Thrust for 10" Crane 900# Class Valve

STATIC TEST

PRESSURE
LOCKING TEST

$$1 \text{ mV/V} \approx 50 \text{ lbf}$$

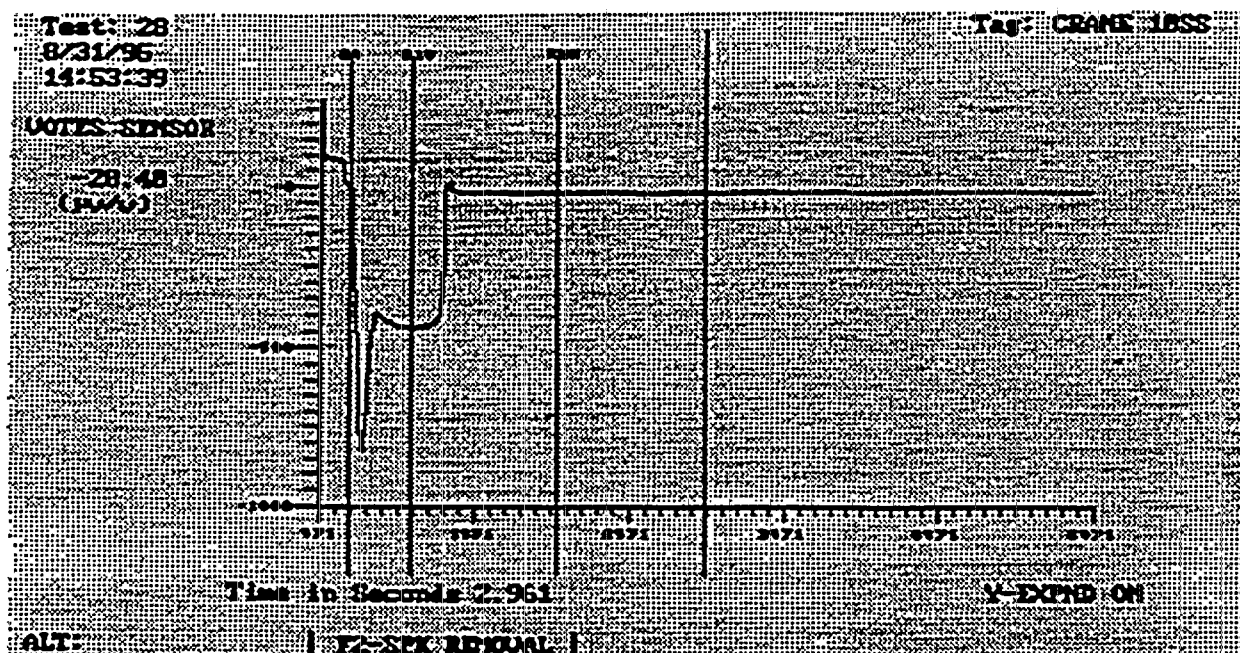
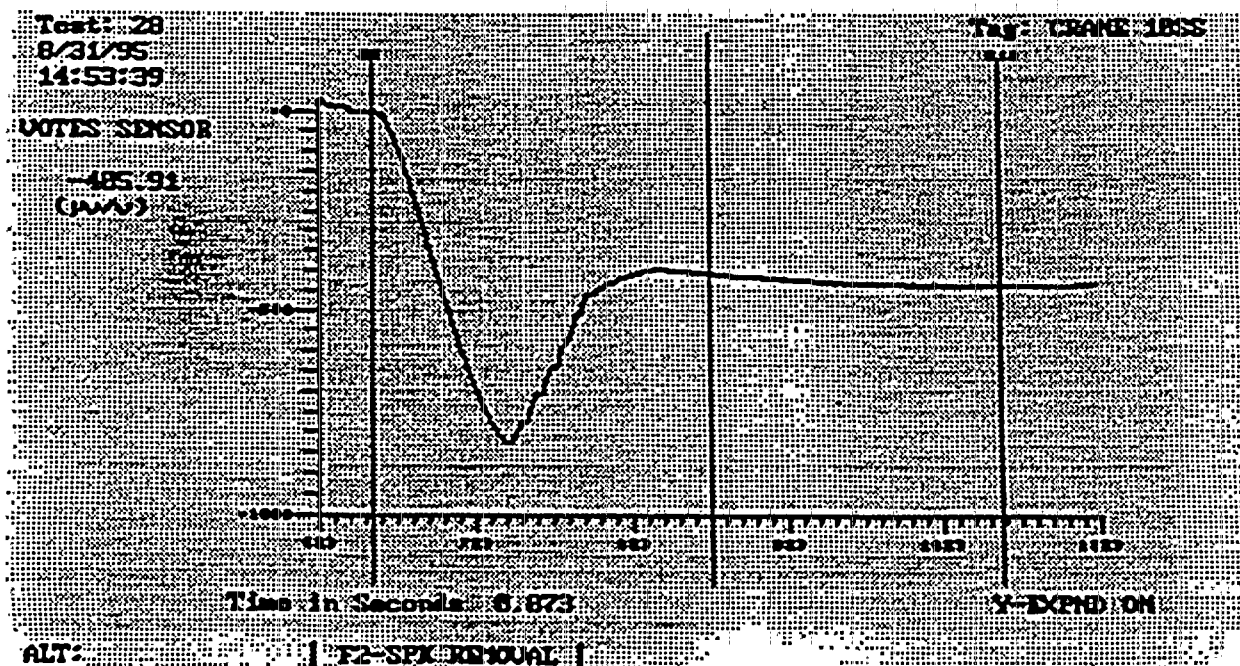
Example of Hydro-Pump DP Test for Determining Seat Friction Coefficient (10" Crane 900# Class Valve)

5 SECOND ZOOM

HALF SECOND ZOOM

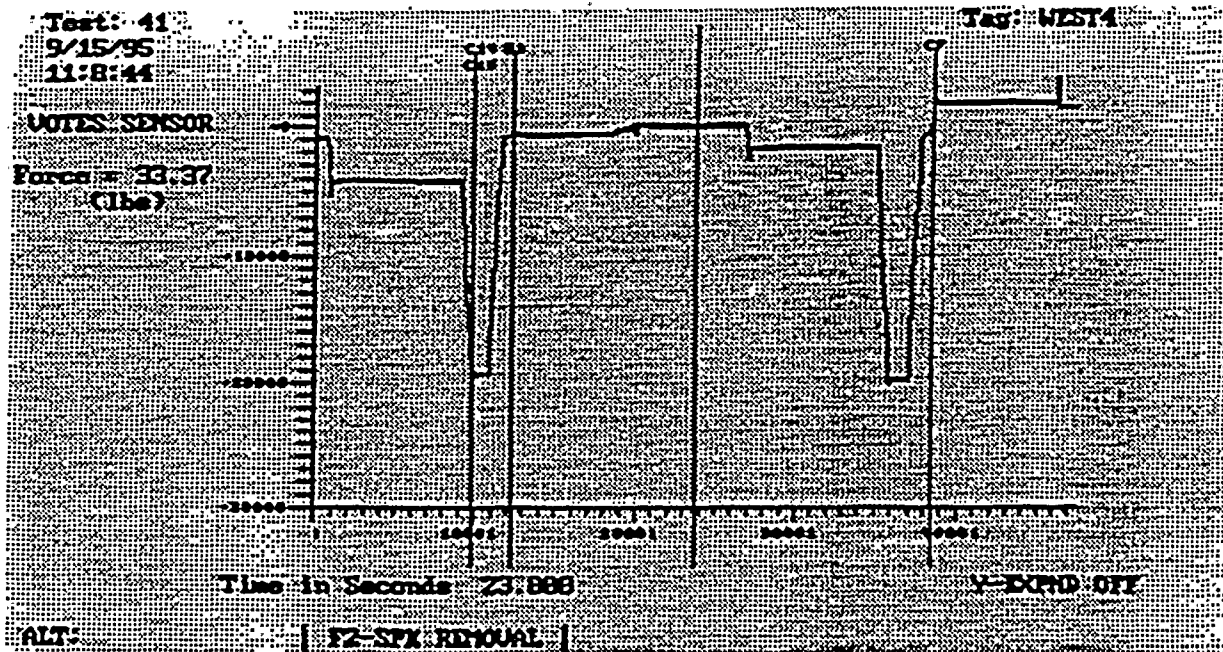
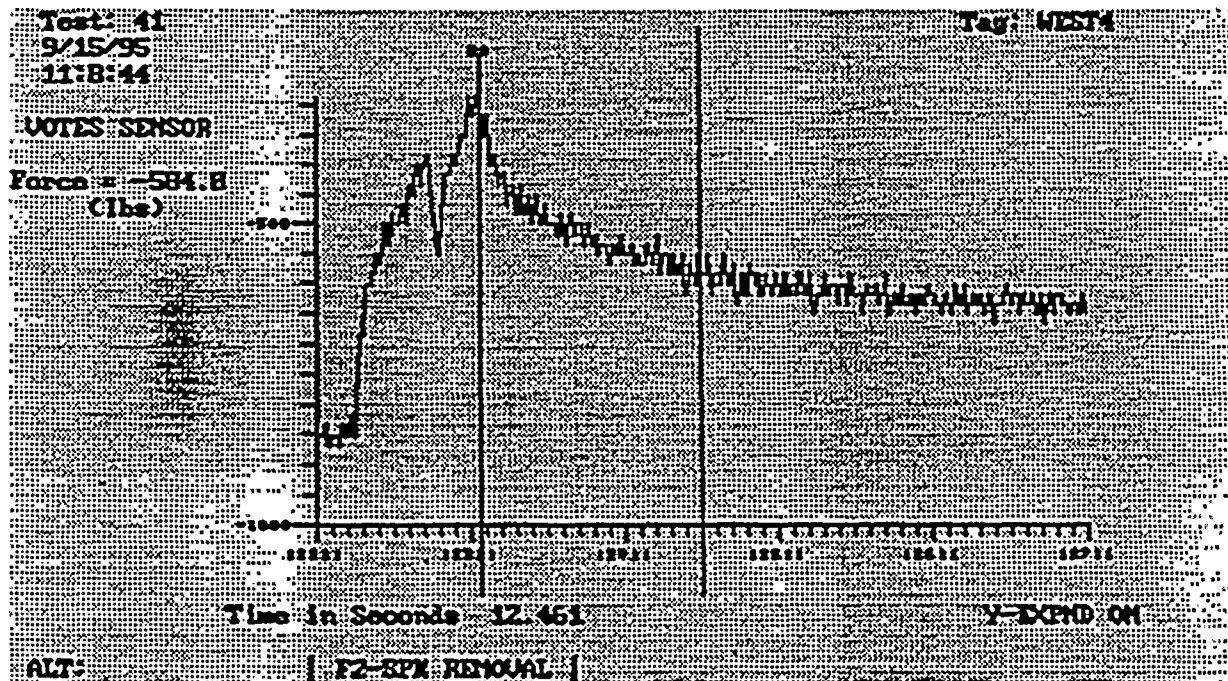
Static Test for 4" Westinghouse 1500# Class Gate Valve

FULL VIEW OF TRACE

HALF SECOND VIEW OF TRACE

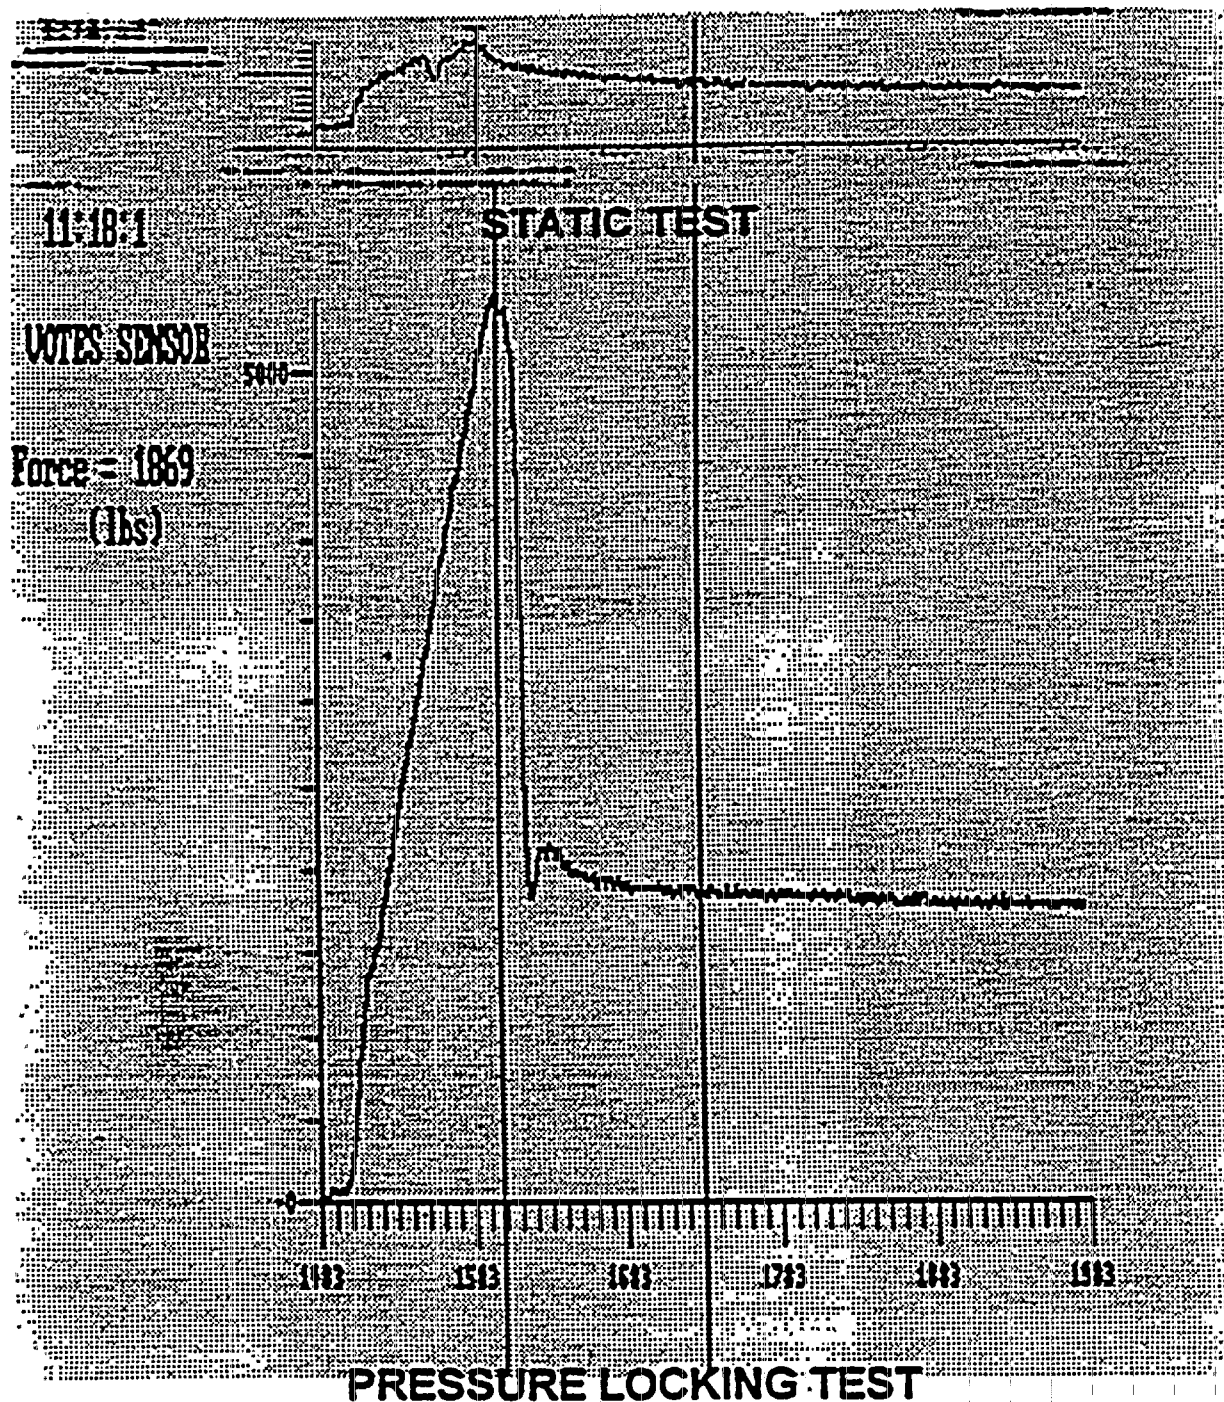
Comparison of Static Unseating to Pressure Locking Unseating Thrust for 4" Westinghouse 1500# Class Valve

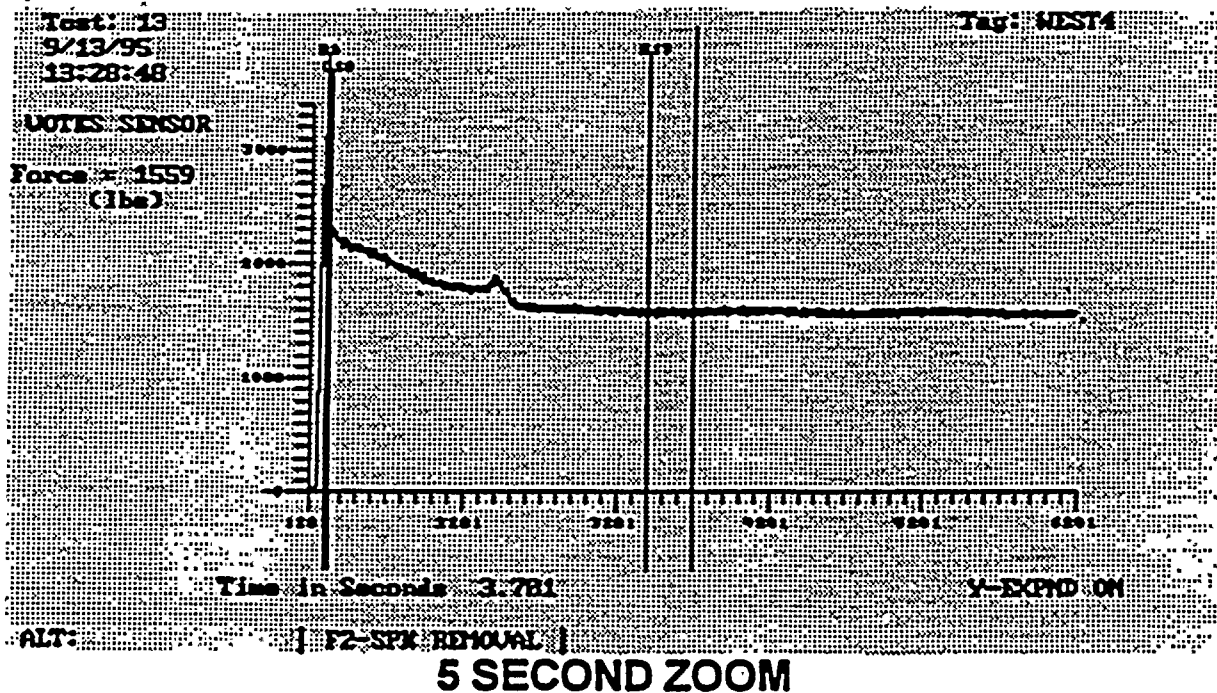
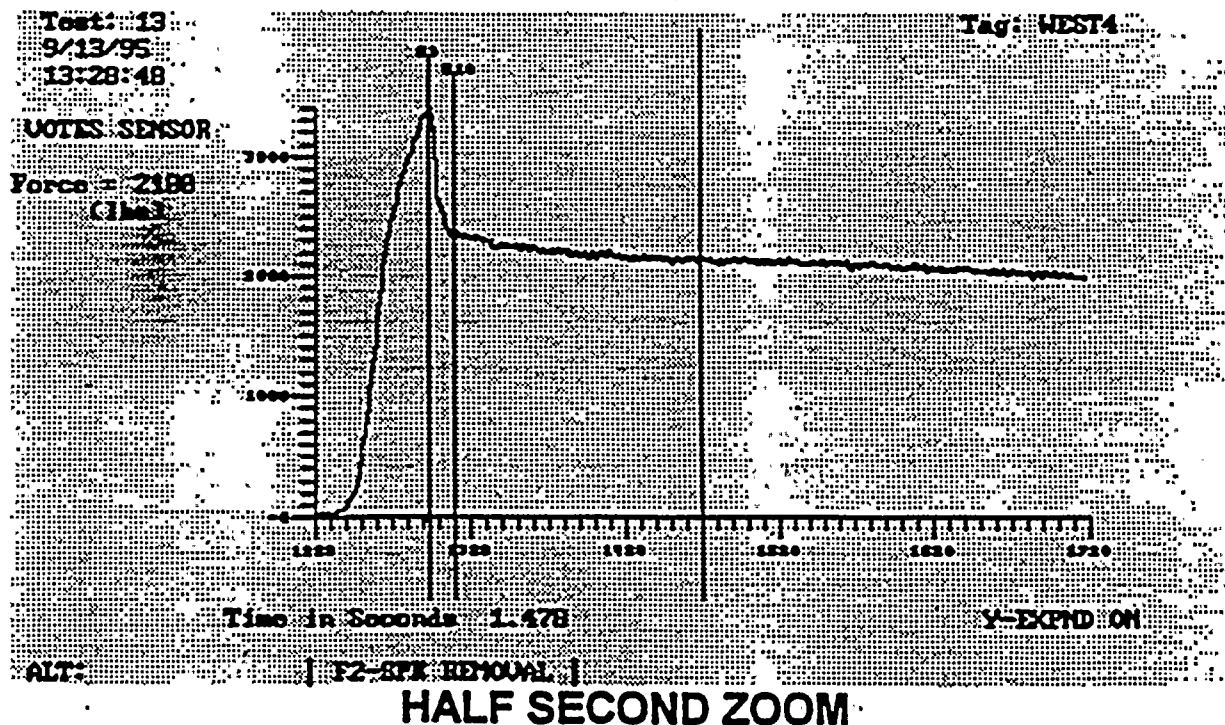
Example of Hydro-Pump DP Test for Determining Seat Friction Coefficient (4" Westinghouse 1500# Gate Valve)

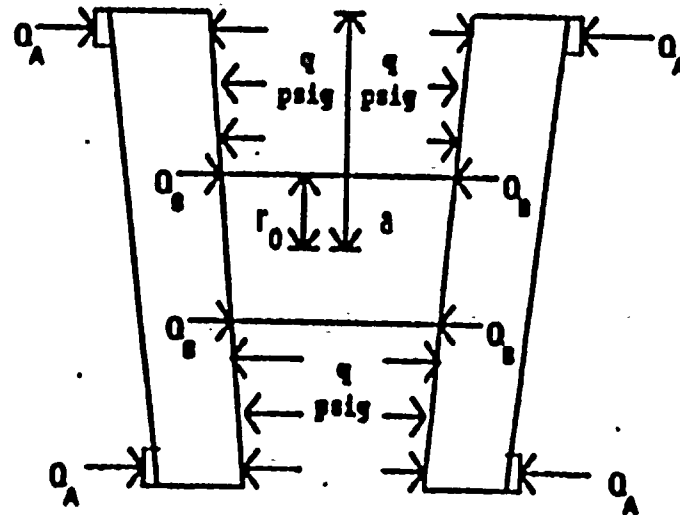
Pressure Locking Force

- Determine the force exerted on the seat ring by the disc due to internal pressure using Roark, Table 24, Case 2d.

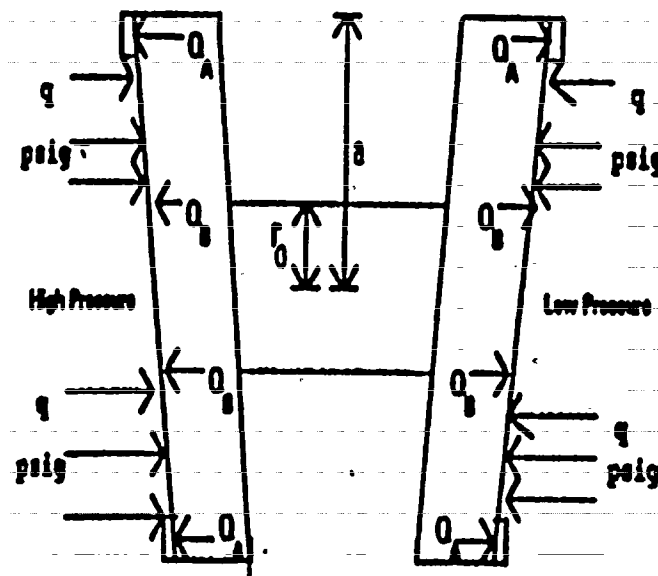
- Determine forces exerted by external pressures on the high and low pressure sides using Case 2d and 1b.

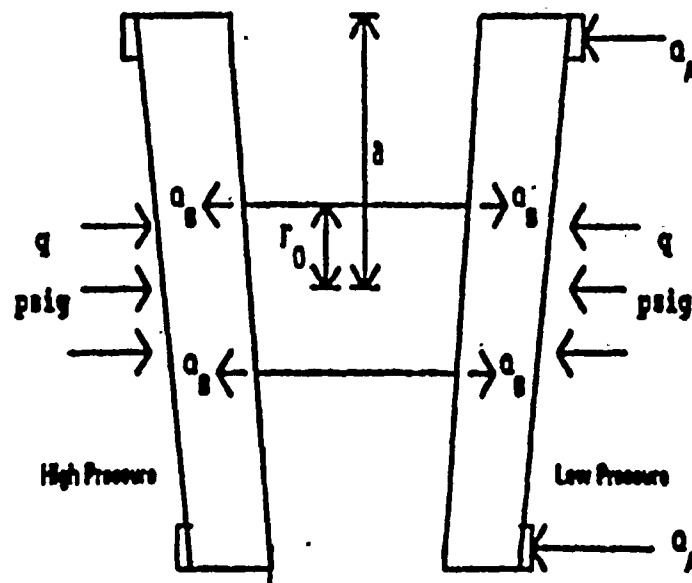
- Case 1b for increased force on the low pressure disc due to hub area that was left out of Case 2d equations.

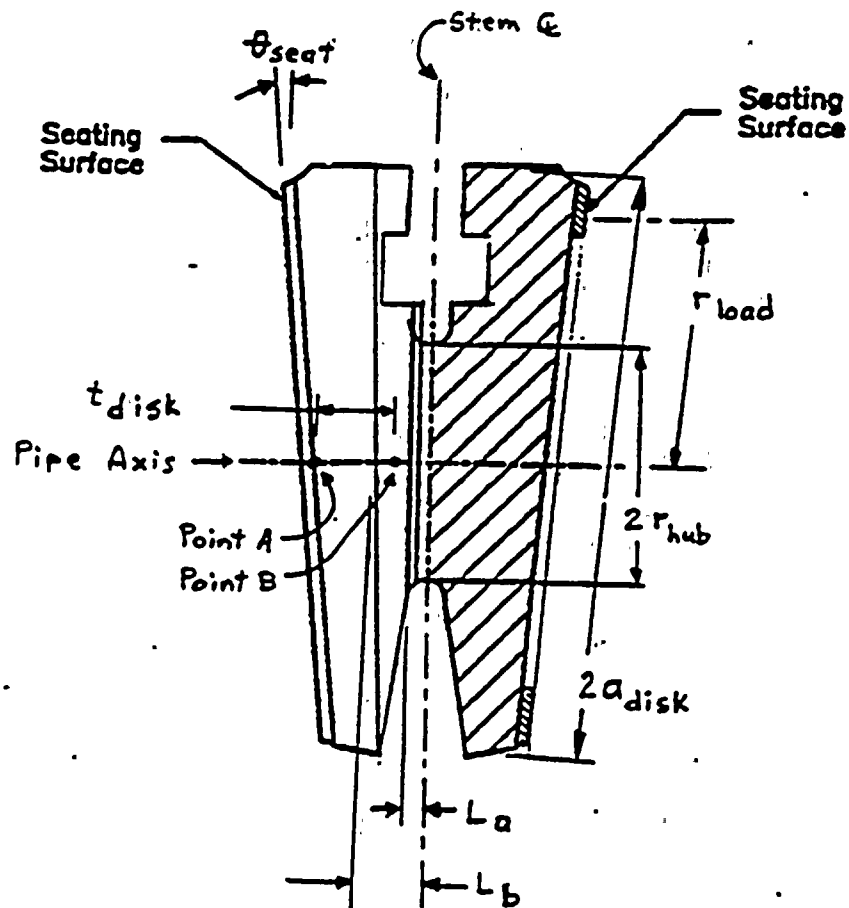
FIGURE 1

DIMENSIONS FOR FLEXIBLE WEDGE GATE VALVES

Figures 1 through 3 provide illustrations of the dimensions which may be appropriate for the model described above. Note the following derived dimensions:

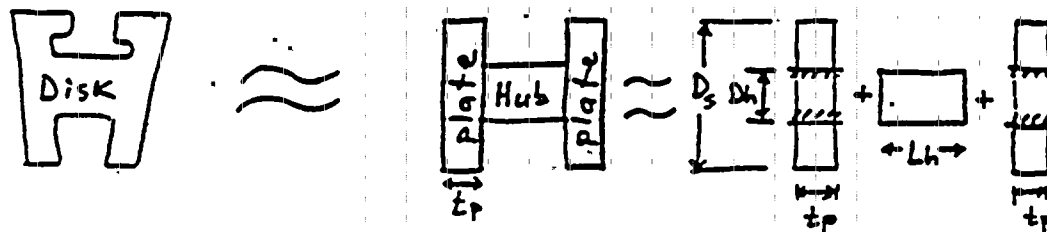
Model disk as solid circular hub with solid flat plate ends with uniform flange thickness.

Model disk flexure by assuming the plate ends are fixed at the hub diameter D_h and free at the mean seat radius D_s :

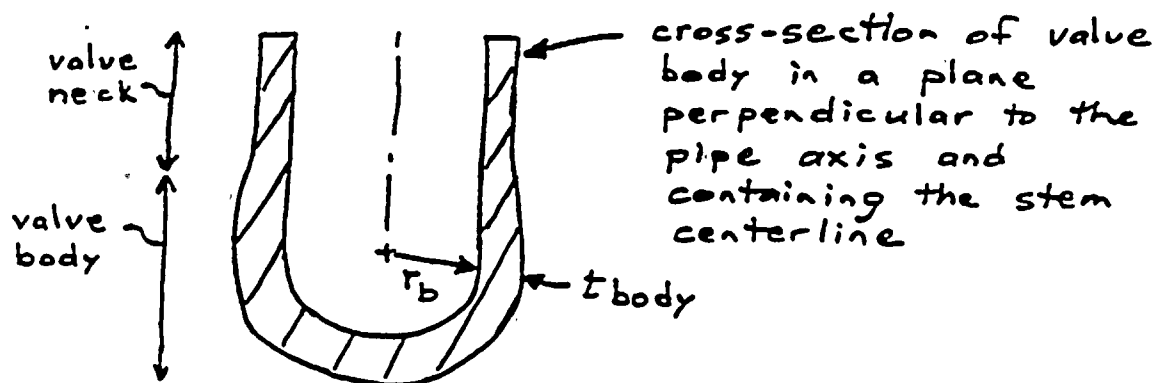
Figure 3

r_b = typical inside radius of valve body in the cross-section illustrated above.

t_{body} = typical valve body as-built wall thickness in the cross-section illustrated above.

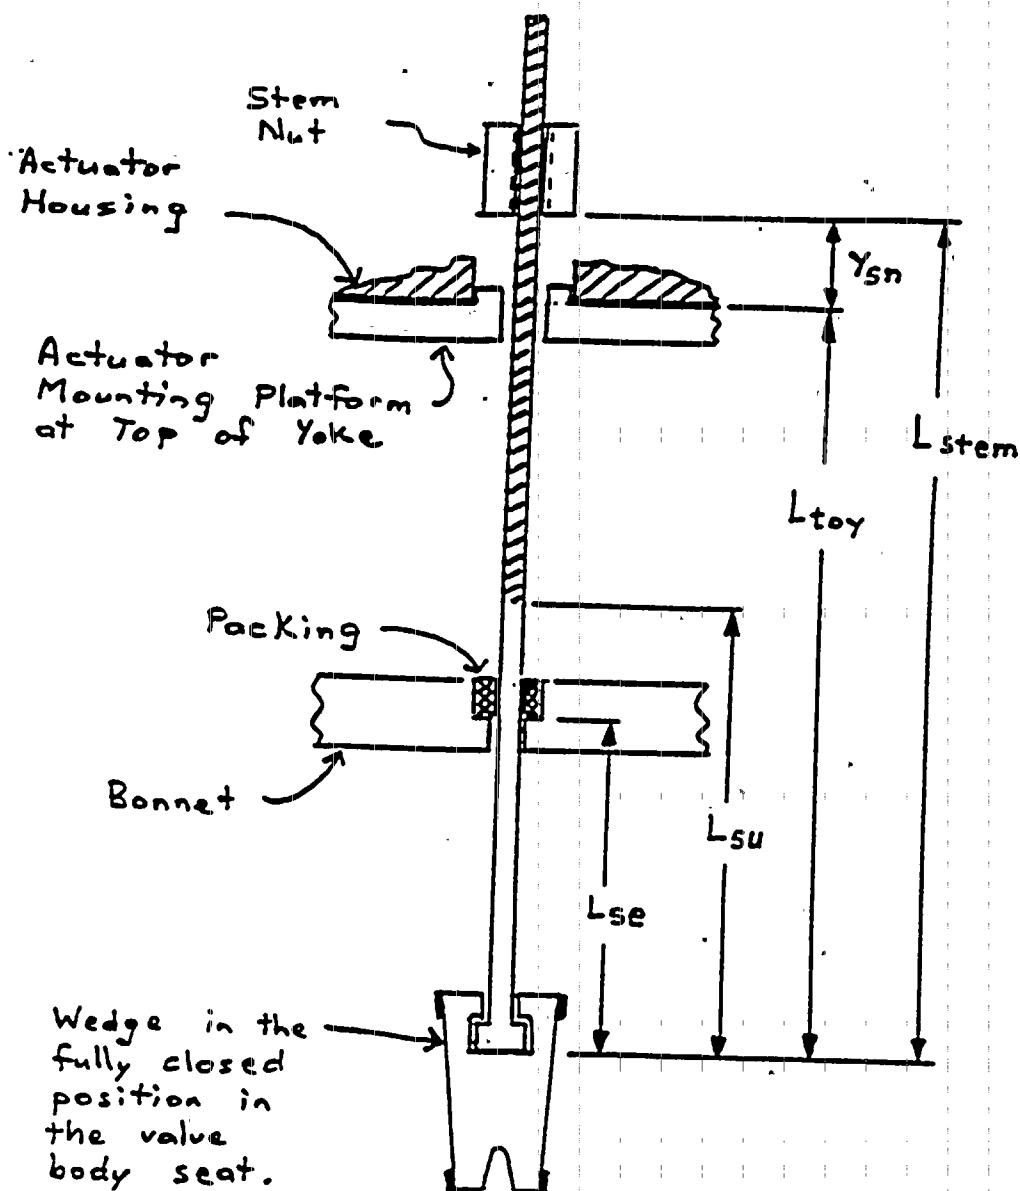
Figure 4

K_h = stiffness of disk hub for axial load $F_b t$

Other dimensions needed in order for TU Electric to perform the desired analyses are illustrated in Figure 4: the length L_{st} of the stem from the bottom of the stem "T Head" to the bottom of the packing chamber in the valve bonnet when the valve is in the closed position with the disk pushed hard into the valve body seat by the stem, and the length L_{sm} of the stem from the bottom of the "T Head" to the start of the threaded section of the stem. Also required is the length L_{stem} of the stem from the bottom of the stem "T Head" to the bottom of the actuator stem nut when the stem is pushing the wedge hard into the valve body seat:

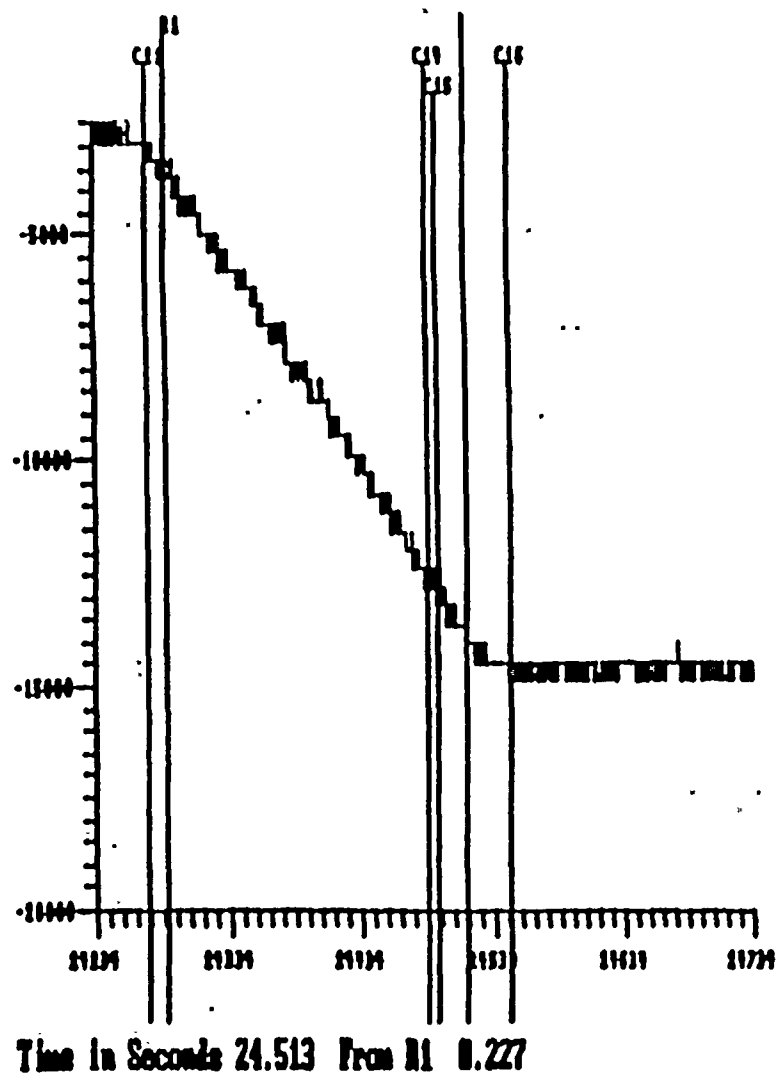
Test: 5
10/14/93
15:46:31

CALIBRATOR/
ALX SENSOR
-14814.5
(lbs)
