TECHNICAL EVALUATION REPORT ON THE
"SUBMITTAL-ONLY" REVIEW OF THE
INDIVIDUAL PLANT EXAMINATION OF EXTERNAL EVENTS
AT TURKEY POINT NUCLEAR PLANT, UNITS 3 AND 4

FINAL REPORT

Completed: January 1997
Final: January 1998

Energy Research, Inc.
P.O. Box 2034
Rockville, Maryland 20847-2034

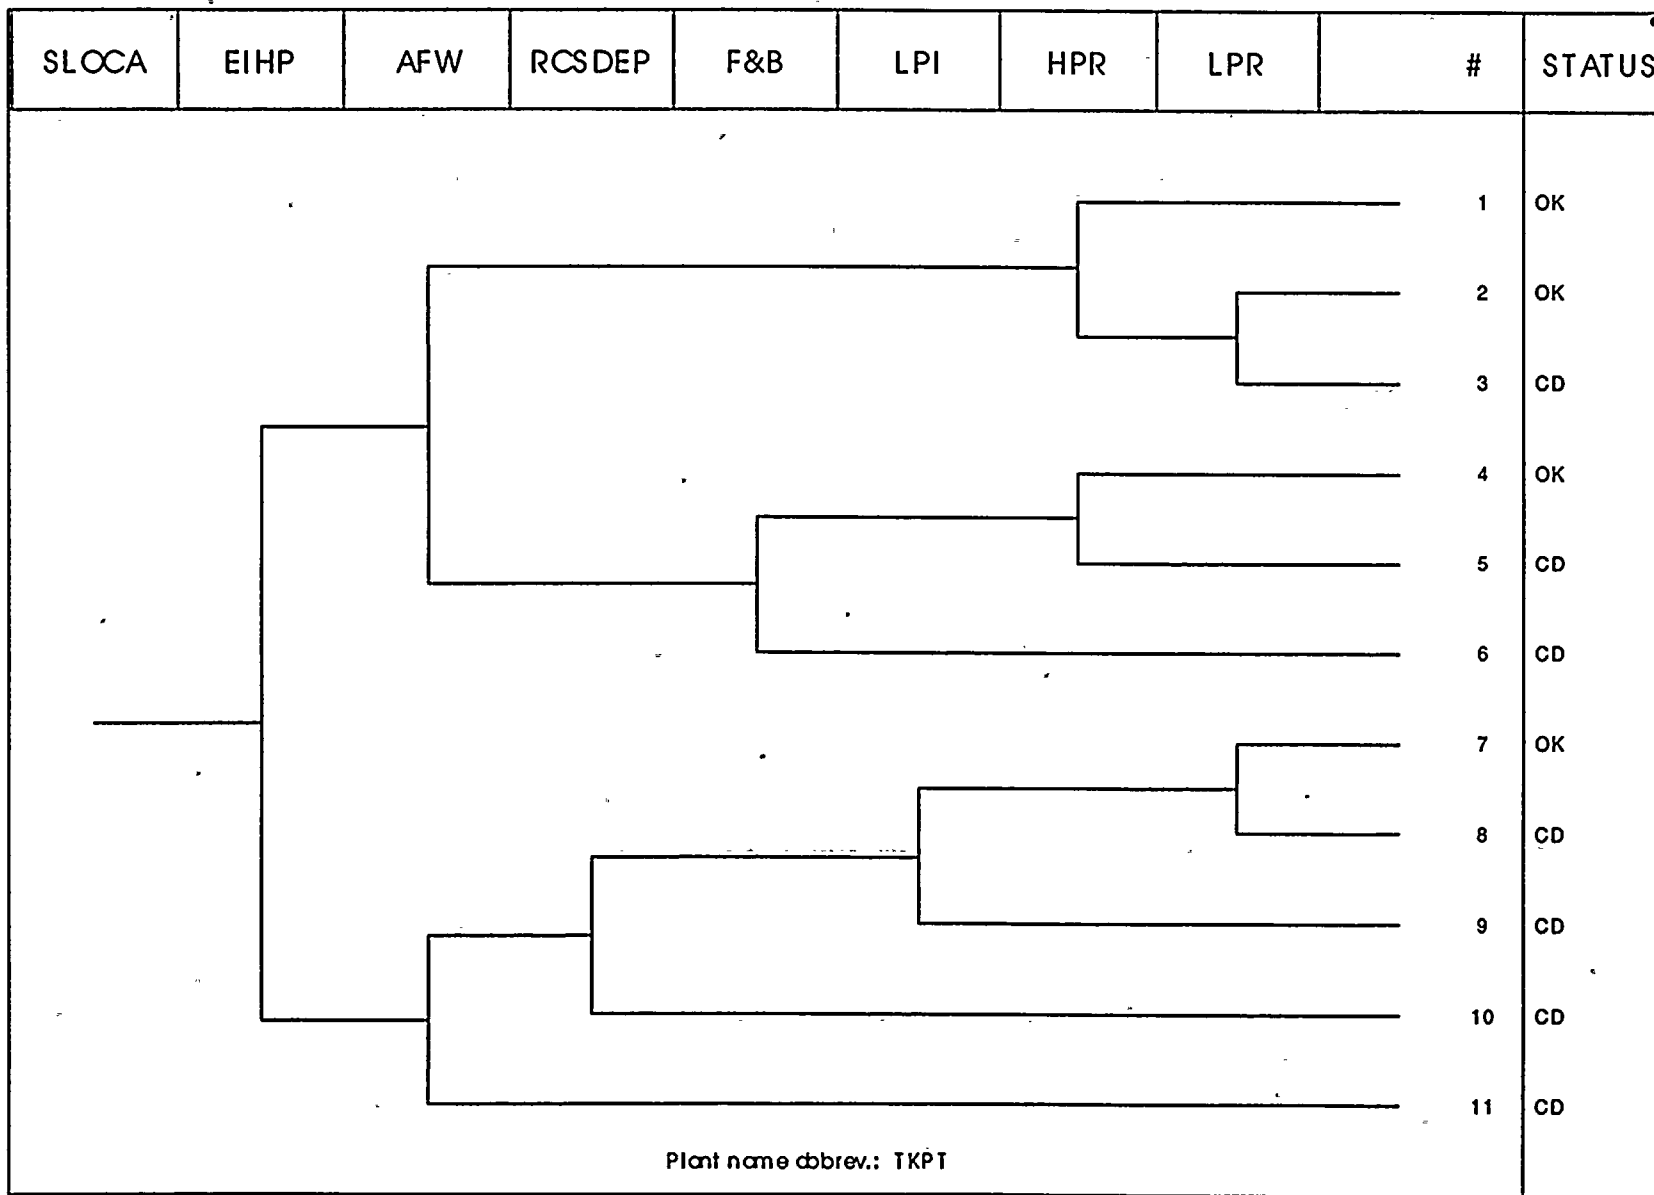
SLOCA	EIHP	AFW	RCSDEP	F&B	LPI	HPR	LPR	#	STATUS

1	OK
								2	OK
								3	CD
								4	OK
								5	CD
								6	CD
								7	OK
								8	CD
								9	CD
								10	CD
								11	CD
