SUBJECT: Request relief from certain requirements of ASME Section XI,
1992 Edition.Relief request 20 re exemption of tendon insp,
encl.

L-99-075
10 CFR 50.55a

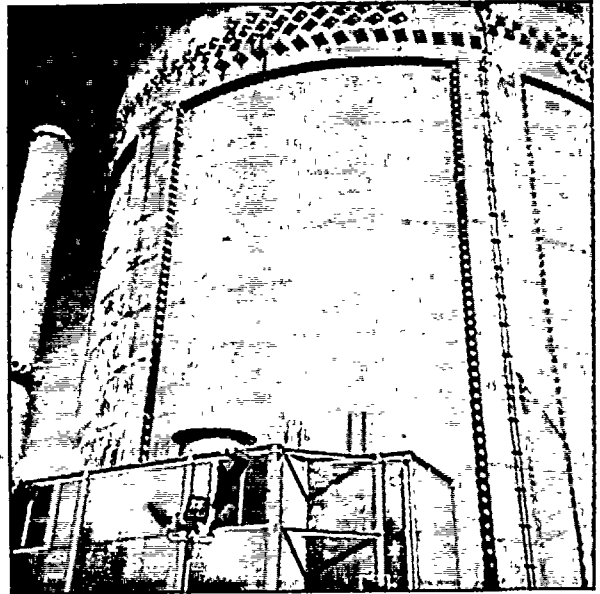
**Photos of Units 3 and 4 Containment Buildings and main steam safety
and atmospheric dump pipes.**

UNIT 3
VIEW LOOKING EAST

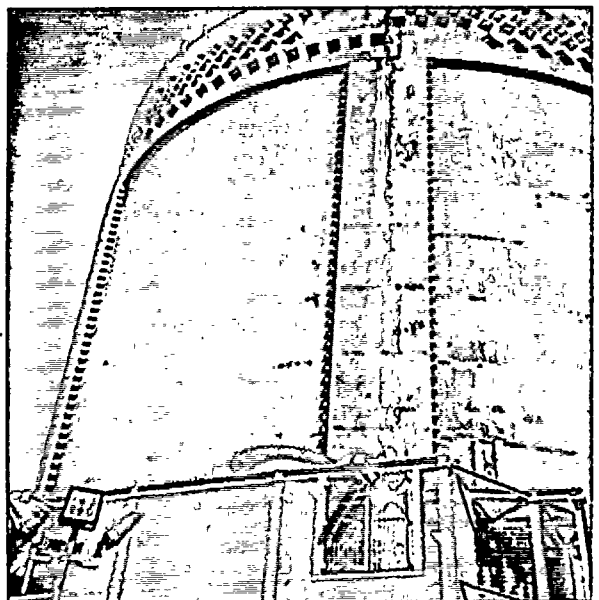
UNIT 4
VIEW LOOKING EAST

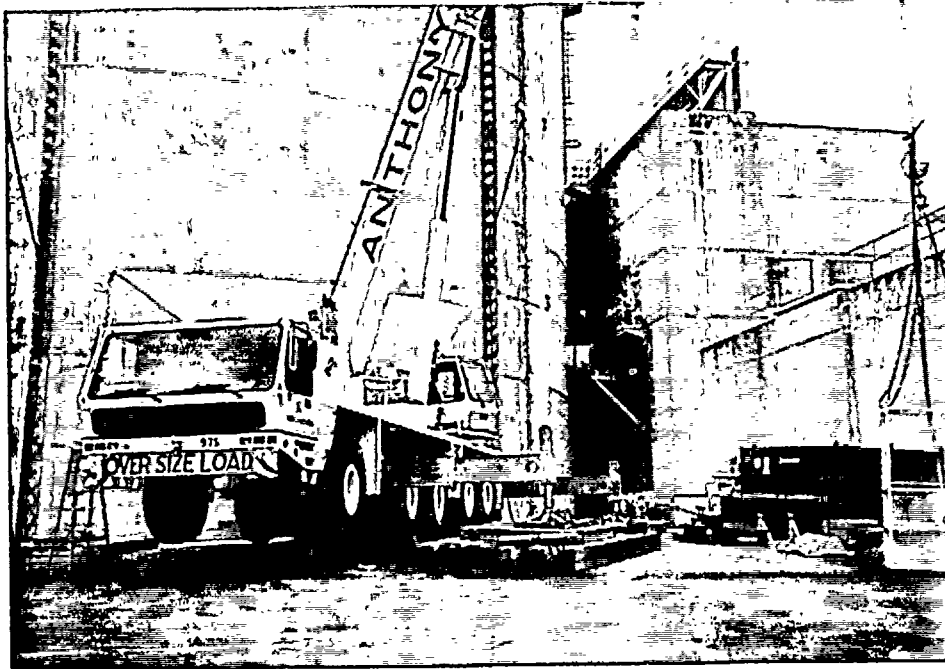
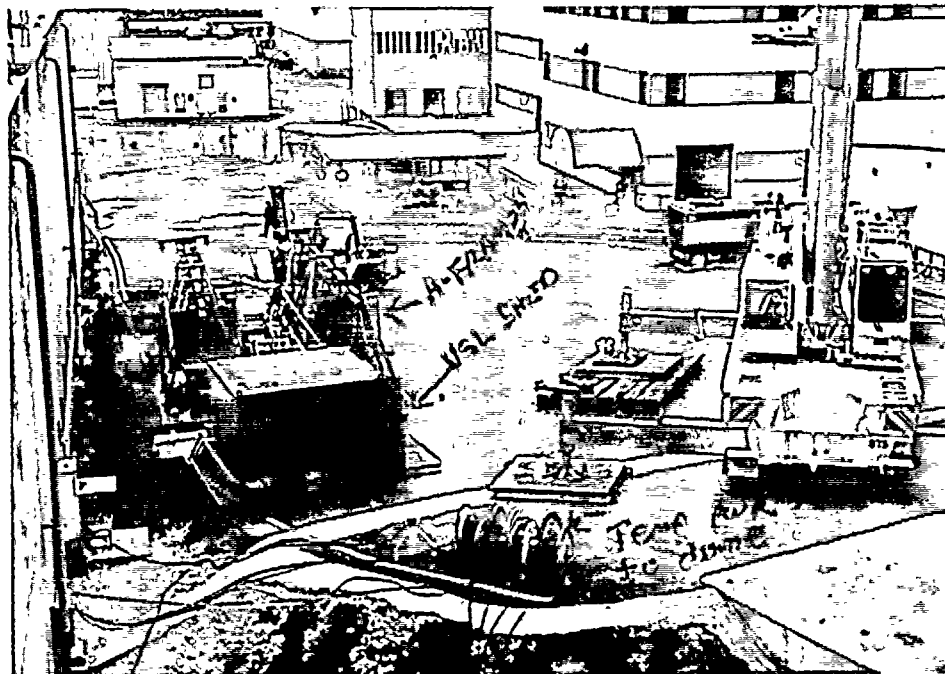
Photos of crane and/inspection equipment on Unit 4 ramp during 25th year tendon inspection.
