H. B. ROBINSON STEAM ELECTRIC PLANT, UNIT NO. 2
DOCKET NO. 50-261/RENEWED LICENSE NO. DPR-23

H. B. ROBINSON STEAM ELECTRIC PLANT, UNIT NO. 2 - REQUEST FOR ADDITIONAL INFORMATION REGARDING APPLICATION TO REVISE TECHNICAL SPECIFICATION SURVEILLANCE REQUIREMENT FREQUENCIES TO SUPPORT 24-MONTH FUEL CYCLES

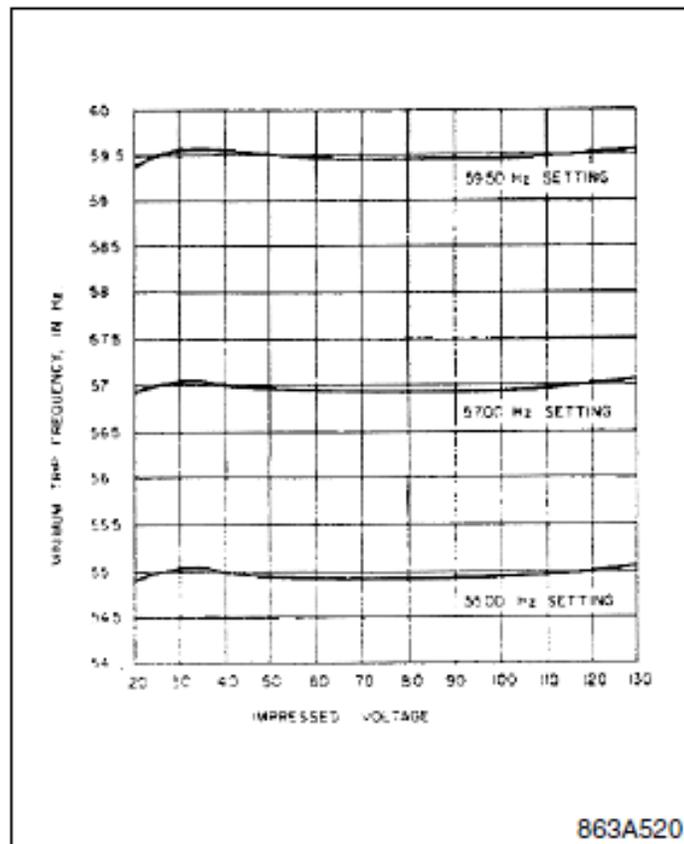
The RCP Underfrequency (UF) relays are Westinghouse type KF underfrequency relays. The calibration of these relays is based on Westinghouse Installation, Operation, and Maintenance Instructions I.L. 41-503F, effective May 1968. The voltage versus frequency setpoint response is relatively flat between 120VAC and 40VAC as shown below:

Figure 7: Typical Voltages vs. Minimum Frequency Curves 60 Hertz KF Underfrequency Relay

The vendor maintenance instructions include verification that the frequency trip setpoint is between 0.06Hz and 0.08Hz above the desired trip frequency when the applied voltage is reduced from 120VAC to 40VAC. This verification of frequency trip point over varying voltages (120VAC and 40VAC) is referred to in the discussion below as consistency of trip setpoint. RNP Calibration Procedure PIC-806, Westinghouse Type KF Underfrequency Relay, provides a desired trip setpoint of 58.20Hz for 120VAC applied voltage, with a tolerance of 58.00Hz to 58.40Hz. At the 40VAC applied voltage, the desired trip setpoint is 0.07Hz greater than the 120VAC frequency setpoint, and a tolerance of 0.060Hz to 0.080Hz above the 120VAC frequency setpoint.
