TERMINATION MODULE

FINAL RESOLUTION

Conductor Insulation Damage of T-MODS Located In Termination Cabinets.

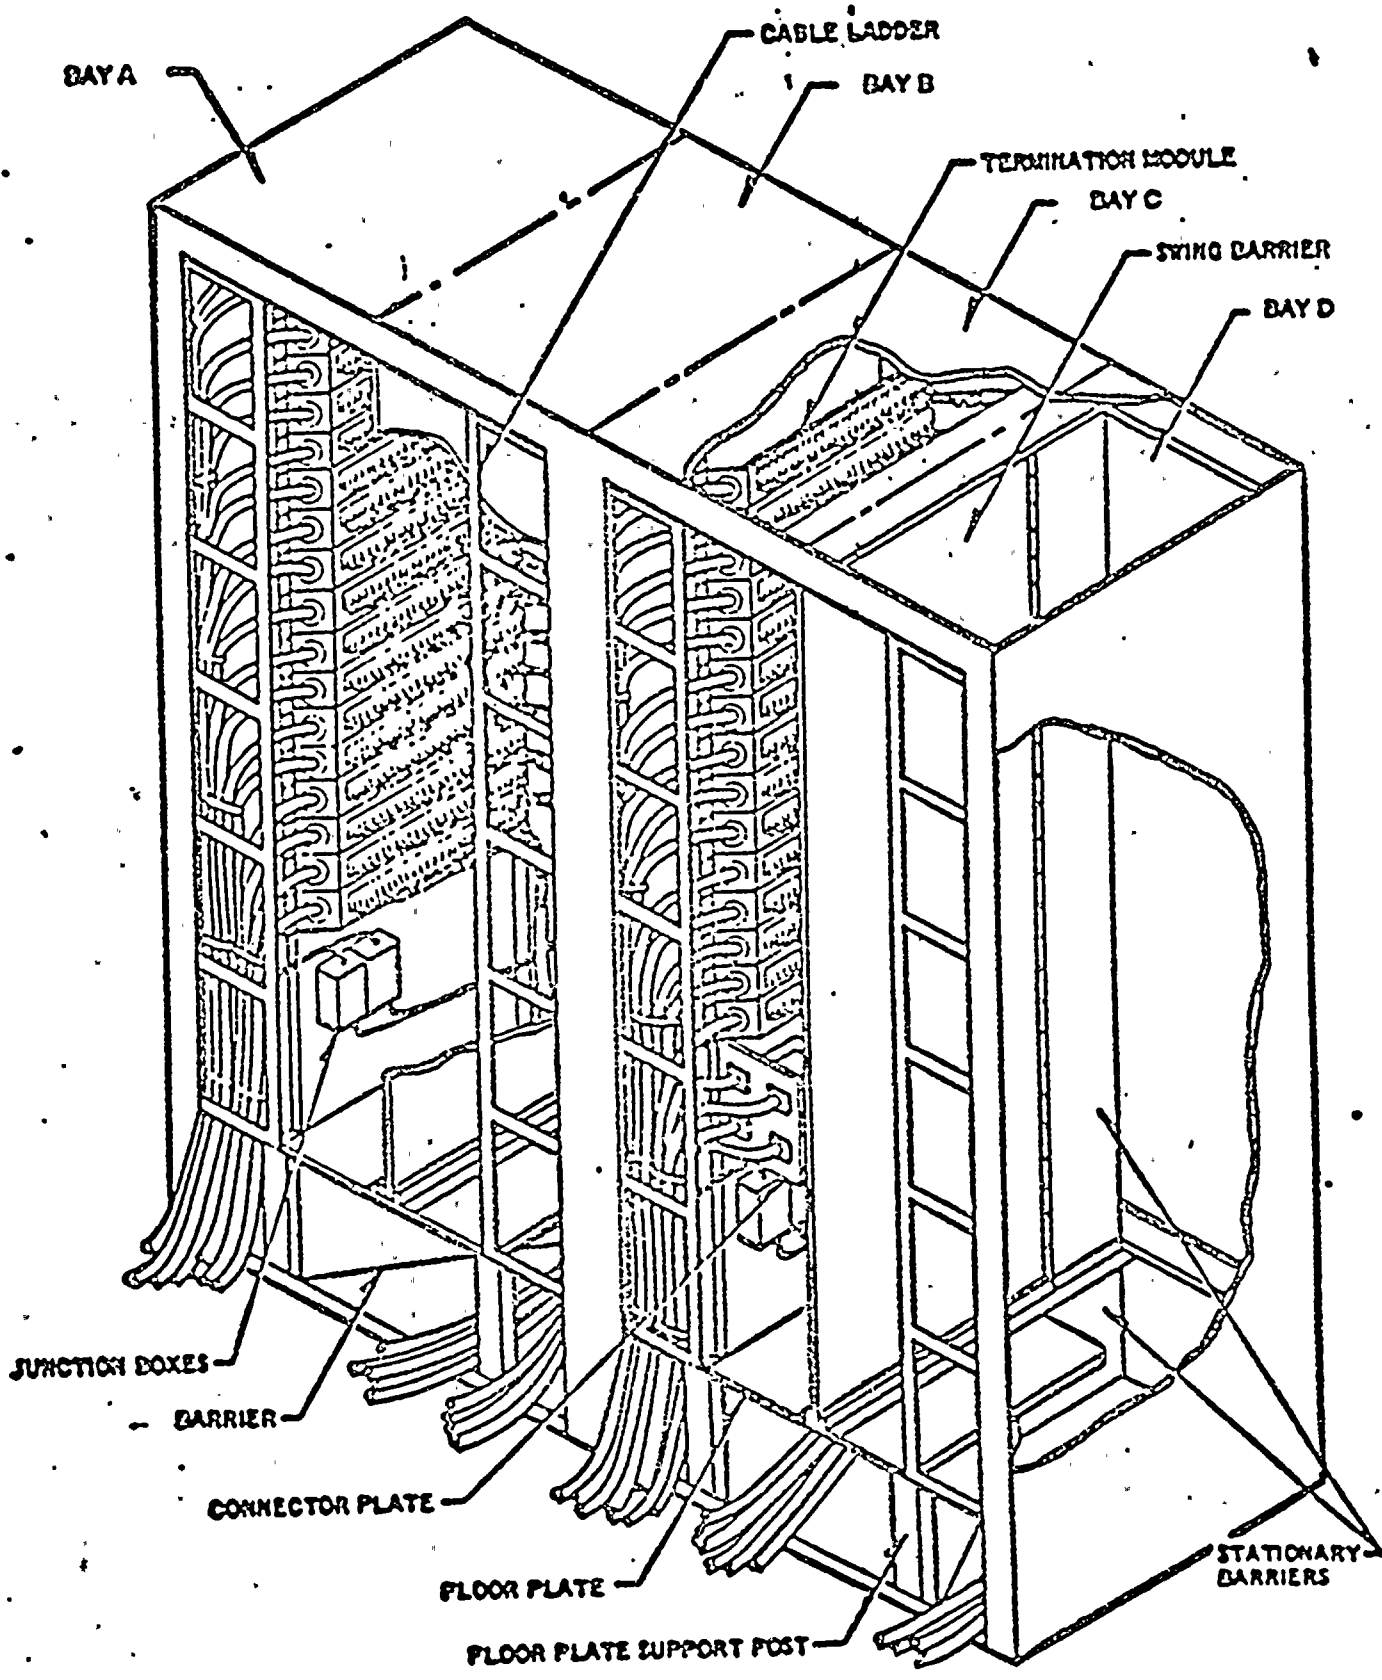
Figure 2-4. Assembled Termination Cabinet (Doors removed for clarity)

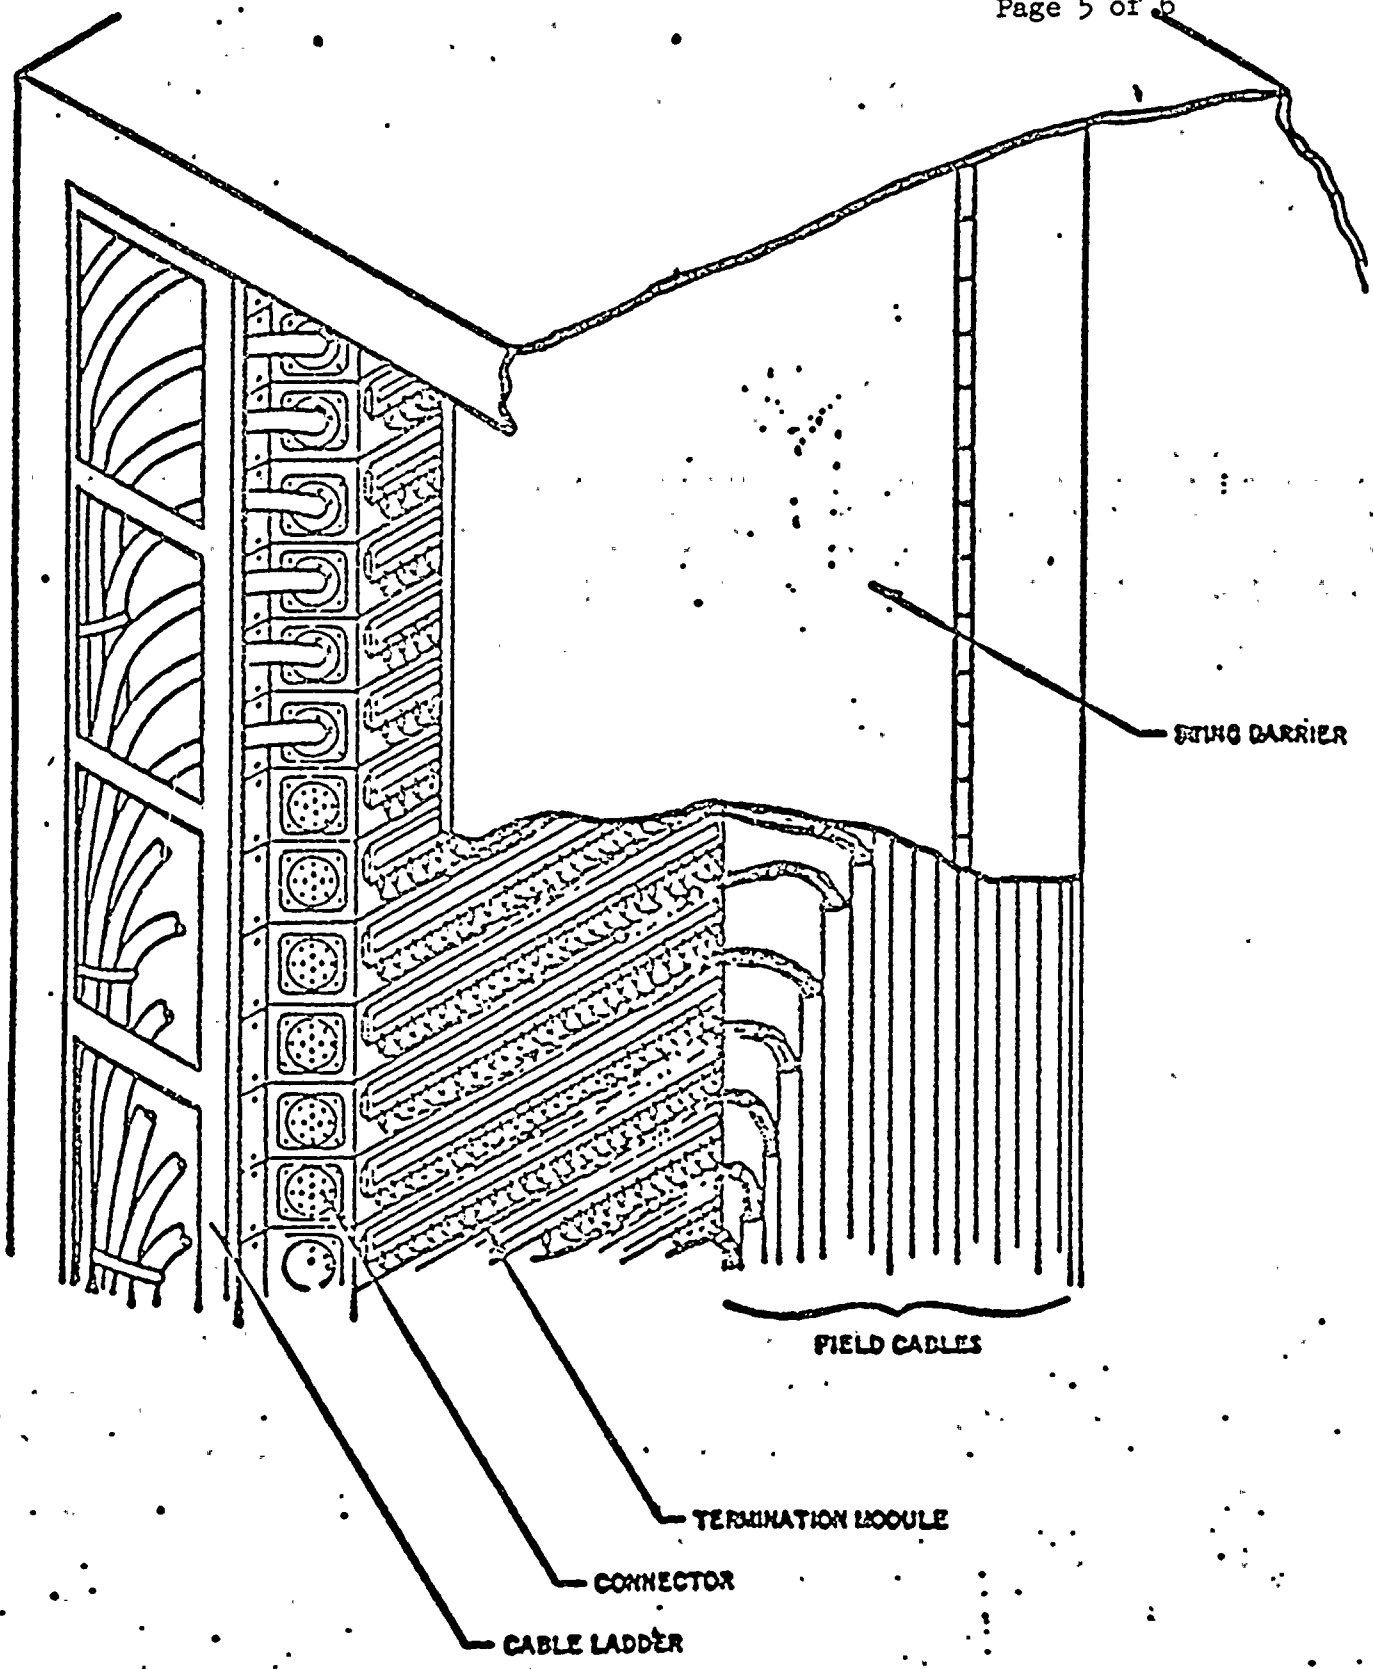
Figure S-5. Termination Cabinet Assembly

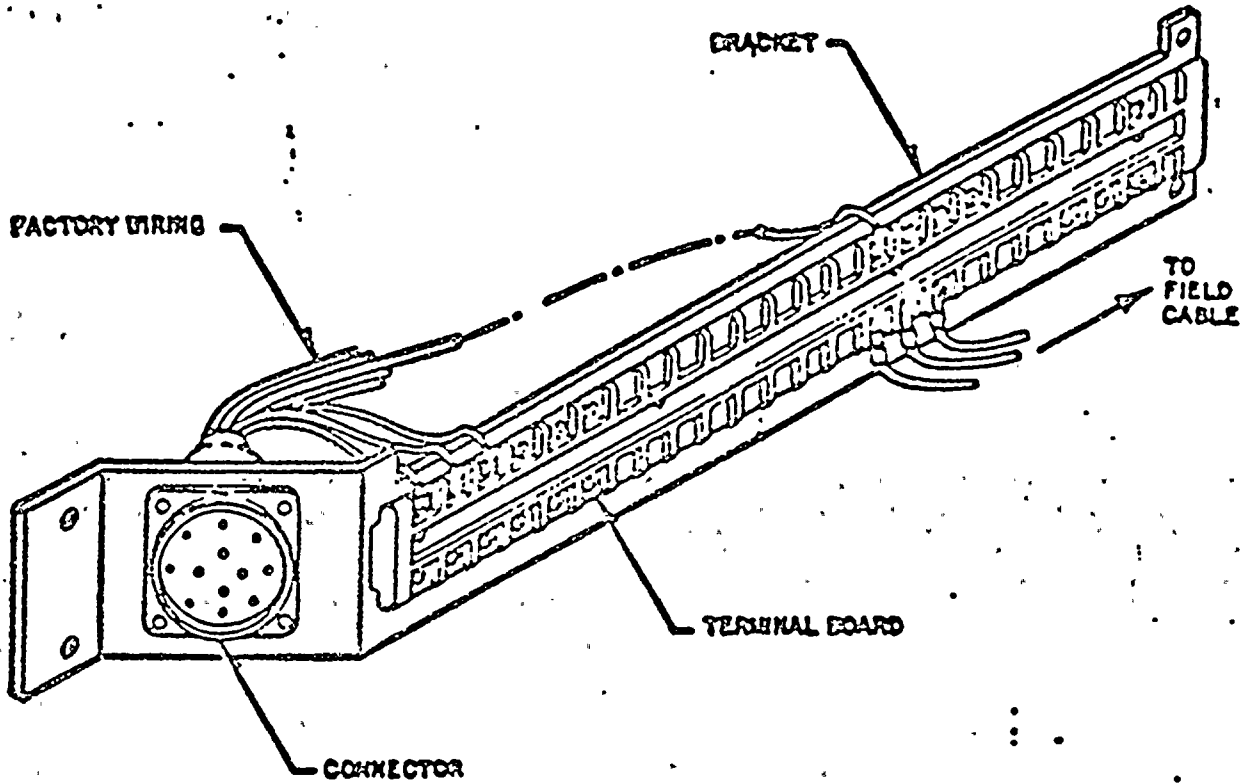
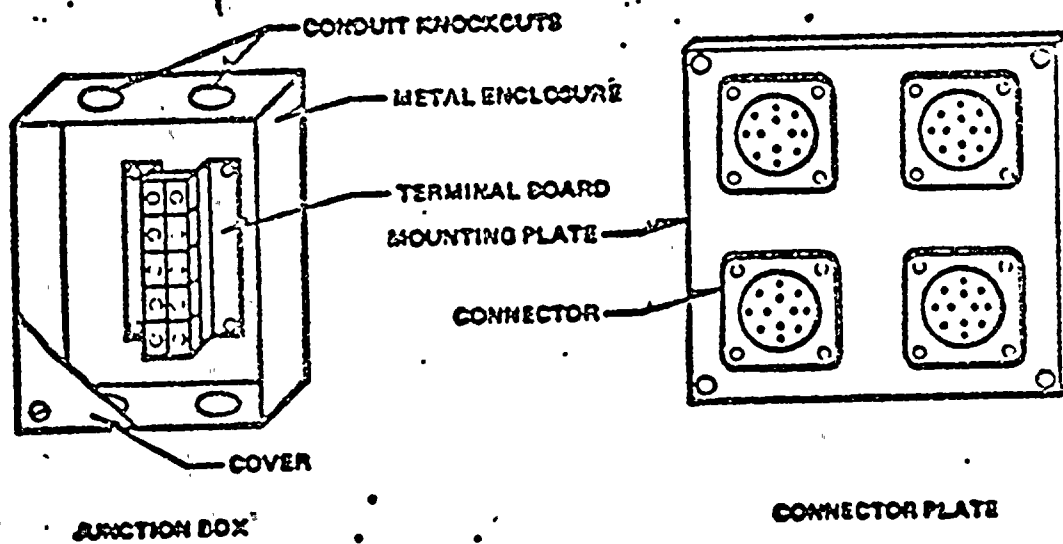
Figure 3-8. Termination Devices

It was determined by GE that 95% of the damaged units were Hi-Density Termination Modules (21 and 48 pin assemblies which use twisted shielded pair and triple cables - 20 awg wire with ferrule terminations on the shields). During the reassembly (i.e., pin insertion and extraction using the standard Amphenol tooling of the termination modules) continual difficulty was observed. The ferrule edge during extraction, and the sharp insertion tool edge during assembly, impacted on the densely packed wires at the connector area. Further damage (3 abrasions out of 900 conductors) was observed during the reassembly operation. The assembled units were then re-inspected and the three added defects were noted.

It was also noted that the sharp edges of the termination module frames caused indentations on the wire insulation of improperly stacked units. It was seen that this was caused by the sharp edge of the steel frame of one module laid against the unprotected wire bundles of an adjacent module. Handling precautions are required to prevent this type of damage, since it can potentially occur any time two modules contact each other.
