**Consumers  
Power  
Company**

DOCKET 50-255 - LICENSE DPR-20 -  
PALISADES PLANT - SEP TOPIC III-3.C,  
INSERVICE INSPECTION OF  
WATER CONTROL STRUCTURES

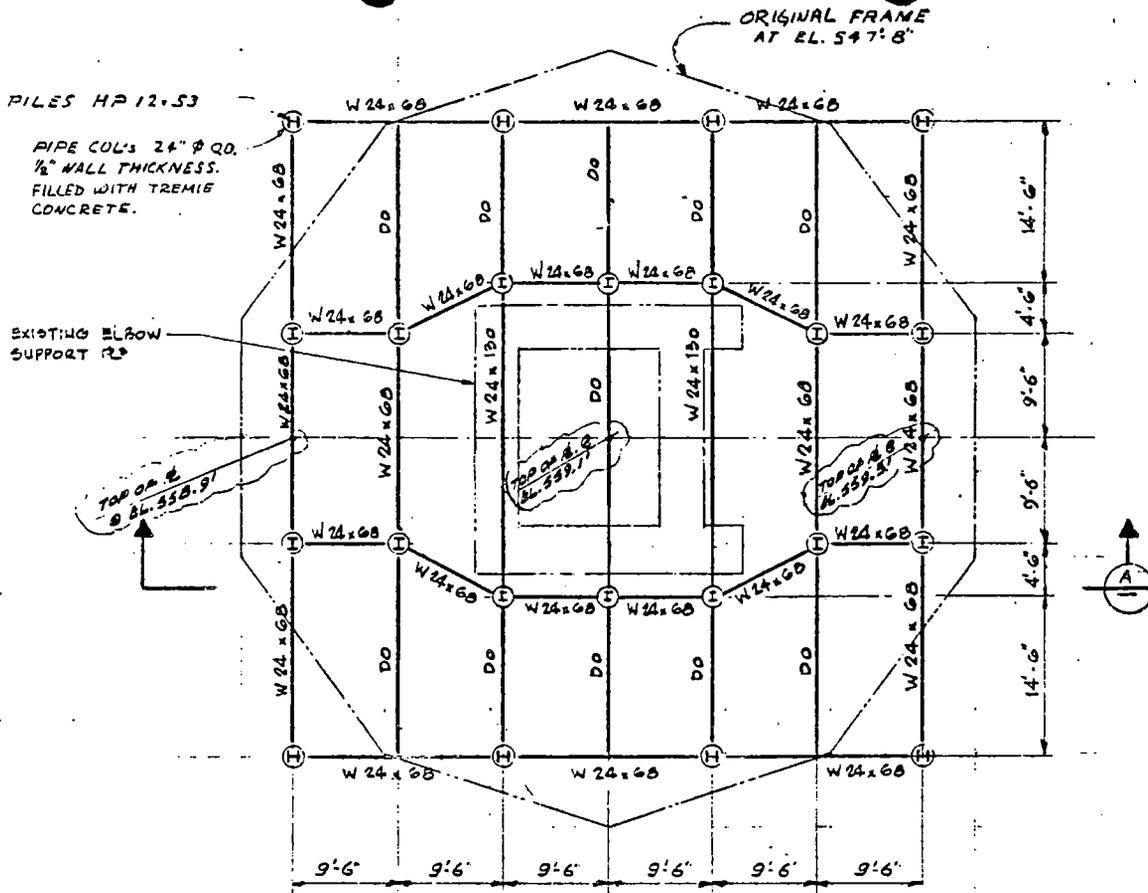
Palisades Plant Intake Crib Structure

PLAN AT EL. 560'-0"  
T.O.S. (EL. VARIES) UNLESS SHOWN OTHERWISE

Fourth, as noted previously, the intake crib superstructure was replaced in mid-1971 due to ice damage which occurred during the previous winter. The new structure is much more substantial than the original. Since that time, the new structure has gone through eleven winters of normal lake ice movement. Inspections of the crib which were performed in 1972 and 1975 revealed no damage and no operating problems which might be attributable to the intake bell or crib have been observed since that inspection.

In summary then, more than ten years and eleven winters have passed since replacement of the intake crib structure with no operational problems due to intake pipe and structure damage or blockage. The sand removal which has been performed was not to correct flow problems but was simply considered good practice. Even if flow blockage of the intake pipe were to occur, however, ample warning and corrective actions are available to ensure sufficient flow to the service water system.
