# **Nuclear Material Events Database**

## **Medical Events Involving Y-90 Microsphere Brachytherapy (Fiscal Year 2008-2017)**

Published January 2018

# Medical Events Involving Y-90 Microsphere Brachytherapy (Fiscal Year 2008-2017)

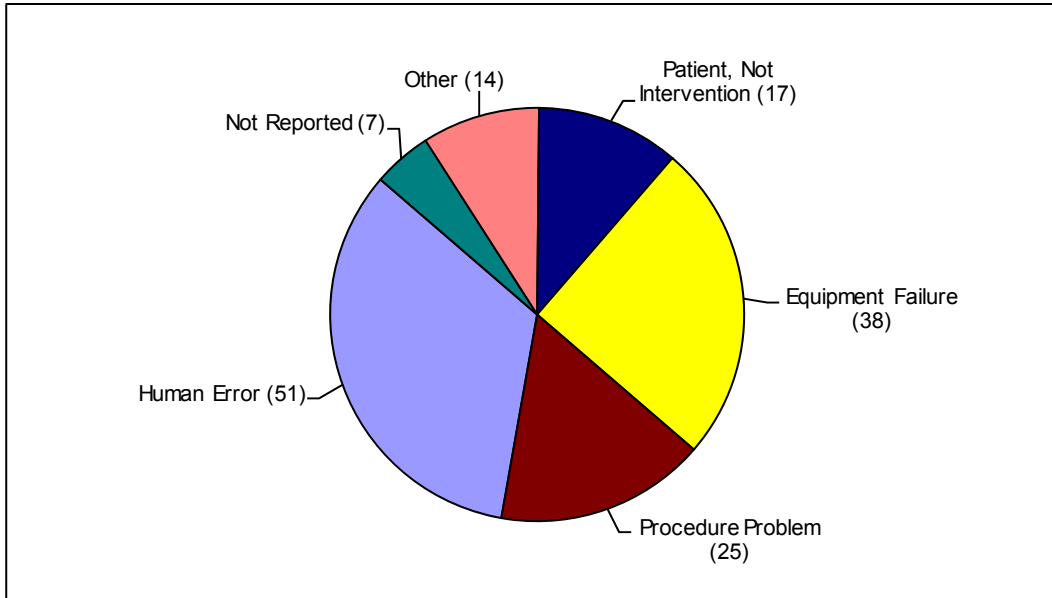
Figure 2 displays the event causes and Figure 3 displays the types of problems encountered (based on reporting requirements). Because this data is very similar between the TheraSphere and SIR-Sphere events, the differences are not highlighted here. Note that although each event has only one cause (Figure 2), the event may involve more than one type of problem (Figure 3). For example, an event where a portion of the microspheres intended for the liver were inadvertently deposited in the duodenum may be reported as less dose than prescribed for the intended site [10 CFR 35.3045(a)(1)(i)] and more dose than expected to the unintended site [10 CFR 35.3045(a)(3)].

Figure 2. Event Causes

The Patient, Not Intervention data in Figure 2 represents events that do not result from patient intervention, yet are reported as beyond the control of the medical licensee. For example, an event where a non-intended site received microspheres due to a change in the patient’s vasculature between the time the treatment was planned and the time it was performed.

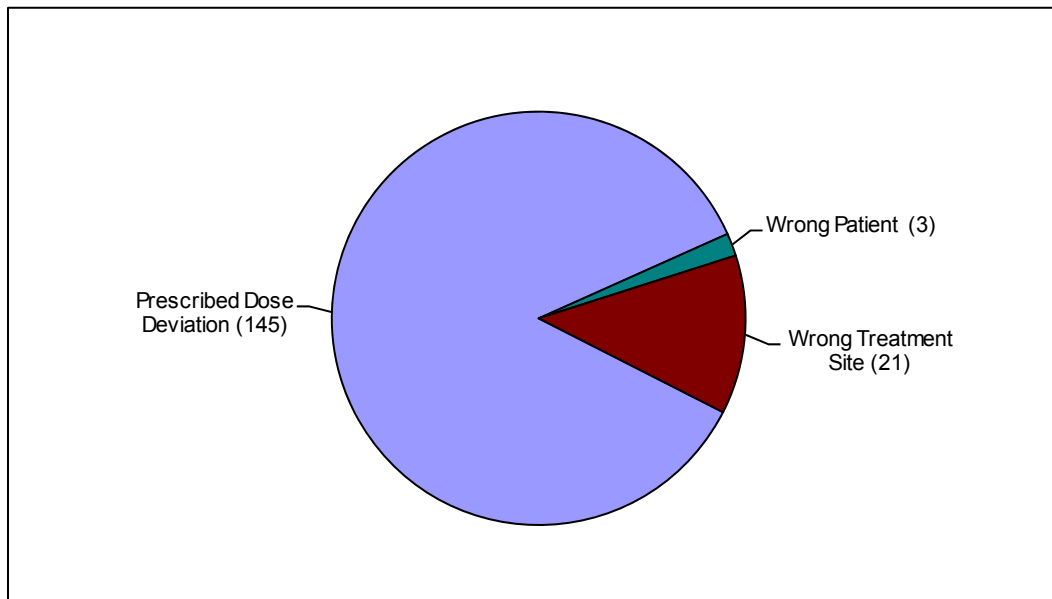
Figure 3. Event Problems (based on reporting requirements)

The Prescribed Dose Deviation data in Figure 3 includes both doses that were less than prescribed and doses that were more than prescribed.

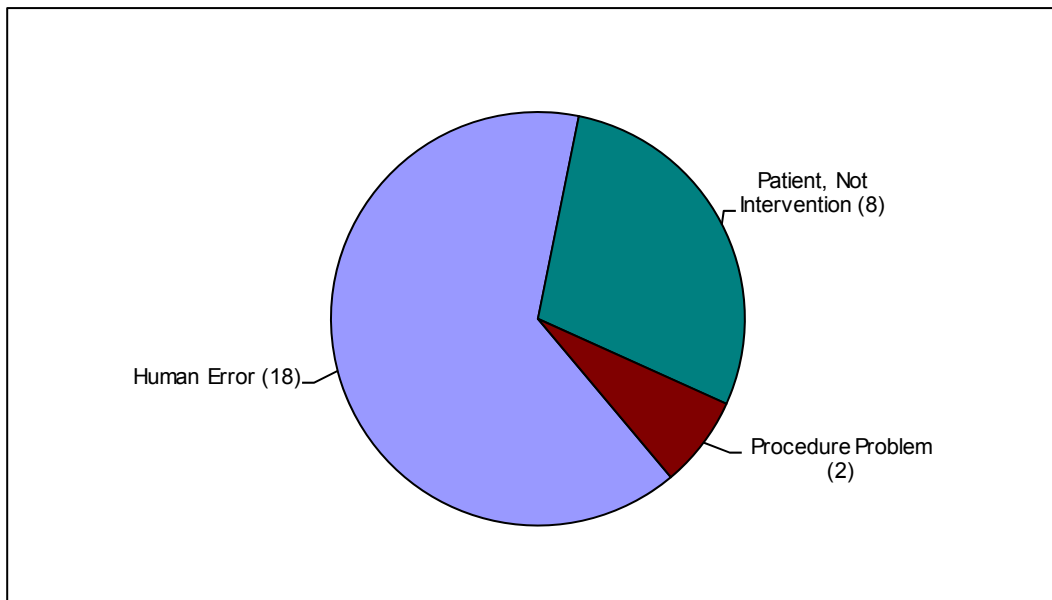
Figure 5 displays the causes of the 28 AO events. Because this data is very similar between the TheraSphere and SIR-Sphere events, the differences are not highlighted here.

Figure 5. AO Event Causes

None of the events resulted from patient intervention. The Patient, Not Intervention data in Figure 5 represents events that do not result from patient intervention, yet are reported as beyond the control of the medical licensee. For example, an event where an unintended site received microspheres due to a change in the patient’s vasculature between the time the treatment was planned and when it was performed. However, the majority of AO events were caused by factors within the licensee’s control (Human Errors and Procedure Problems).
