U.S. NUCLEAR REGULATORY COMMISSION  
REGION I

Report No. 50-311/87-29

Facility Name: Salem Unit 2

Areas Inspected: A special, announced team inspection was conducted to verify compliance with the requirements of 10 CFR 50, Appendix R, Section III.G, J, L and O concerning fire protection features to ensure the ability to achieve and maintain safe shutdown in the event of a fire.

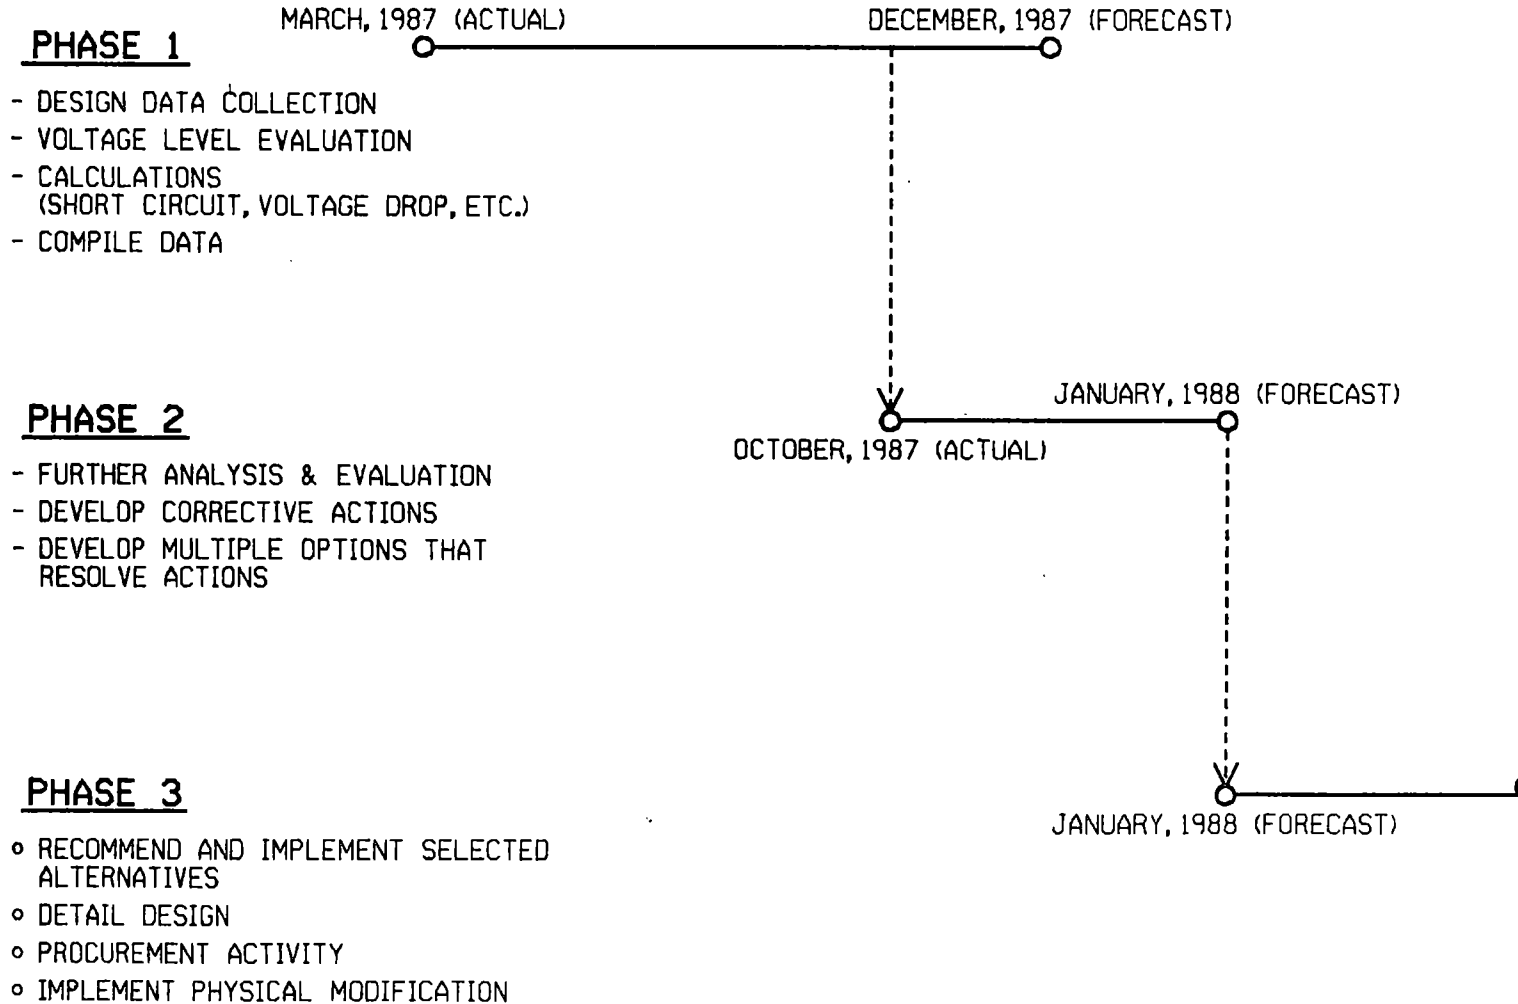
# SALEM ELECTRICAL DISTRIBUTION SYSTEM IMPROVEMENT PROGRAM

PHASE 1

DEVELOP A COMPREHENSIVE DESIGN BASIS INCLUDING:

- 1) DEVELOP A COMPREHENSIVE DESIGN BASIS INCLUDING:
  - A) DESIGN DOCUMENTS
  - B) CALCULATIONS
  - C) PROCEDURES
  - D) NRC LICENSING ISSUES
- 2) ANALYZE SYSTEM DEFICIENCIES/WEAKNESSES
- 3) DEVELOP FEASIBILITY STUDIES FOR SYSTEM IMPROVEMENT OPTIONS
