UNITED STATES
NUCLEAR REGULATORY COMMISSION
REGION IV
1600 EAST LAMAR BOULEVARD
ARLINGTON, TEXAS 76011-4511

SUBJECT: HOMESTAKE MINING COMPANY, NRC INSPECTION
REPORT 040-08903/2018-001

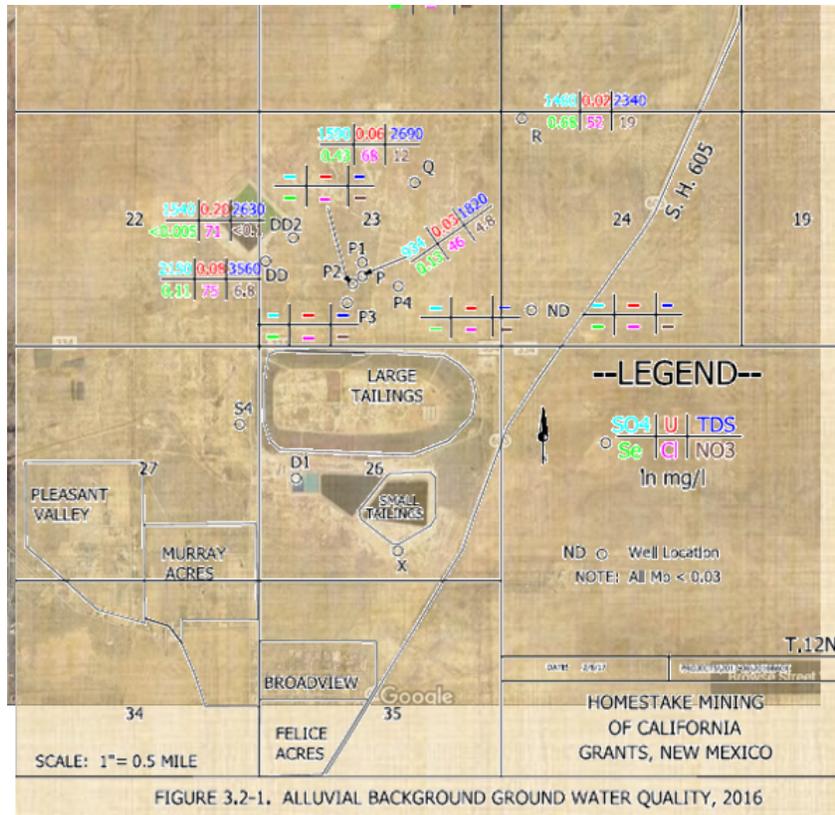
Figure 1. Overlay of Alluvial Background Ground Water Quality with Satellite Images (adapted from Figure 3.2-1 of the 2016 Annual Performance Report for Homestake and Google Maps)

Evaporation Pond EP-3 was approved by License Amendment 35 and is discussed in the NRC's Technical Evaluation Report dated June 26, 2008 (ADAMS Accession No. ML080920562). License Condition 35.A states, in part, that "[w]ell DD and one additional monitoring well to the middle of the southeast side of EP-3 (to be named later) is to be added to the Table list and will be monitored semi-annually for the B and F list of parameters." An overlay of satellite images and monitoring wells from the 2016 Annual Performance Review (see Figure 1 below) shows well DD2, which was drilled in 2008 and is located on the southeast side EP-3. The inspectors concluded that well DD2 was the well "to be named later" as currently listed in the license. Additionally, during the site inspection, the licensee's site hydrologist identified well DD2 as the unnamed well described in License Condition 35.A. The NRC plans to update this license condition during a future revision of the license.
