RAI 3.6.2.2.2-1a (High Voltage Insulators)

LRA 3.6.2.2.2 Degradation of Insulator Quality due to Presence of Any Salt Deposits and Surface Contamination, and Loss of Material due to Mechanical Wear

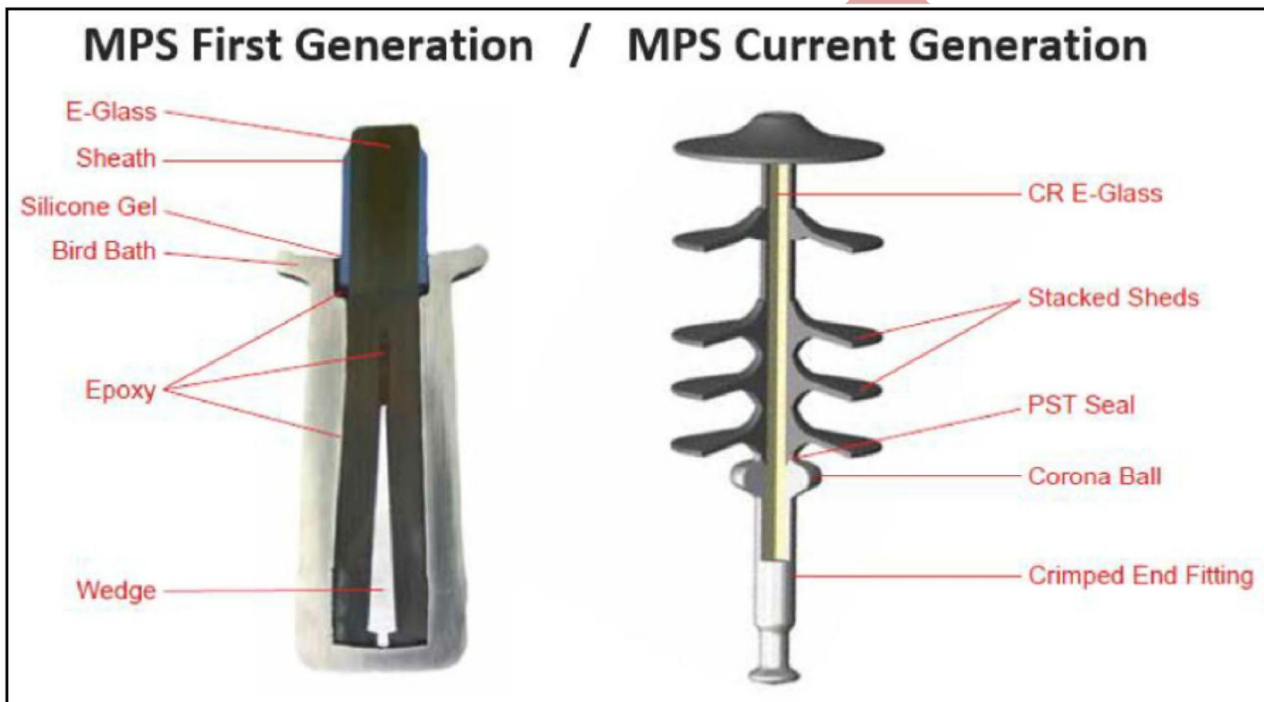
The RBS polymer high-voltage insulators are a recent generation of MPS polymer insulators that have been manufactured since 2007. The RBS polymer insulators do not use epoxy. The following figure shows the difference between the first generation of MPS polymer insulators and the generation of MPS polymer insulators that are used at RBS.

The MPS polymer insulators in service at RBS use a PST sealing system, which is a triple seal design. The triple seal or PST seal comprises the primary seal (P), the secondary seal (S), and the tertiary seal (T). The primary seal is a silicone rubber sheath compressed into the chamfer of the crimped end fitting. The secondary seal is RTV (room temperature vulcanizing) silicone applied to the rod, sheath, and end fitting interface. The tertiary seal is a final external RTV silicone seal applied to the sheath and end fitting interface. The RBS polymer insulators do not utilize silicone gel. The response to RAI 3.6.2.2-1 included silicone rubber, but did not explicitly identify RTV silicone as a type of silicone rubber. The silicone rubber material includes the RTV silicone that is part of the PST seal system. The RBS polymer insulators do not include silicone gel or sealants other than RTV silicone.
